# JOINT INVESTIGATION REPORT

INCIDENT NO: 3030308 JIV report S/N: 0000966

1. Fountain Incident Number: 3030308 2. Type of incident: OIL SPILL  
3. Name of Location: 4" MORIVER WELL SBT FLOWLINE  
4. Name of nearest community: ODAGWA 5. State: RIVERS 6. LGA: ETCHE  
7. Production Facility/Installation: CRUDE OIL FLOWLINE  
8. Asset Owner/Hub: THE SHELL PETROLEUM DEVELOPMENT COMPANY OF NIGERIA LIMITED / LAND EAST HUB.

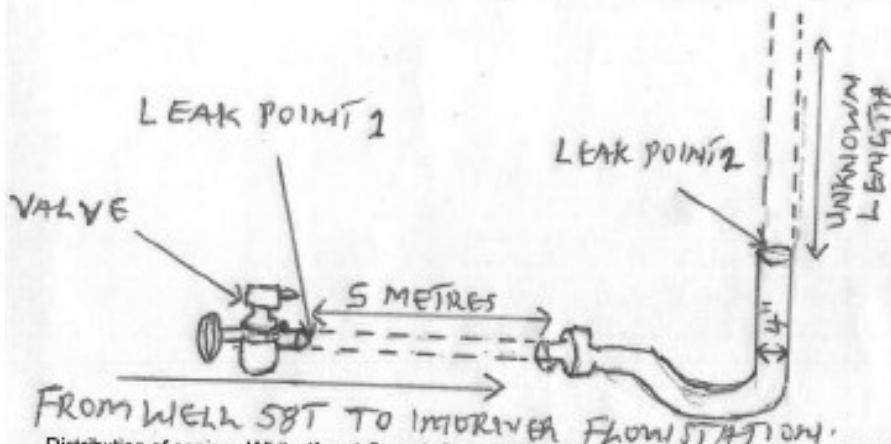
LONG STRETCH OF AN EXCAVATED TRENCH BY UNKNOWN PERSON(S) WAS OBSERVED.

| <input type="checkbox"/> Failed Weld-on illegal hot tap valve | <input type="checkbox"/> Failed Clamp, | <input checked="" type="checkbox"/> Missing Pipeline/Flowline |

SECTION OF 4" IMO RIVER WELL SBT FLOWLINE AT ODAGWA SHOWING POSITIONS OF MISSING FLOWLINE.

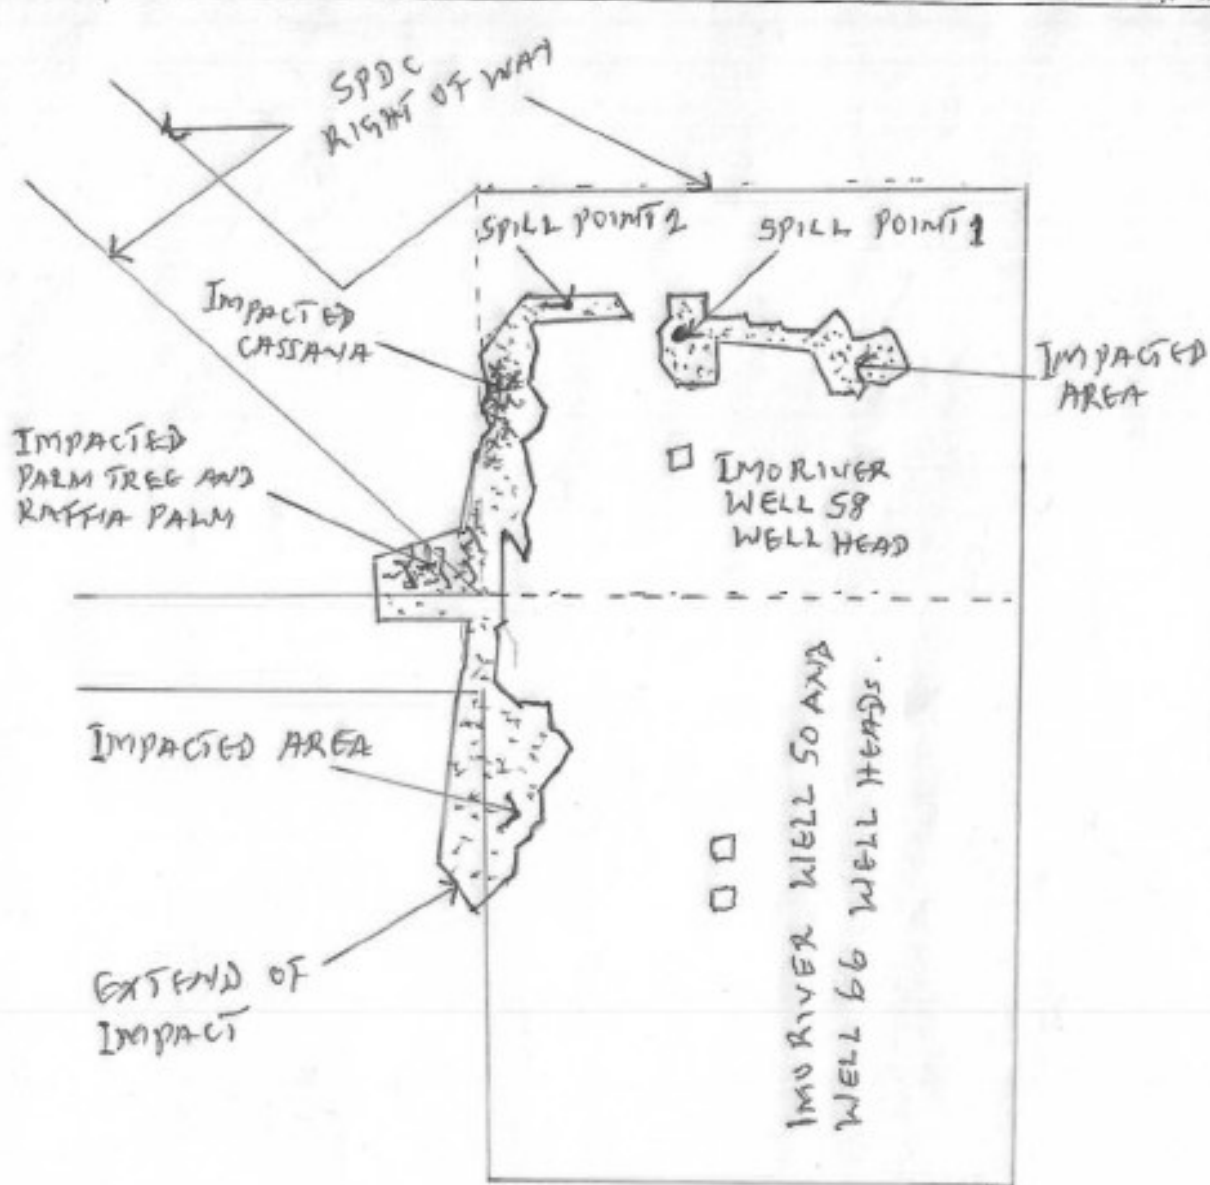
f. Appendix 1: Overview sketch of the site

Location: 4" IMORIVER WELL 58T FLOWLINE AT ODAGWA
