JOINT INVESTIGATION REPORT

INCIDENT NO: 3043673 JIV report S/N: 01/75

1. Escalant Incident Number: 3043673 2. Type of incident* OIL SPILL
3. Name of Location 36" RUMUEKPE - NKPOKU PIPELINE
4. Name of nearest community MBODO ALUU 5. State RIVERS 6. LGA IKWERRE
7. Production Facility Installation CRUDE OIL PIPELINE
8. Asset Owner Hub THE SHELL PETROLEUM DEVELOPMENT COMPANY OF NIGERIA LTD (SPDC)/PIPELINE

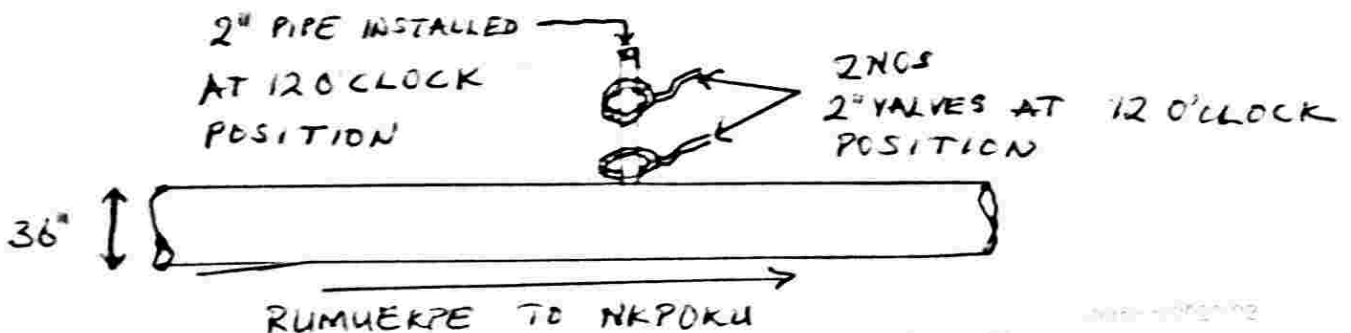
| <input checked="" type="checkbox"/> Crude oil theft (illegal bunkering) point, | <input type="checkbox"/> Saver-pit over flow | <input type="checkbox"/> Third party tampering with Clamp |

- Third party interference (Sabotage crude oil theft) Line theft Accidental 3rd party damage
 Operational Others (including Mystery spills) _____

E. GRAPHIC DESCRIPTION OF LEAK POINT (where detailed report of the leak point should be contained in the leak report, a rough sketch of the site should be added as an appendix) A SECTION OF 36" RUMUEKPE - NKPOKU PIPELINE AT ALUU SHOWING 2 NOS 2" BALL VALVE INSTALLED ON A 2" PIPE AT 12 O'CLOCK POSITION BY UNKNOWN PERSON(S)

REPAIR BY SPLIT-T ONGOING
