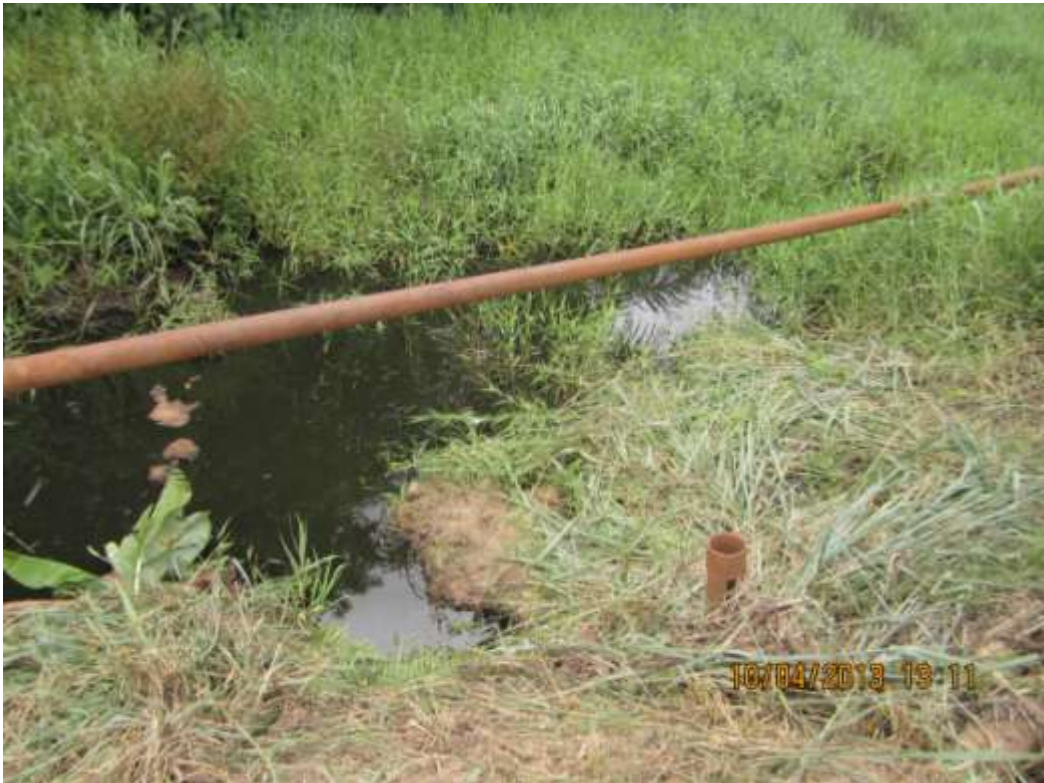
Overview: Part of spill impact on Adibawa Well8S flowline right of way at Edagberi. Picture was taken during Joint Investigation of 10th April 2013.

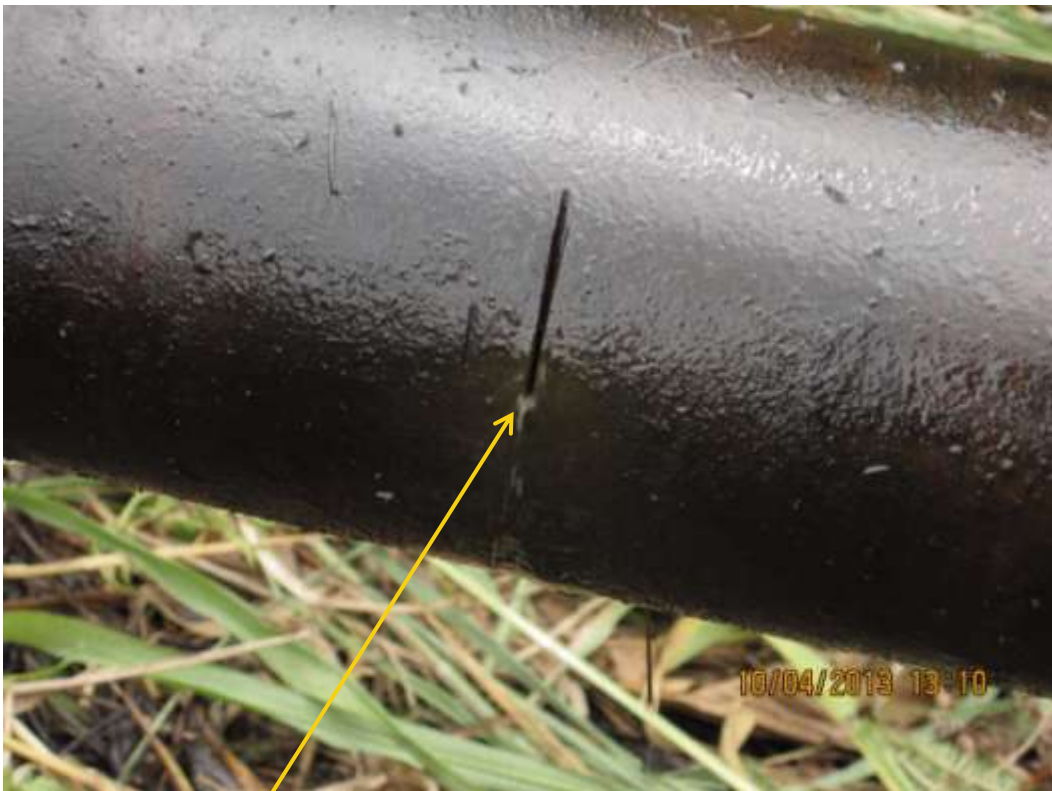
Close up: Hacksaw cut on Adibawa Well8S flowline at Edagberi. Picture was taken during Joint Investigation of 10th April 2013.
