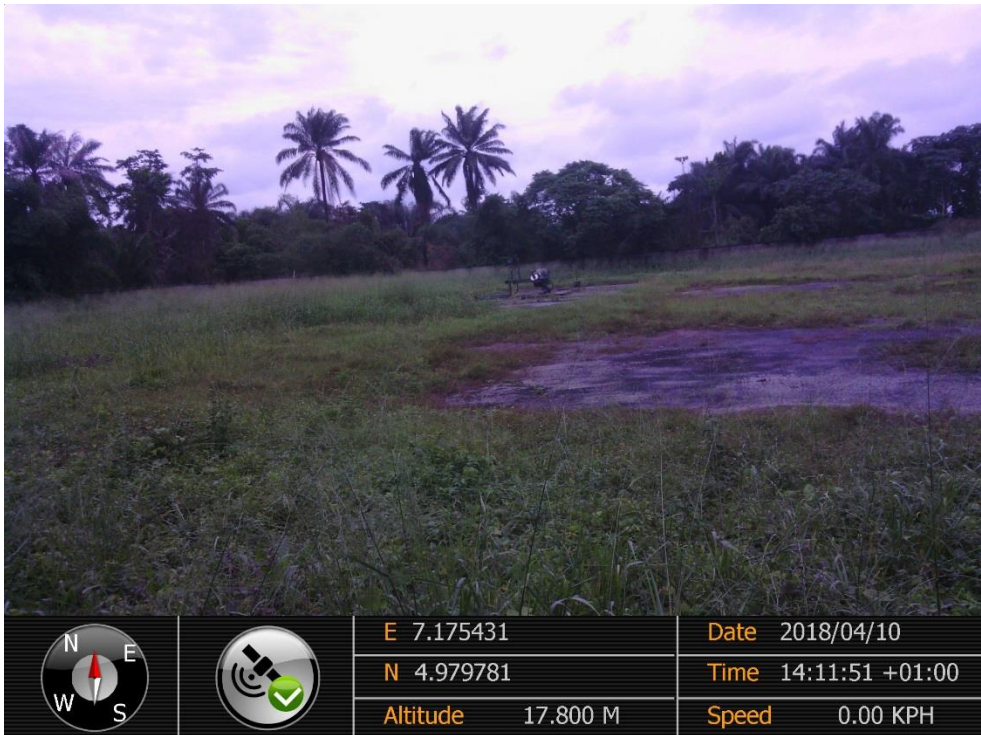
**Overview:** Part of spill impact on Imo River Well 31S 6" Flowline at Owaza. Picture was taken during Joint Investigation of 10<sup>th</sup> April 2018.

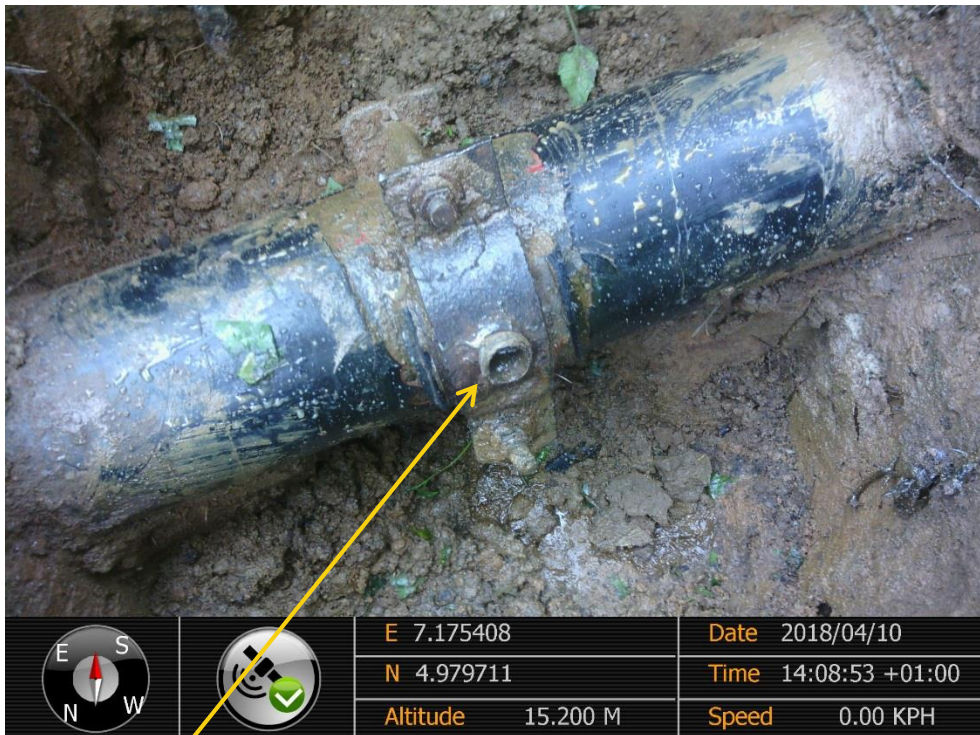
**Close-up:** Failed Half Inch Nipple on Imo River Well 31S 6" Flowline at Owaza. Picture was taken during Joint Investigation of 10<sup>th</sup> April 2018.
