JOINT INVESTIGATION REPORT

INCIDENT NO: 2060312 JIV report S/N: 1075

1. Spill incident Number: 2060312 2. Type of incident* OIL SPILL
3. Name of Location 18" ASSA - RUMUEKPE PIPELINE
4. Name of nearest community OCHIA 5. State: IMO 6. LGA OHAJI/EGBEMA
7. Type of Production facility/Installation OIL PIPELINE
8. Asset owner/District THE SHELL PETROLEUM DEVELOPMENT COMPANY OF NIGERIA LTD (SPDC) / PIPELINE

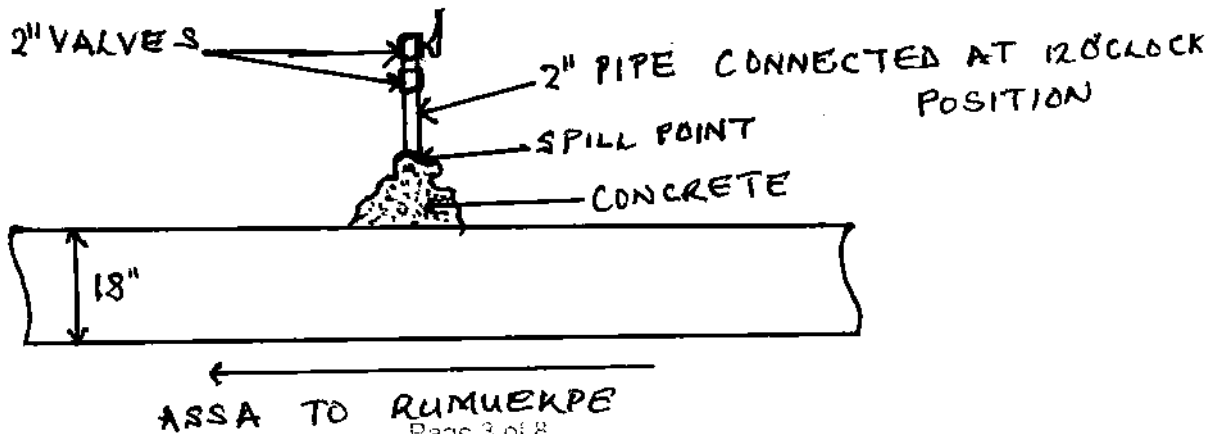
Additional observations around the spill point: THE JOINT INVESTIGATION TEAM SAW (1) SAND BAGS DURING EXCAVATION (2) A 2" PIPE CONNECTED AT 12 O'CLOCK POSITION WITH 2" VALVES CONNECTED TO THE 2" PIPE

A SECTION OF 18" ASSA - RUMUEKPE PIPELINE AT OCHIA SHOWING A 2" PIPE WITH VALVE CONNECTED AT THE TOP OF THE VERTICAL 2" PIPE BY UNKNOWN PERSONS. (A CRUDE THEFT POINT.)

REPAIR BY CLAMPING
