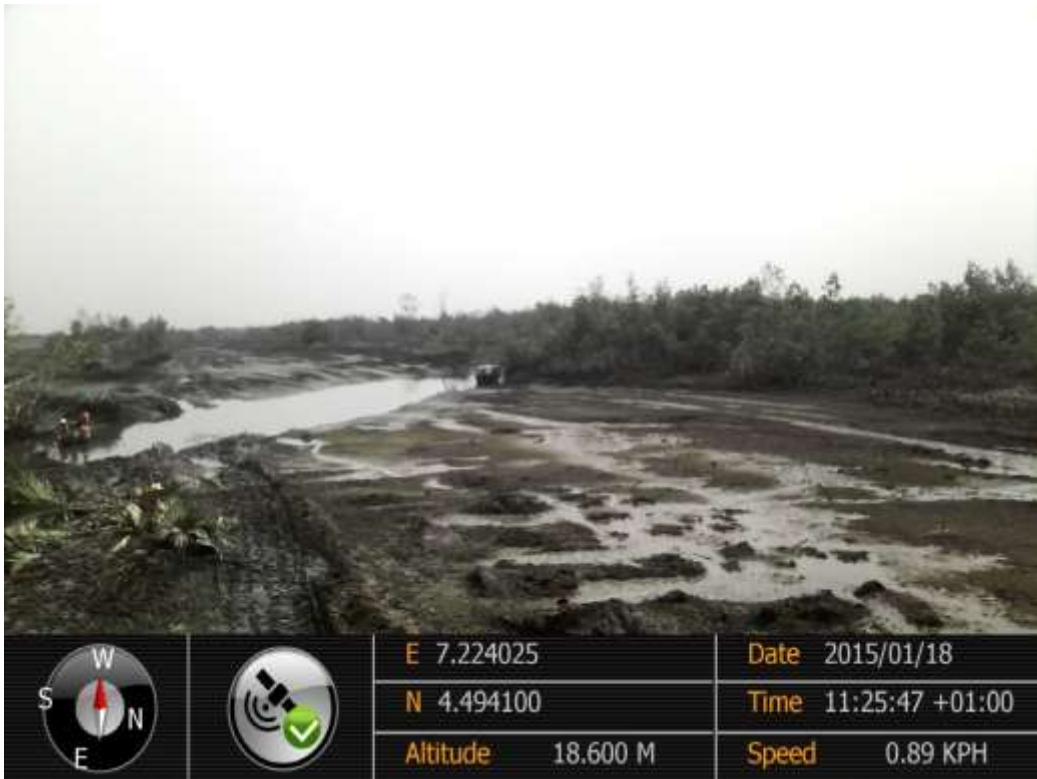
**Overview:** Part of spill impact on on Bonny Well2L Flowline Right of Way at Erekeriri/Okolo Launch. Picture was taken during Joint Investigation of 18<sup>th</sup> January 2015.

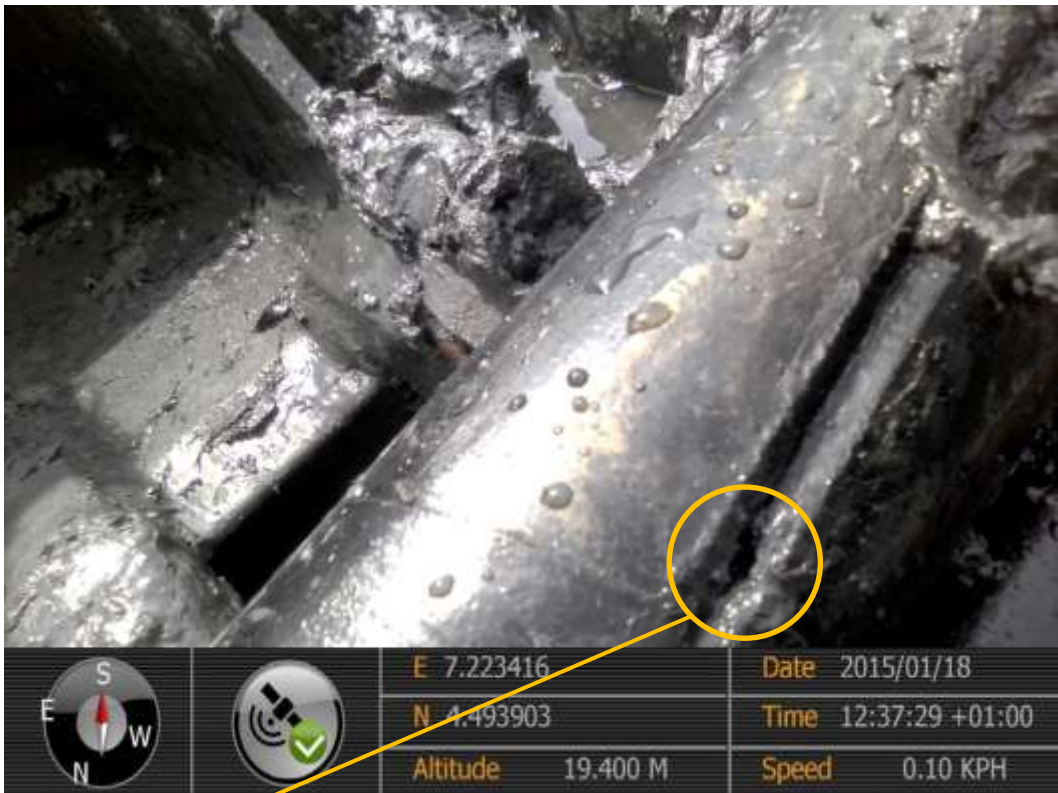
**Close-up:** Spill due to corrosion on Bonny Well2L Flowline at Erekeriri/Okolo Launch. Picture was taken during Joint Investigation of 18<sup>th</sup> January 2015.
