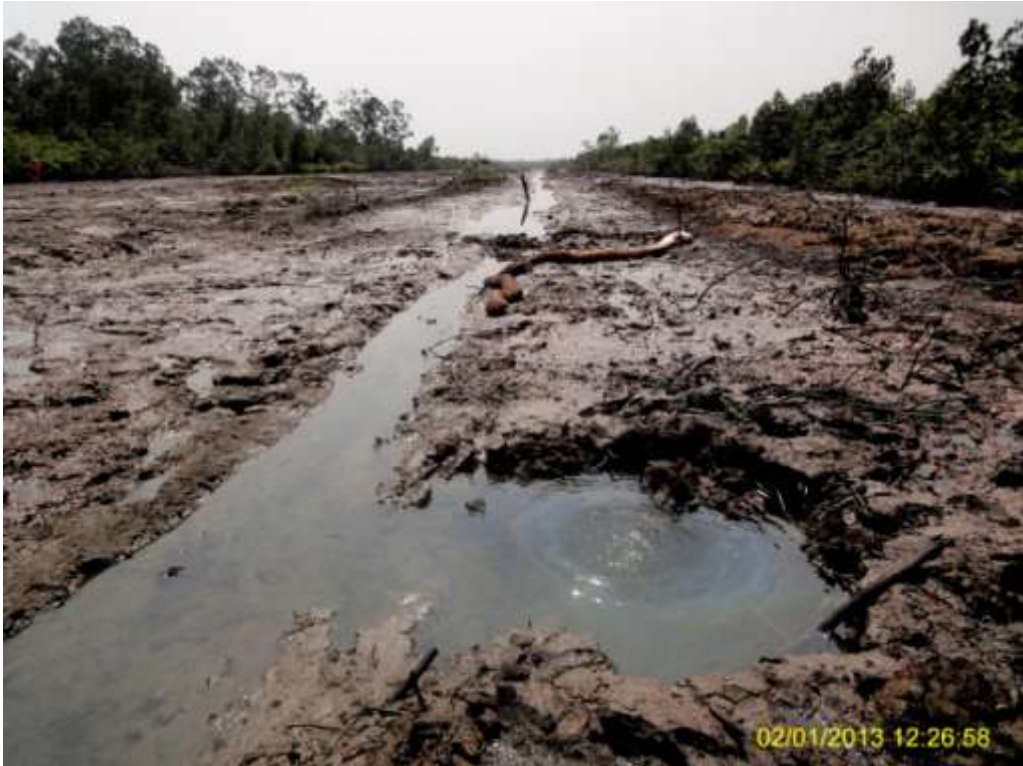
Overview: Part of spill impact on Cawthorne Channel Well41S flowline right of way at Elemama. Picture was taken during Joint Investigation of 2nd January 2013.

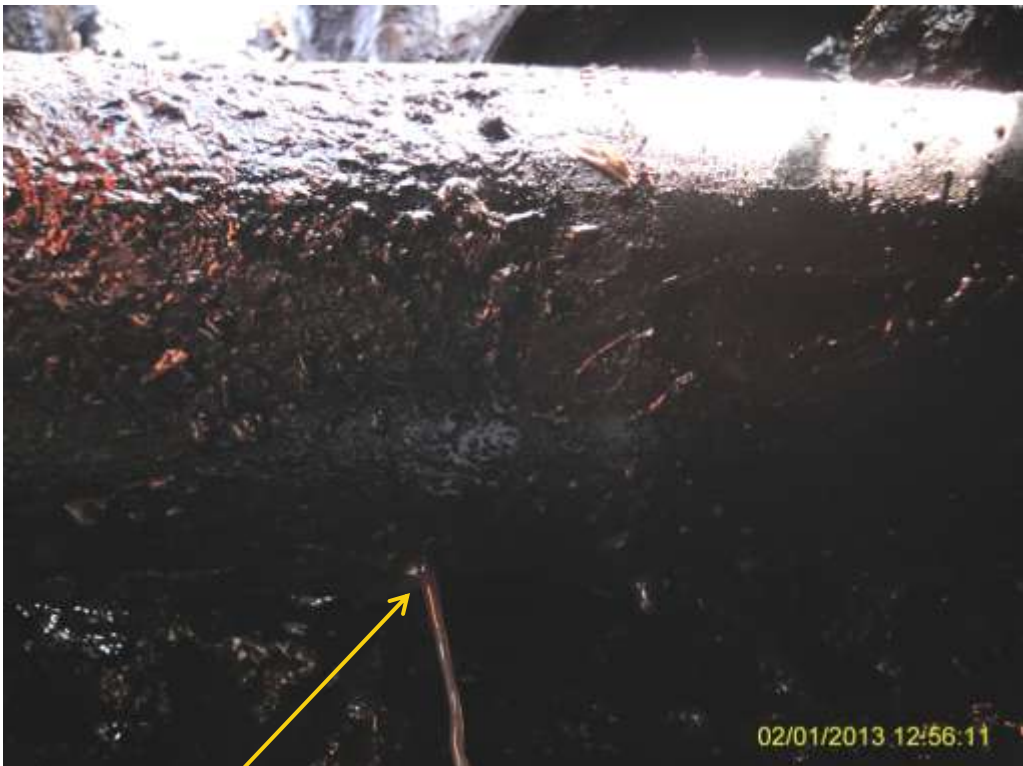
Close up: Spill due to corrosion on Cawthorne Channel Well41S flowline at Elemama. Picture was taken during Joint Investigation of 2nd January 2013.
