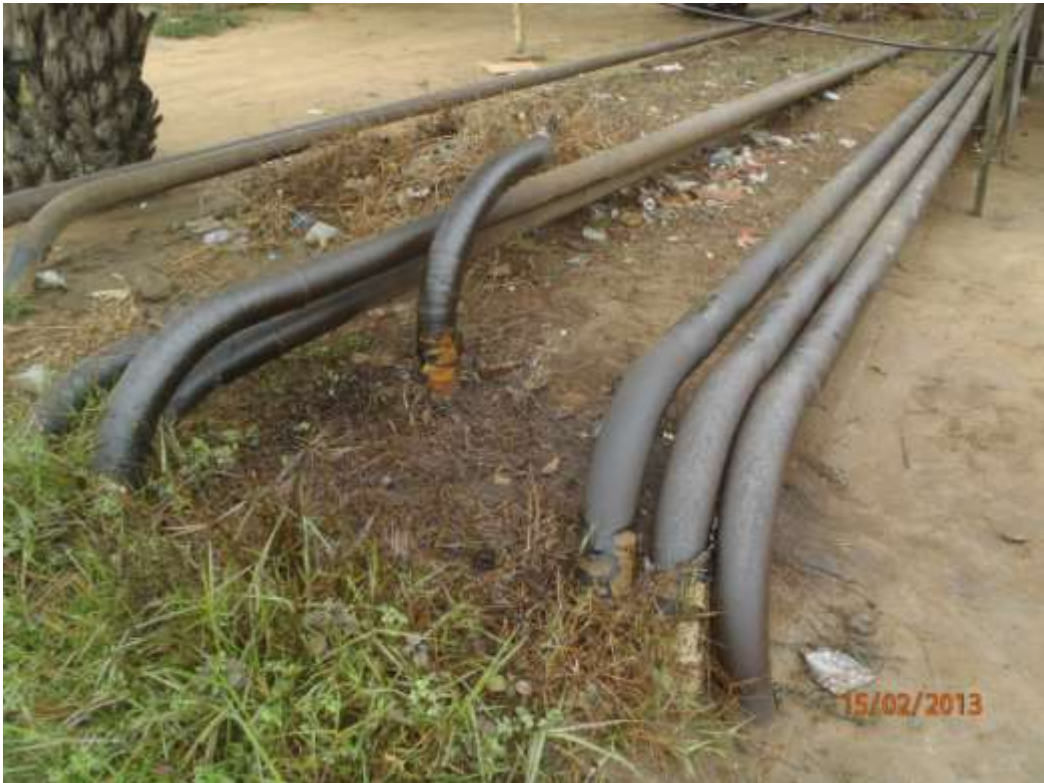
Overview: Part of spill impact on Obigbo Well 9L flowline right of way at Umuebulu. Picture was taken during Joint Investigation of 15th February 2013.

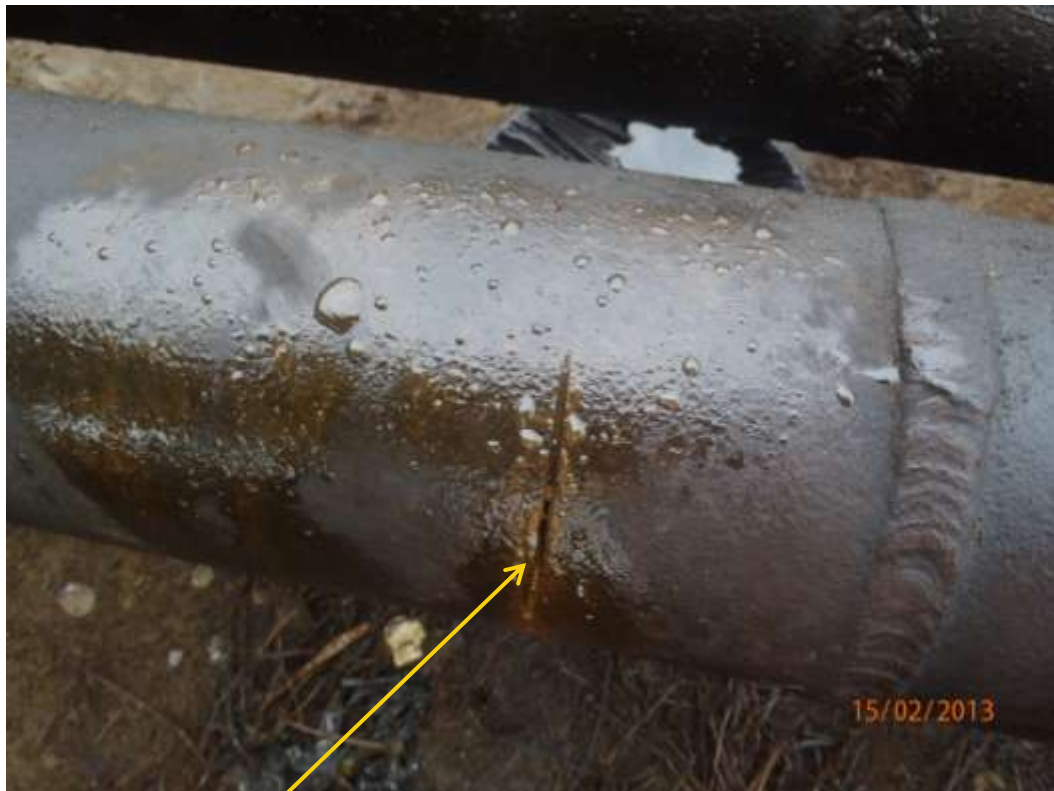
Close up: Hacksaw cut on Obigbo Well 9L flowline at Umuebulu. Picture was taken during Joint Investigation of 15th February 2013.
