JOINT INVESTIGATION REPORT

INCIDENT NO: 2568440 JIV report S/N: 1030226

1. Fountain Incident Number: 2568440 2. Type of incident* OIL SPILL
3. Name of Location 12" MORIVER 2 - EBUBU PIPELINE
4. Name of nearest community OGALE 5. State: RIVERS 6. LGA ELEME
7. Type of Production facility/Installation OIL PIPELINE
8. Asset owner/District THE SHELL PETROLEUM DEVELOPMENT COMPANY
OF NIGERIA LIMITED / PIPELINE

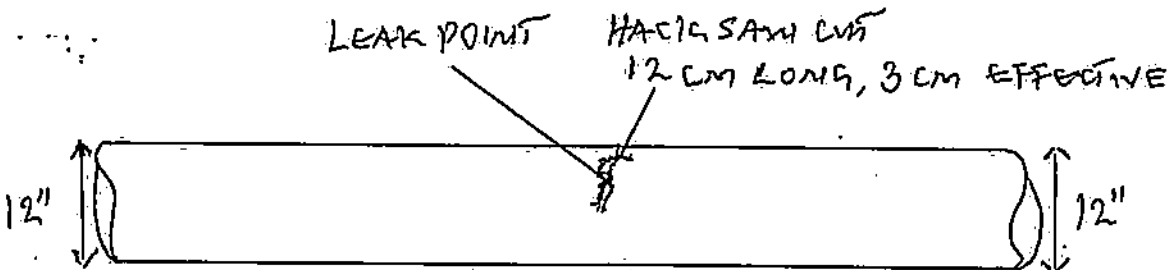
| <input type="checkbox"/> Drilled hole | <input checked="" type="checkbox"/> Hack saw cut | <input type="checkbox"/> Tear (_____) |

SECTION OF 12" IMO RIVER 2 - EBUBU PIPELINE AT OGALE SHOWING HACK SAW CUT AT 1-2 O'CLOCK POSITION BY UNKNOWN PERSON

RECOVERY AND REPAIR WORK ACTIVITIES ARE ONGOING

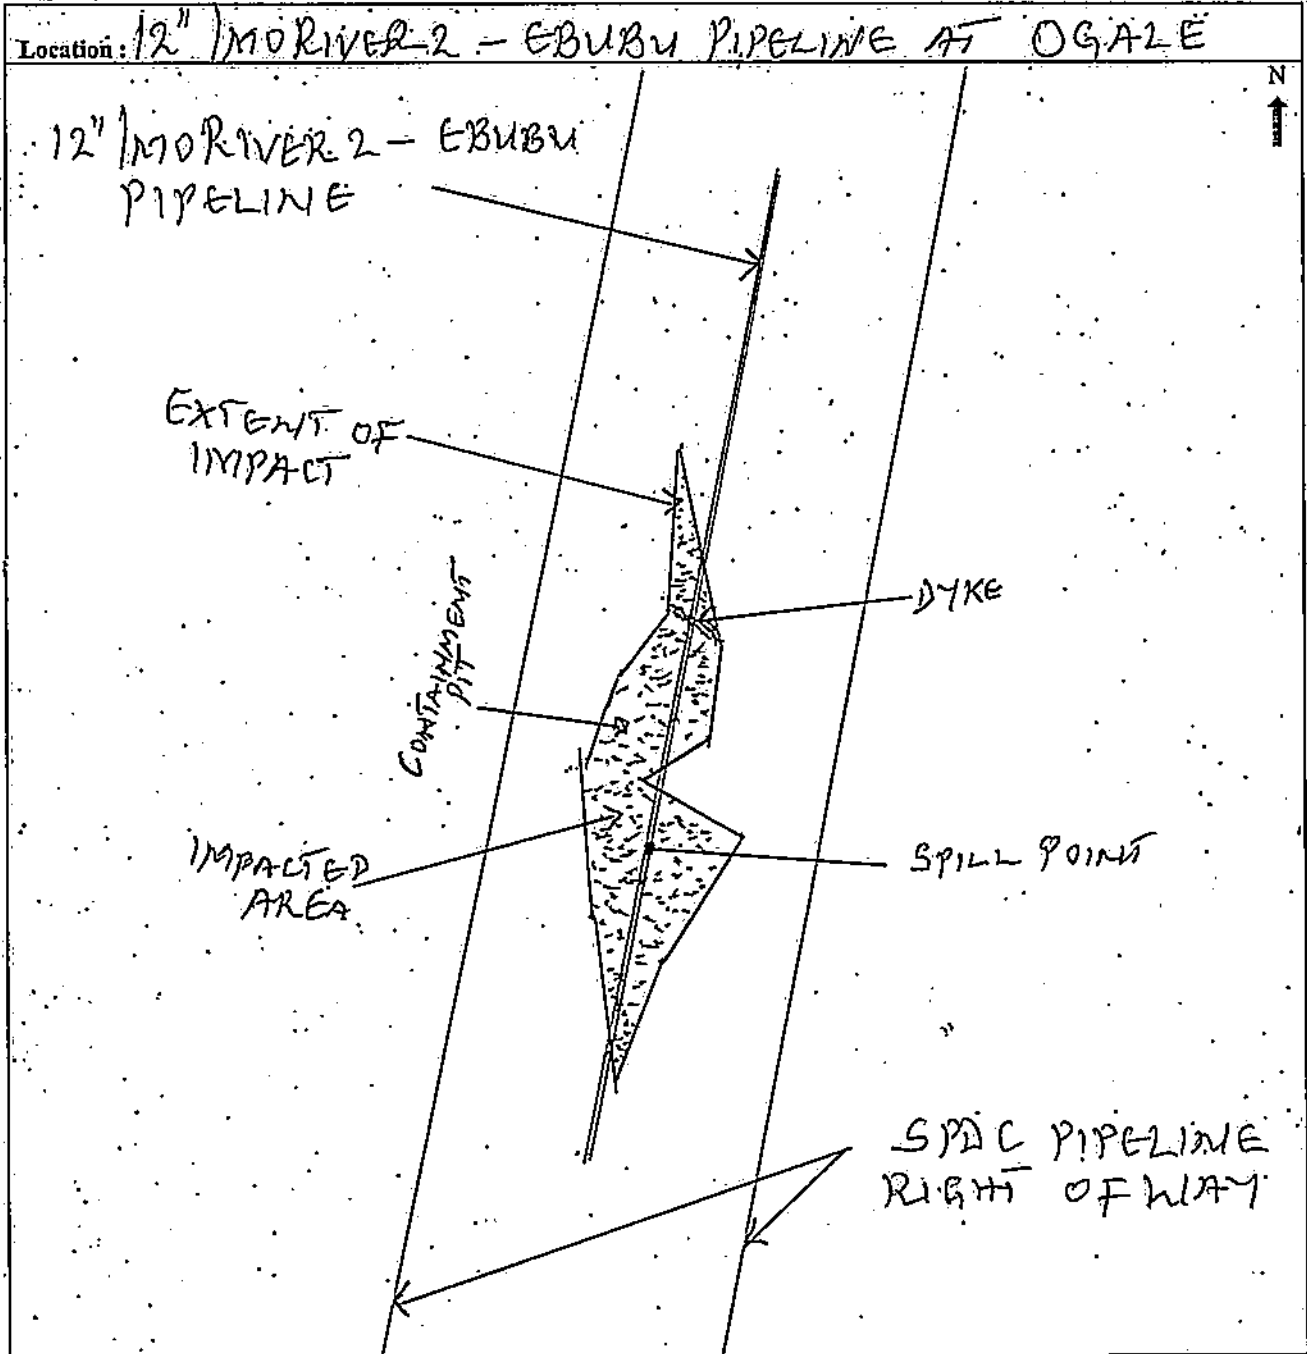
f. Appendix d: Overview sketch of the site

- Total calculated area of impact 0.02 ha
- Impact within SPDC R.O.W. YES
- Impact outside SPDC R.O.W. NO
