JOINT INVESTIGATION REPORT

INCIDENT NO: 2571635 JIV report S/N: 1030234

1. Fountain Incident Number: 2571635 2. Type of incident* OIL SPILL
3. Name of Location 14" OKORDIA - RUMUEKPE PIPELINE
4. Name of nearest community IKATA 5. State: RIVERS 6. LGA ATHOADA EAST
7. Type of Production facility/Installation OIL PIPELINE
8. Asset owner/District THE SHELL PETROLEUM DEVELOPMENT COMPANY
OF NIGERIA LIMITED / PIPELINE

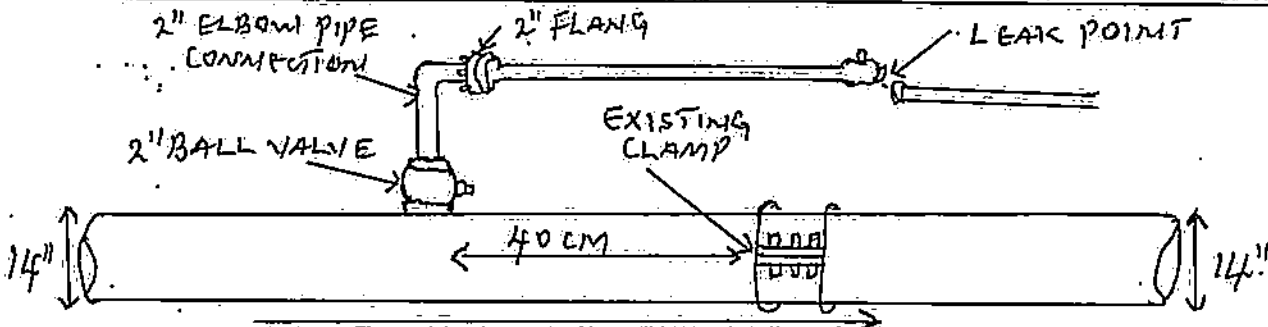
| <input checked="" type="checkbox"/> Failed Weld-on illegal hot tap valve | <input type="checkbox"/> Failed Clamp, | <input type="checkbox"/> Missing Pipeline/Flowline |
| <input checked="" type="checkbox"/> Crude oil theft (illegal bunkering) point, | <input type="checkbox"/> Saver-pit over flow | <input type="checkbox"/> Third party tampering with Clamp |

SECTION OF 14" OKORDIA - RUMUOKPE PIPELINE AT IKATA SHOWING CRUDE OIL THEFT POINT INSTALLED AT 12 O'CLOCK POSITION.

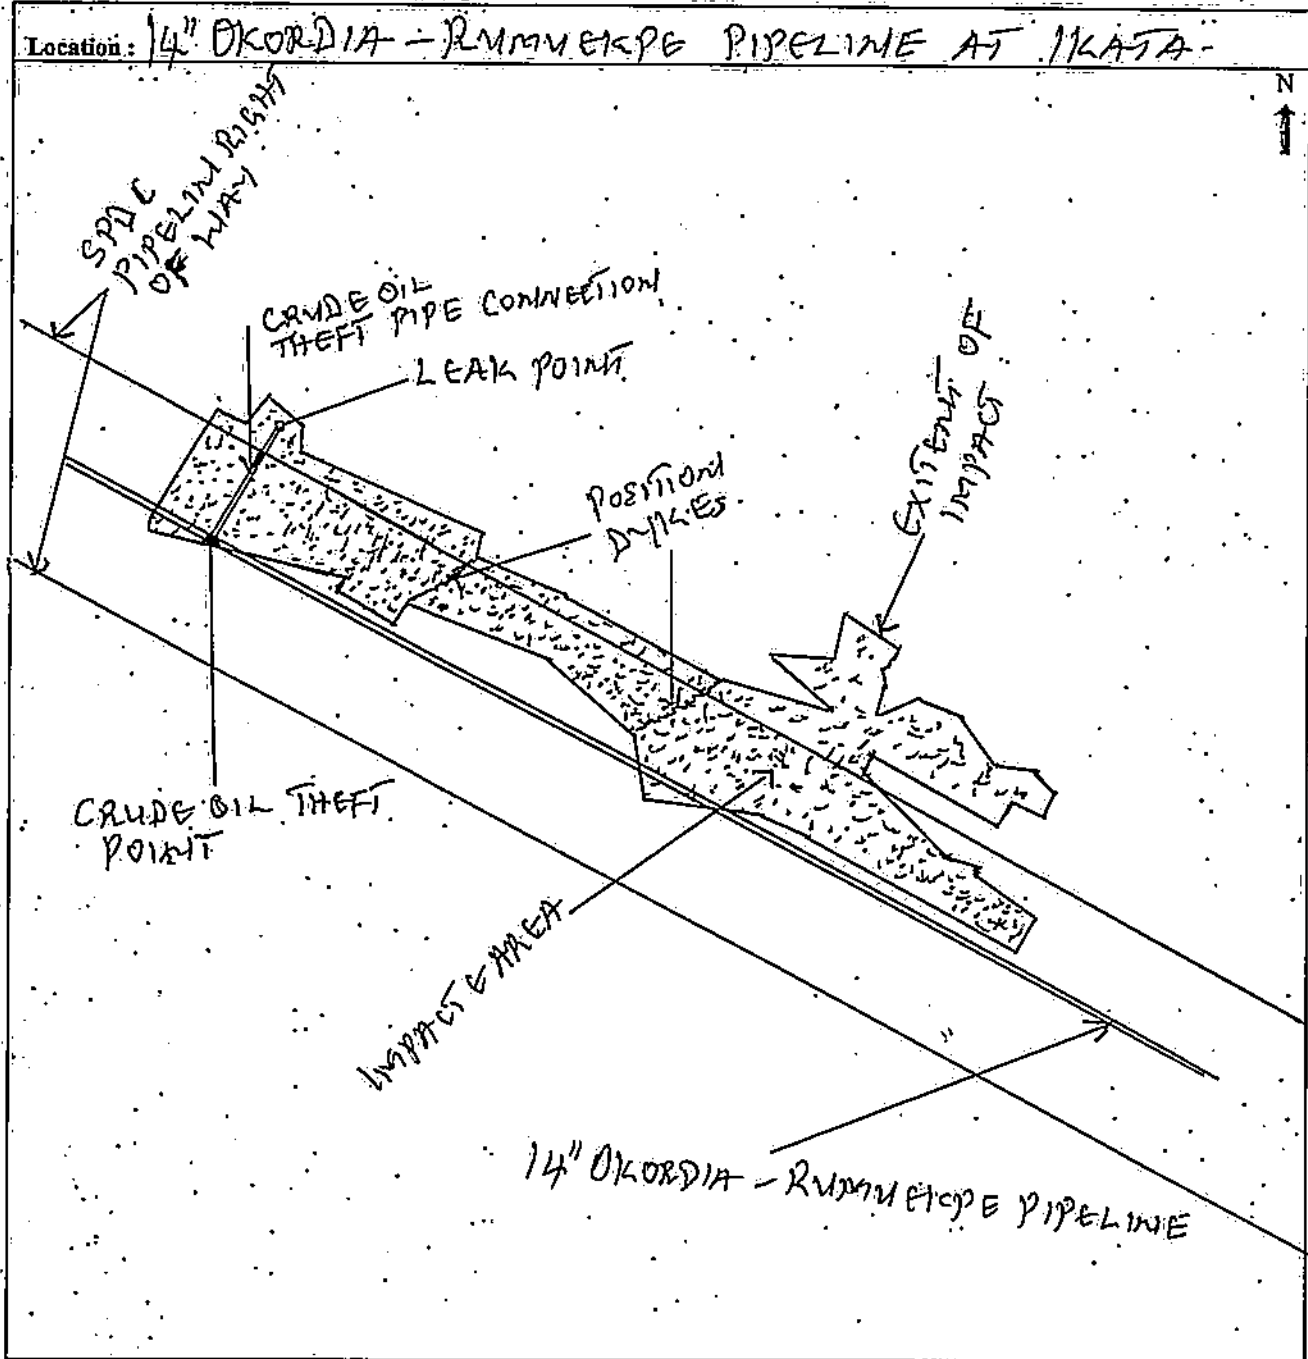
f. Appendix 1: Overview sketch of the site

- Total calculated area of impact 0.19 Ha
- Impact within SPDC R.O.W YES
- Impact outside SPDC R.O.W YES
