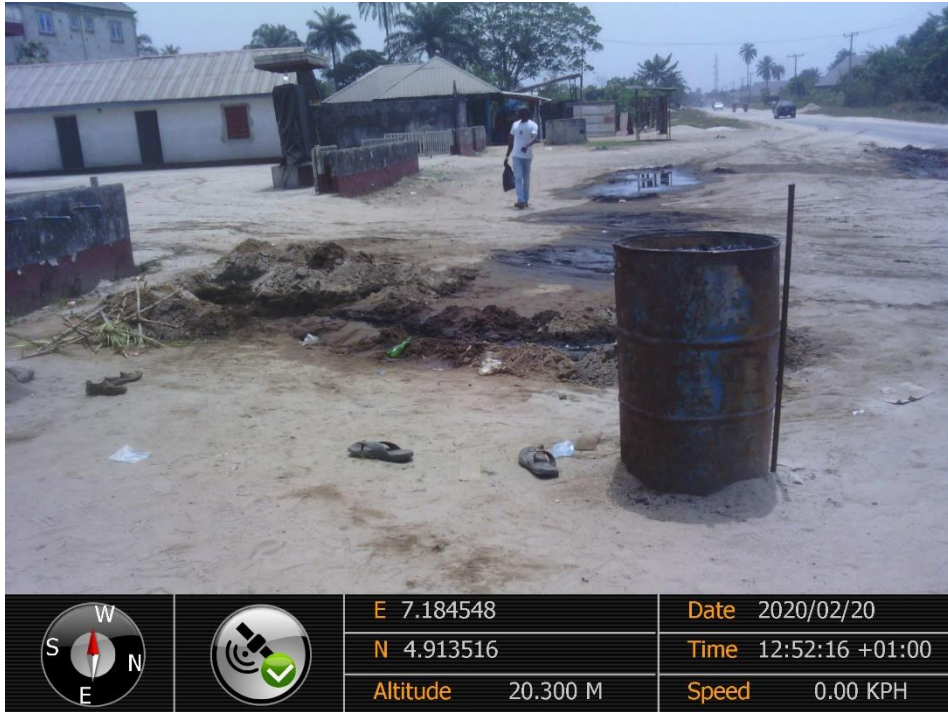
Overview: Part of spill impact on 12" Imo River1 – Ogale Pipeline Right of Way at Uzuaku. Picture was taken during Joint Investigation of 20th February 2020.

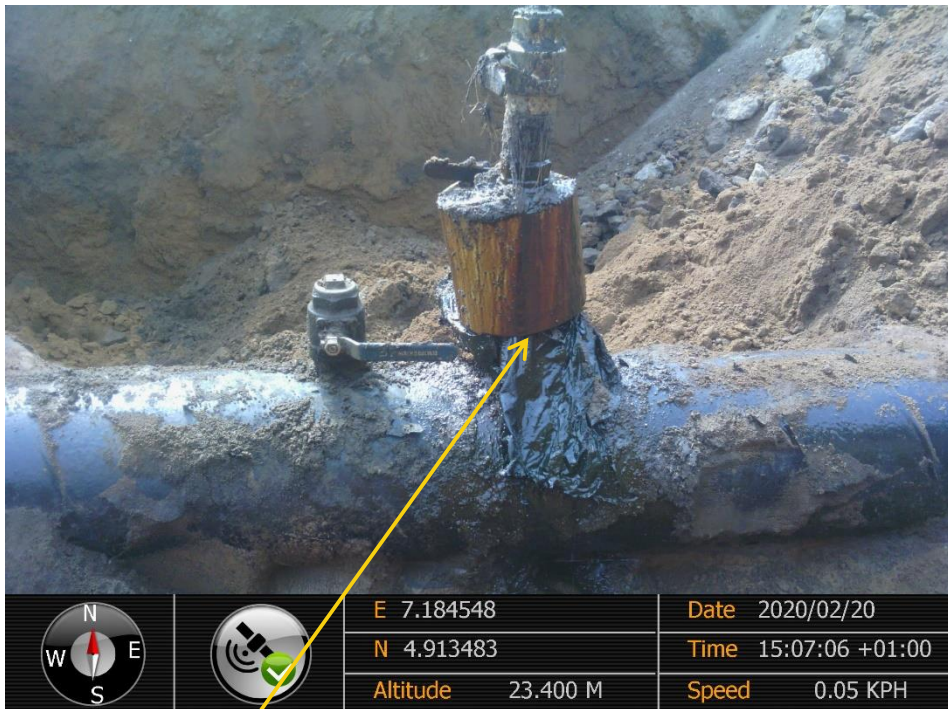
Close-up: Leaking 2" Ball Valve Installed at 12 o'clock position on 12" Imo River1 – Ogale Pipeline at Uzuaku. Picture was taken during Joint Investigation of 20th February 2020.
