JOINT INVESTIGATION REPORT

INCIDENT NO: 2584798 JIV report S/N: 0117

1. Spill incident Number: 2584798 2. Type of incident*: OIL SPILL
 3. Name of Location: 36" NKPOKU - BOMU PIPELINE
 4. Name of nearest community: ATALI 5. State: RIVERS 6. LGA: OBIO/AKPOR
 7. Type of Production facility/Installation: OIL PIPELINE
 8. Asset owner/District: THE SHELL PETROLEUM DEVELOPMENT COMPANY OF NIGERIA LTD (S.P.D.C)/PIPELINE

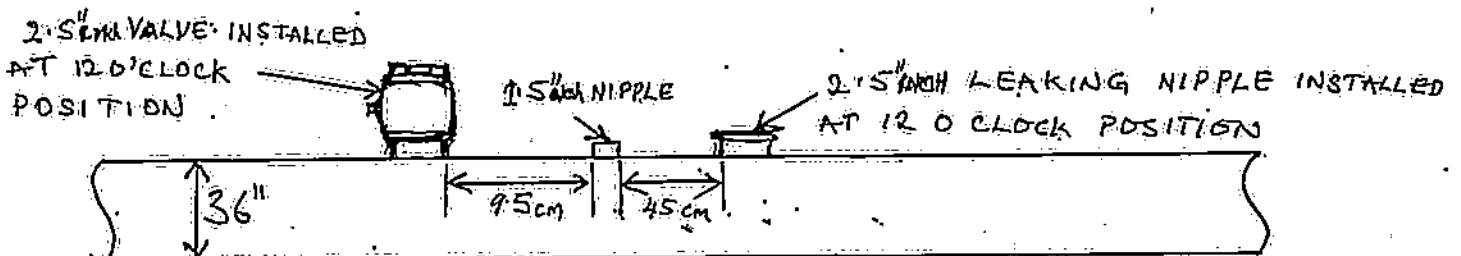
| <input checked="" type="checkbox"/> Crude oil theft (illegal bunkering) point | <input type="checkbox"/> Saver-pit over flow | <input type="checkbox"/> Third party tampering with Clamp |

E. GRAPHIC DESCRIPTION OF LEAK POINT (while detailed report of the leak point should be contained in the leak report, overview sketch of the site should be added as an appendix 1) A SECTION OF 36" NKPOKU - BOMU PIPELINE AT ATALI SHOWING 3 NO. ILLEGAL CONNECTIONS (CRUDE THEFT VALVES) INSTALLED AT 12 O'CLOCK POSITIONS BY UNKNOWN PERSONS.

SPILL RESPONSE AND LEAK REPAIR BY
CLAMPING.

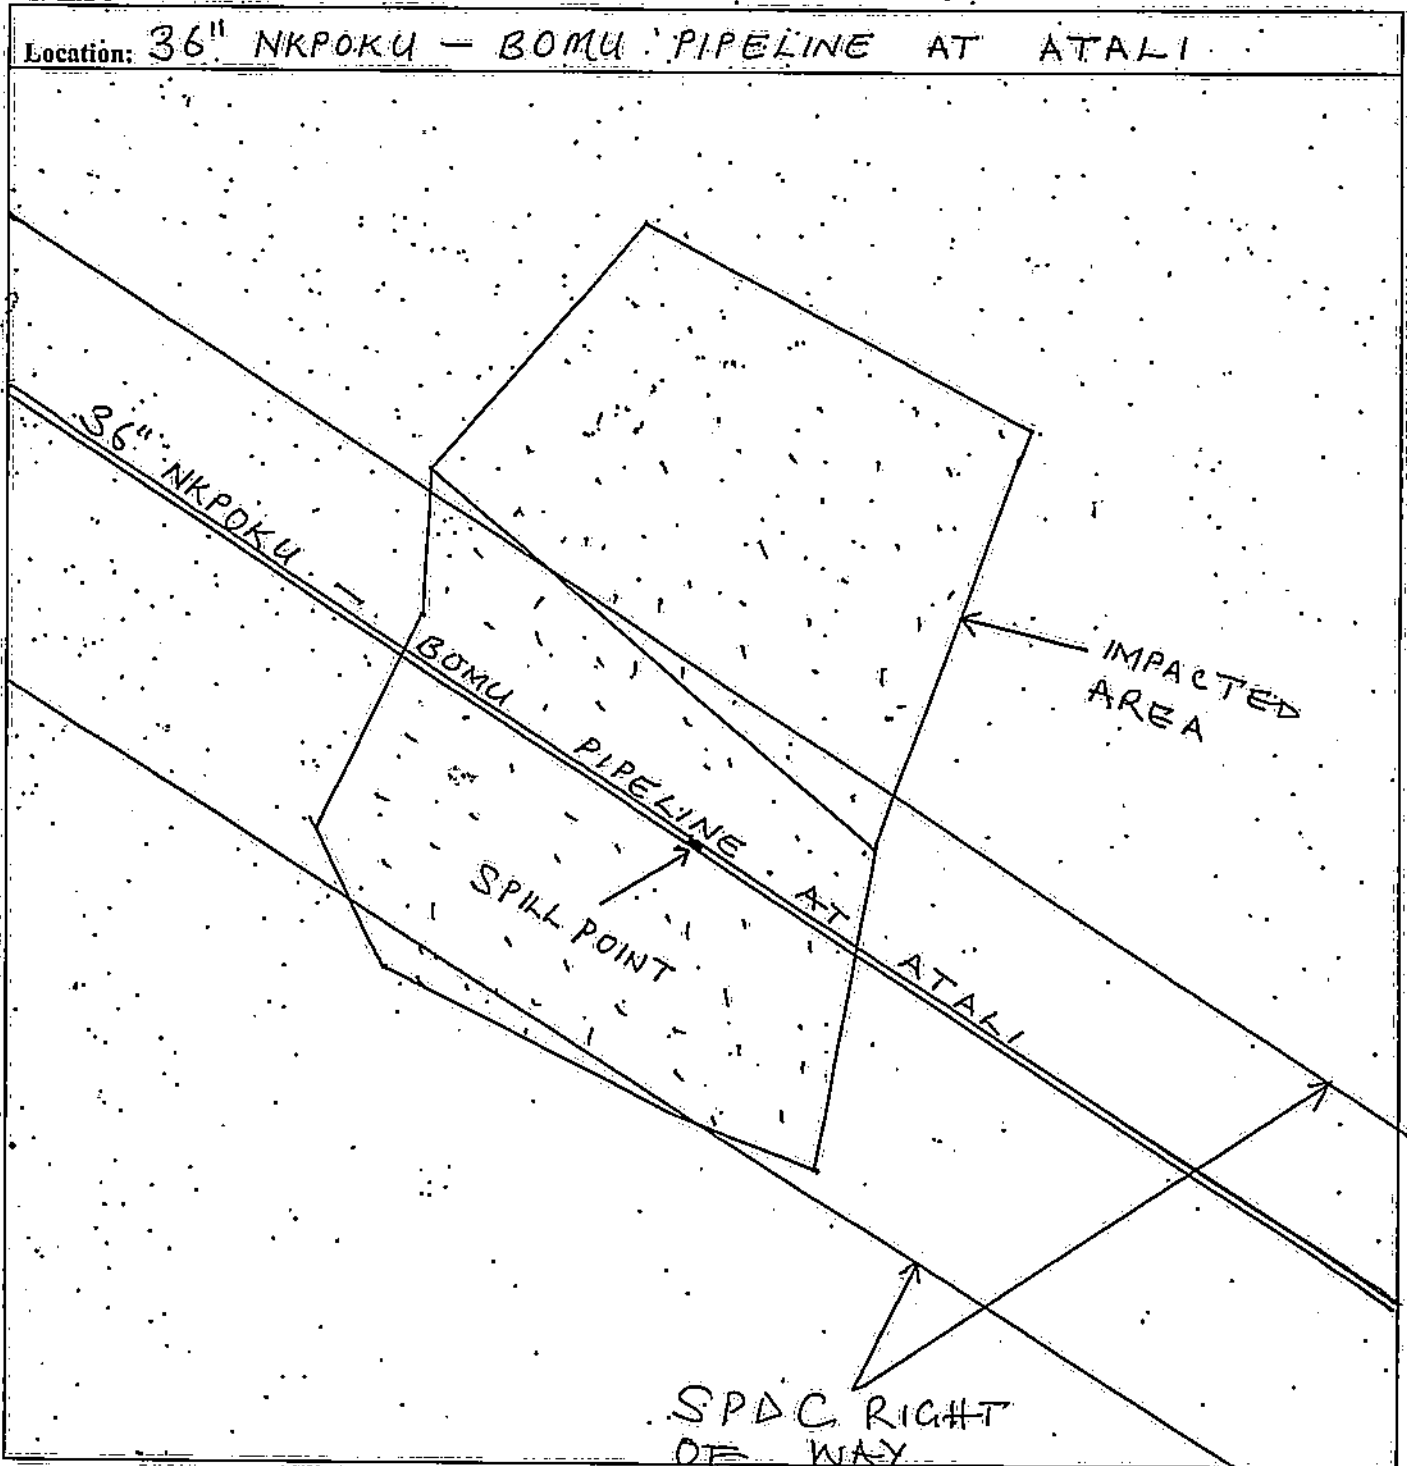
f. Appendix 1: Overview sketch of the site

- Total calculated area of impact 0.60Ha
- Impact within R.O.W YES
- Impact outside R.O.W YES
