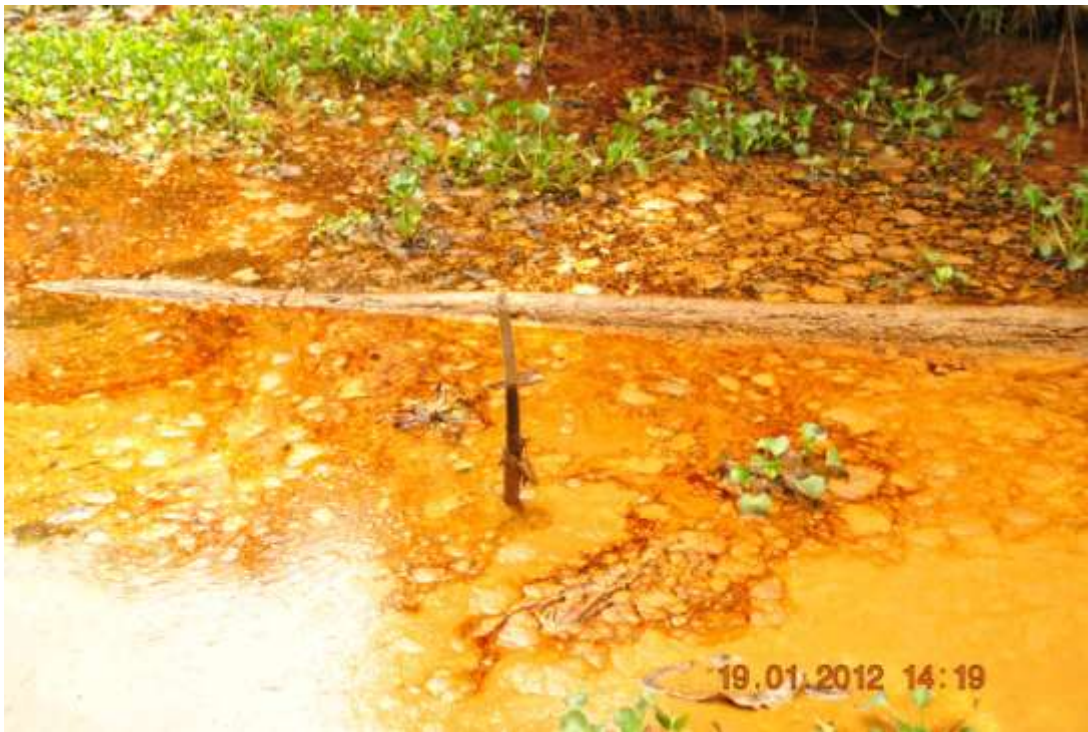
Overview: Part of spill impact on Opukushi Well33L flowline at Egbema-Angalabiri.
Picture was taken during Joint Investigation of 19th January 2012.

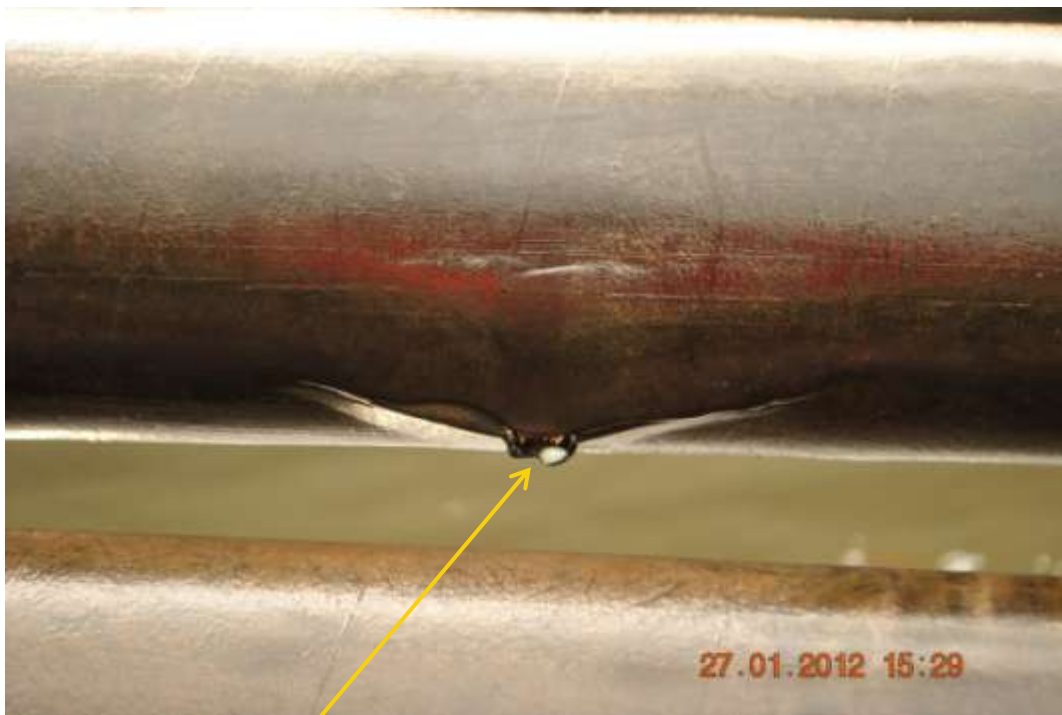
Close-up: Point of internal corrosion on Opukushi Well33L flowline at Egbema-Angalabiri.
Picture was taken during Joint Investigation of 27th January 2012.
