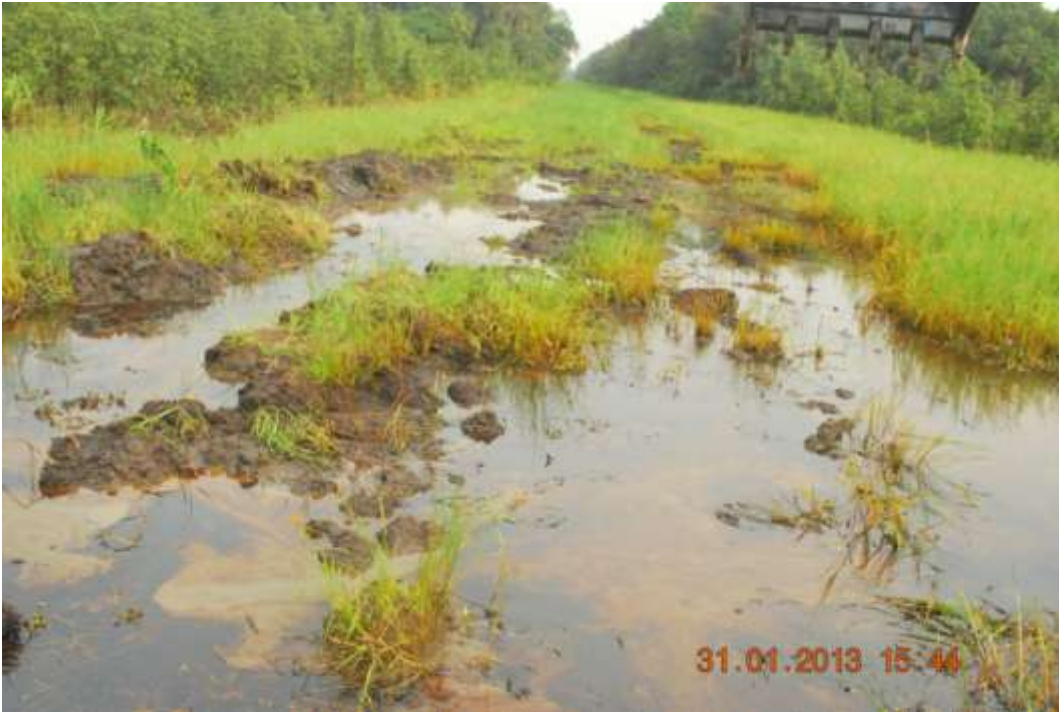
Overview: Part of spill impact on Opukushi Well24T flowline right of way at Agbidiamama. Picture was taken during Joint Investigation of 31st January 2013.

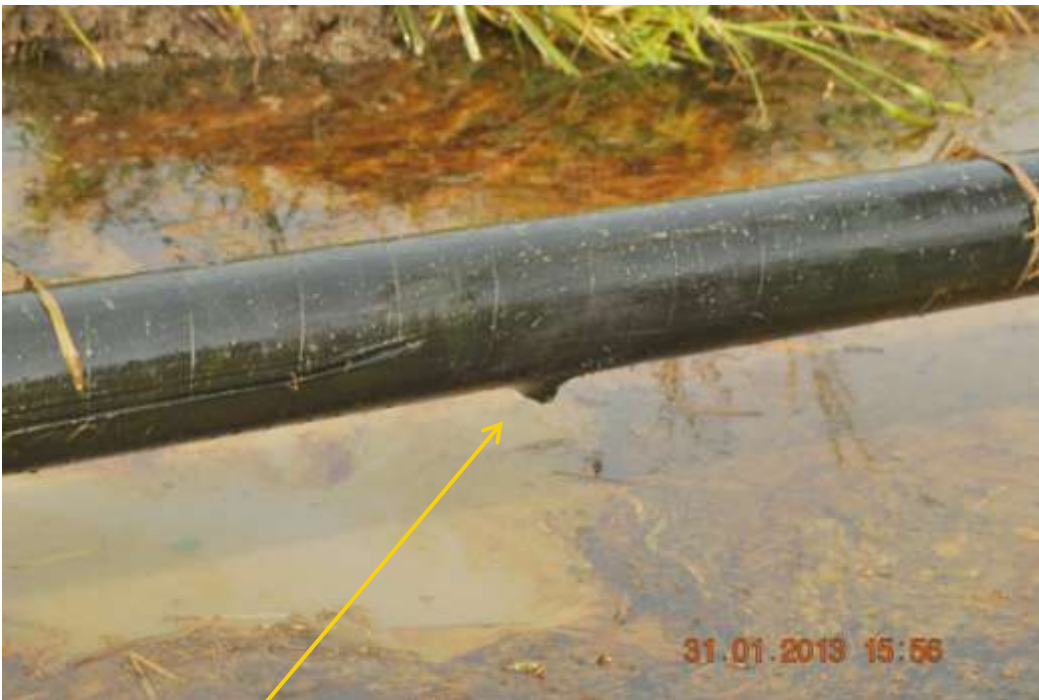
Close up: Bulge due to corrosion on Opukushi Well24T flowline at Agbidiamama. Picture was taken during Joint Investigation of 31st January 2013.
