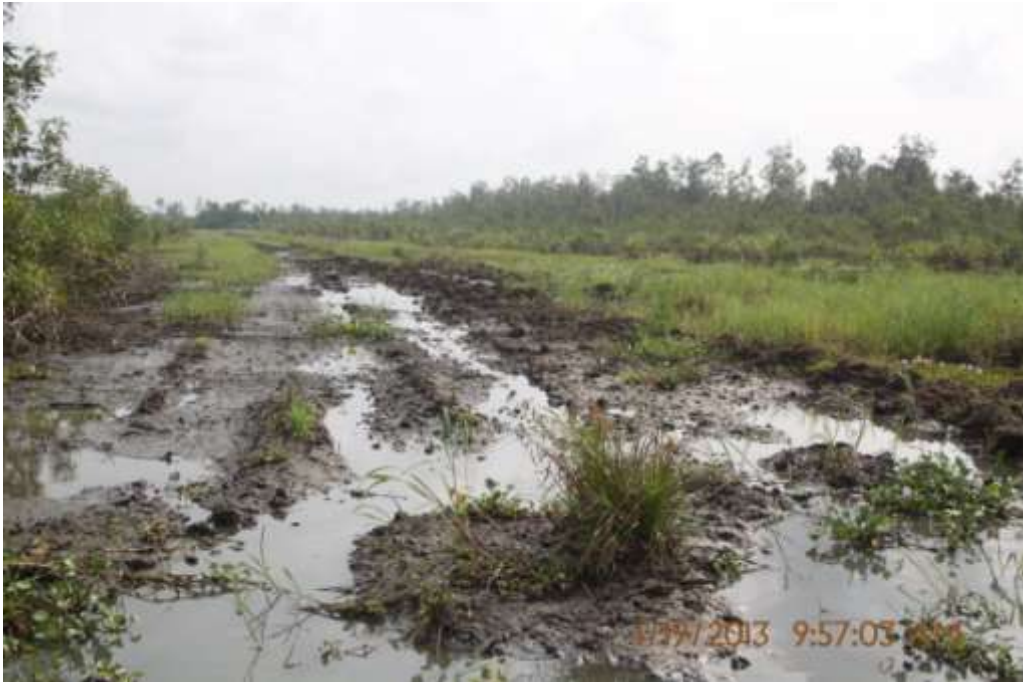
Overview: Part of spill impact on Kanbo Well5L & S flowline right of way at Amabulu. Picture was taken during Joint Investigation of 19th January 2013.

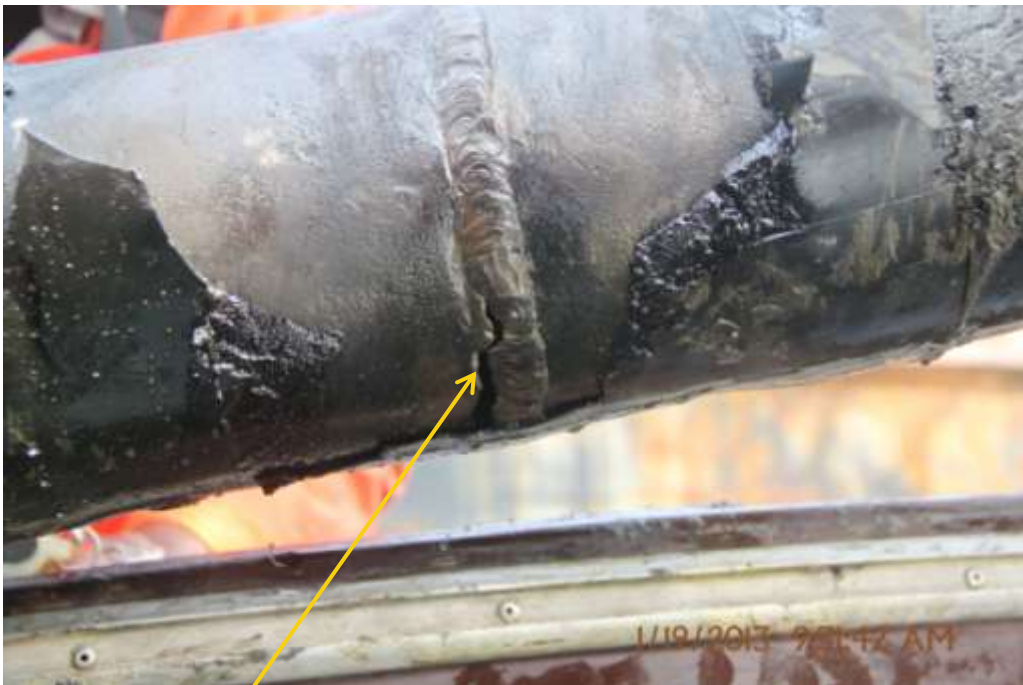
Close up: Failed weld on Kanbo Well5L & S flowline at Amabulu. Picture was taken during Joint Investigation of 19th January 2013.

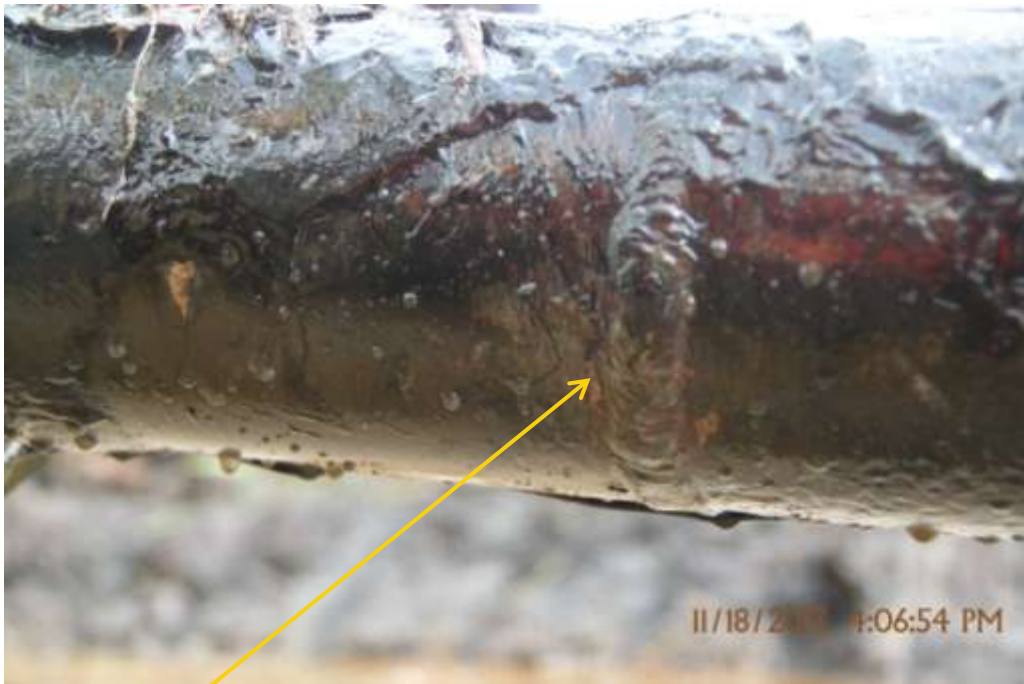
Close up: Failed weld on Kanbo Well5L & S flowline at Amabulu. Picture was taken during Joint Investigation of 19th January 2013.

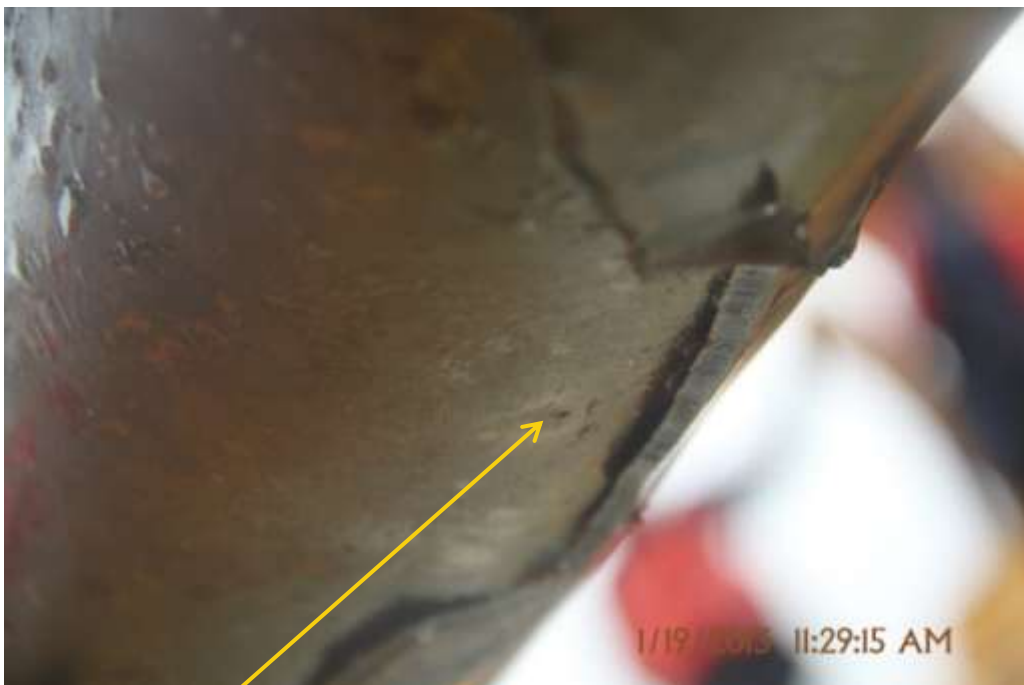
Close up: Pinhole at 6 o'clock position on Kanbo Well5L & S flowline at Amabulu. Picture was taken during Joint Investigation of 19th January 2013.
