JOINT INVESTIGATION REPORT

INCIDENT NO: 1554020 JIV report S/N: Nº 0000082

1. Spill incident Number: 1554020 2. Type of incident* OIL SPILL
3. Name of Location 28" BOMU - BONNY PIPELINE
4. Name of nearest community K-DERE/KPOR 5. State: RIVERS 6. LGA GOKANA
7. Type of Production facility/Installation OIL PIPELINE
8. Asset owner/District THE SHELL PETROLEUM DEVELOPMENT COMPANY OF NIGERIA LIMITED / PIPELINE

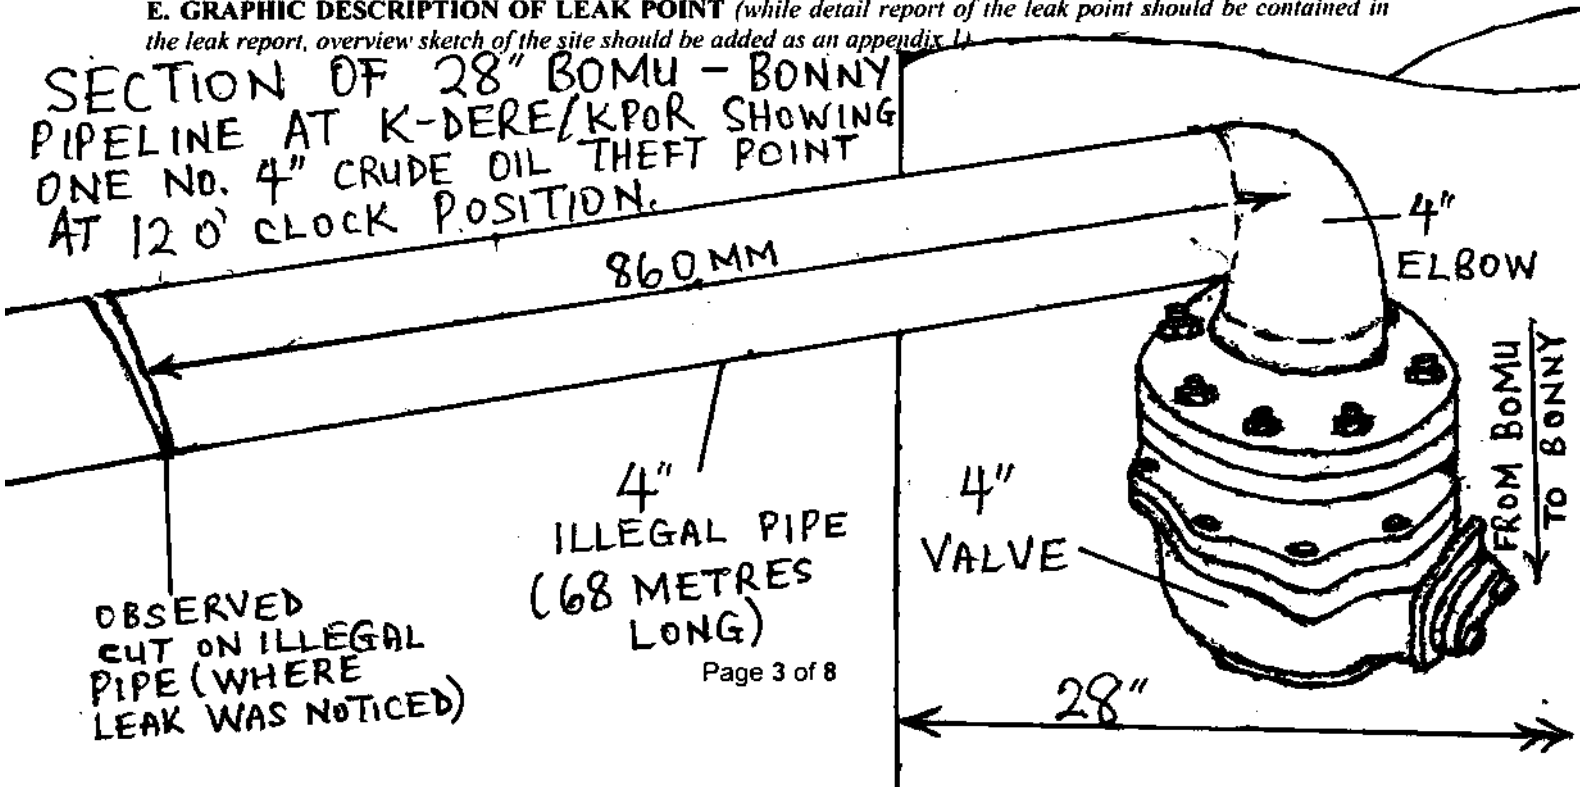
Additional observations around the spill point: THE JOINT INVESTIGATION TEAM, ON ARRIVAL AT SITE, OBSERVED THE SPILL POINT BUBBLING. UPON EXCAVATION, IN THE COURSE OF JIV, AROUND THE SPILL POINT, LEAK WAS NOTICED FROM A CUT ON A 4" ILLEGAL PIPE CONNECTION BEYOND THE SPDC RIGHT OF WAY. SPILL SITE WAS NOTICED ADJACENT TO A REMEDIATION SITE.

SECTION OF 28" BOMU - BONNY PIPELINE AT K-DERE/KPOR SHOWING ONE NO. 4" CRUDE OIL THEFT POINT AT 12 O' CLOCK POSITION.

OBSERVED CUT ON ILLEGAL PIPE (WHERE LEAK WAS NOTICED)

4" ILLEGAL PIPE (68 METRES LONG)

REPAIR WAS DONE BY DISCONNECTING THE ILLEGAL PIPE CONNECTION AND BLIND-FLANGING THE CRUDE OIL THEFT POINT.
