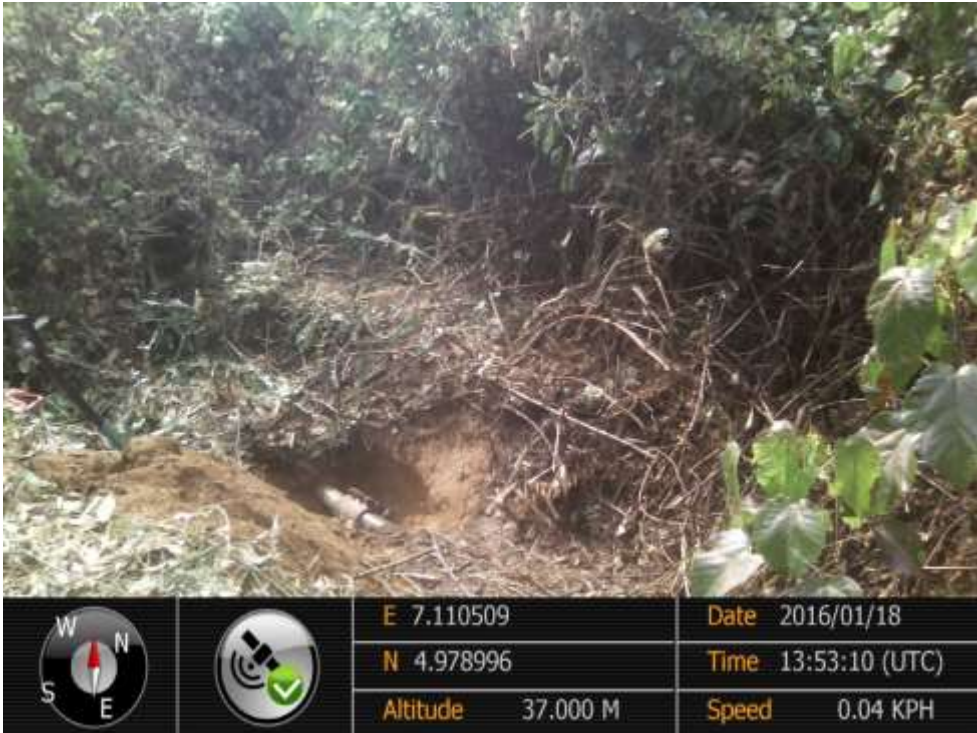
Overview: Part of spill impact on 4" Nkali Well10S Flowline Right of Way at Odagwa2. Picture was taken during Joint Investigation of 18<sup>th</sup> January 2016.

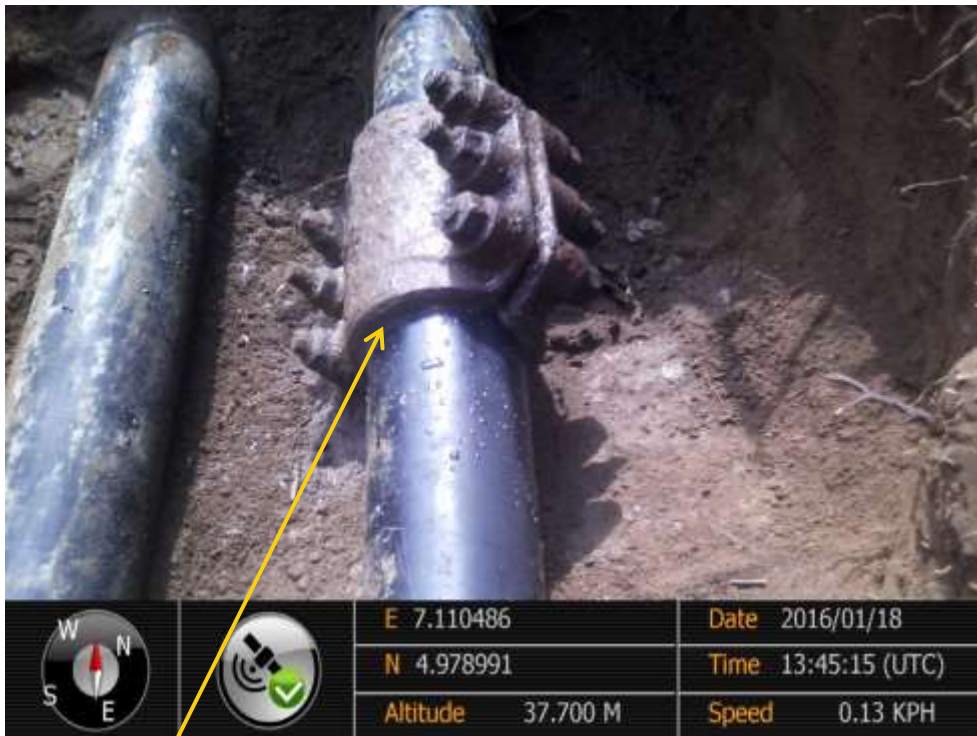
Close-up: Failed clamp on 4" Nkali Well10S Flowline at Odagwa2. Picture was taken during Joint Investigation of 18<sup>th</sup> January 2016.
