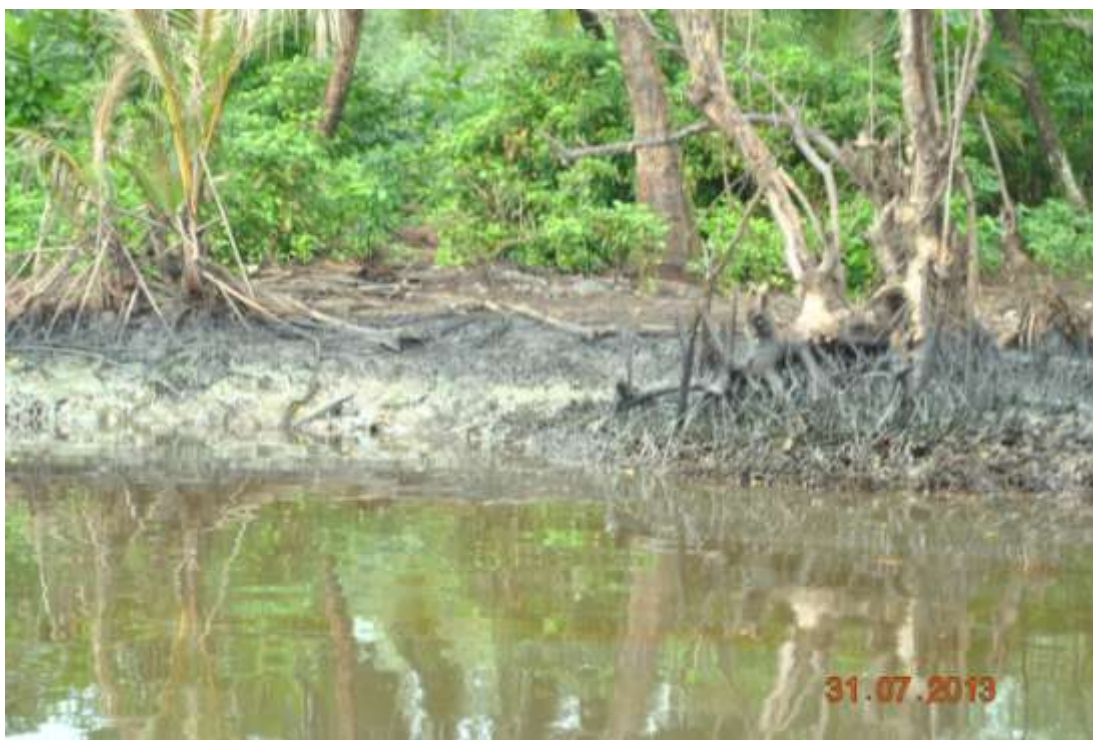
Overview: Part of spill impact on 20" Otumara-Escravos pipeline right of way at Ugboegungun. Picture was taken during Joint Investigation of 31st July 2013.

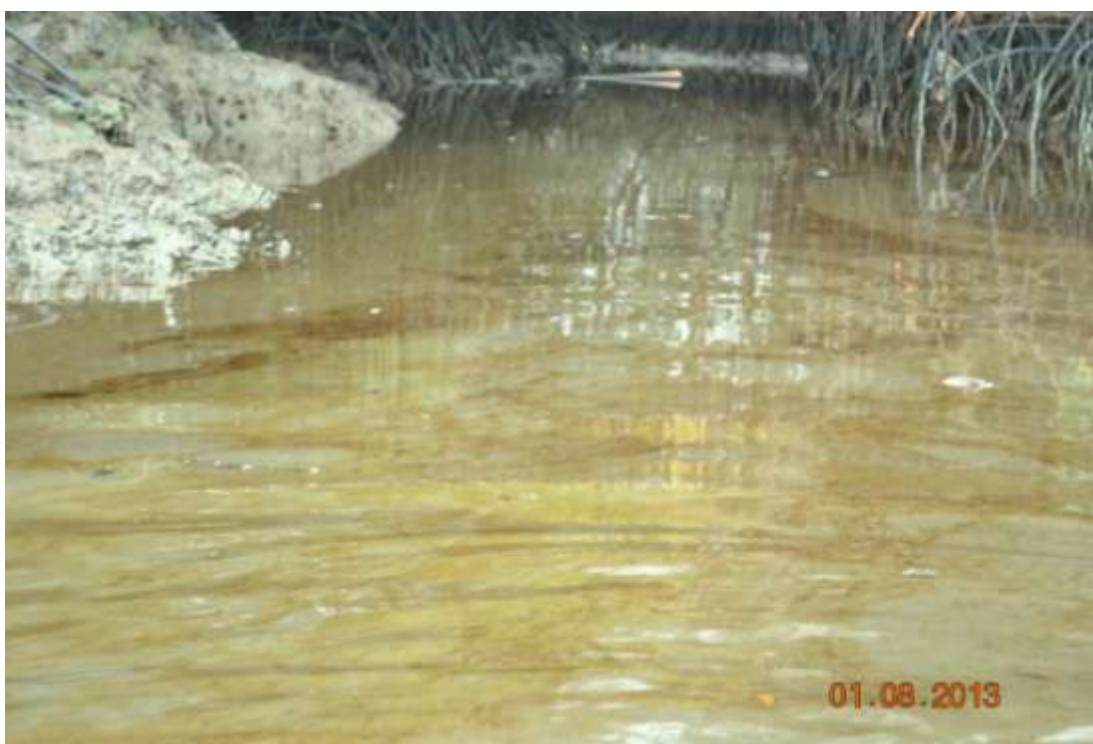
Overview: Part of spill impact on 20" Otumara-Escravos pipeline right of way at Ugboegungun. Picture was taken during Joint Investigation of 1st August 2013.

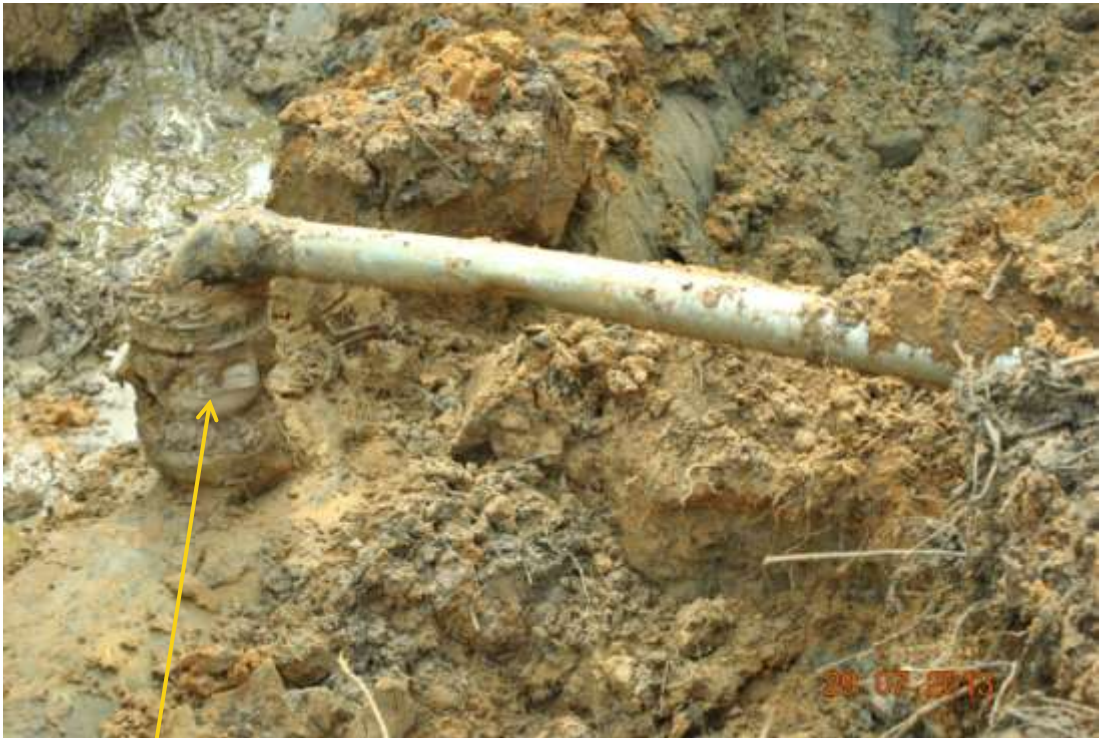
Close up: Illegal fitting on 20" Otumara-Escravos pipeline at Ugboegungun. Picture was taken during Joint Investigation of 29th August 2013.

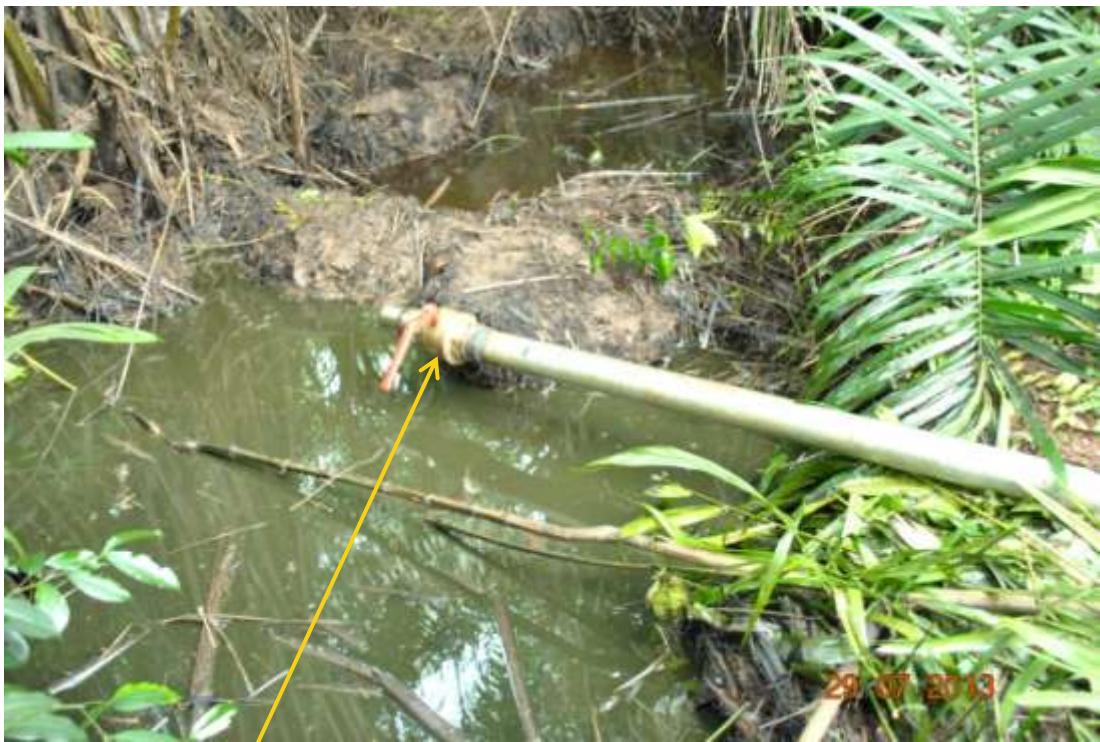
Close up: Illegal fitting on 20" Otumara-Escravos pipeline at Ugboegungun. Picture was taken during Joint Investigation of 29th August 2013.

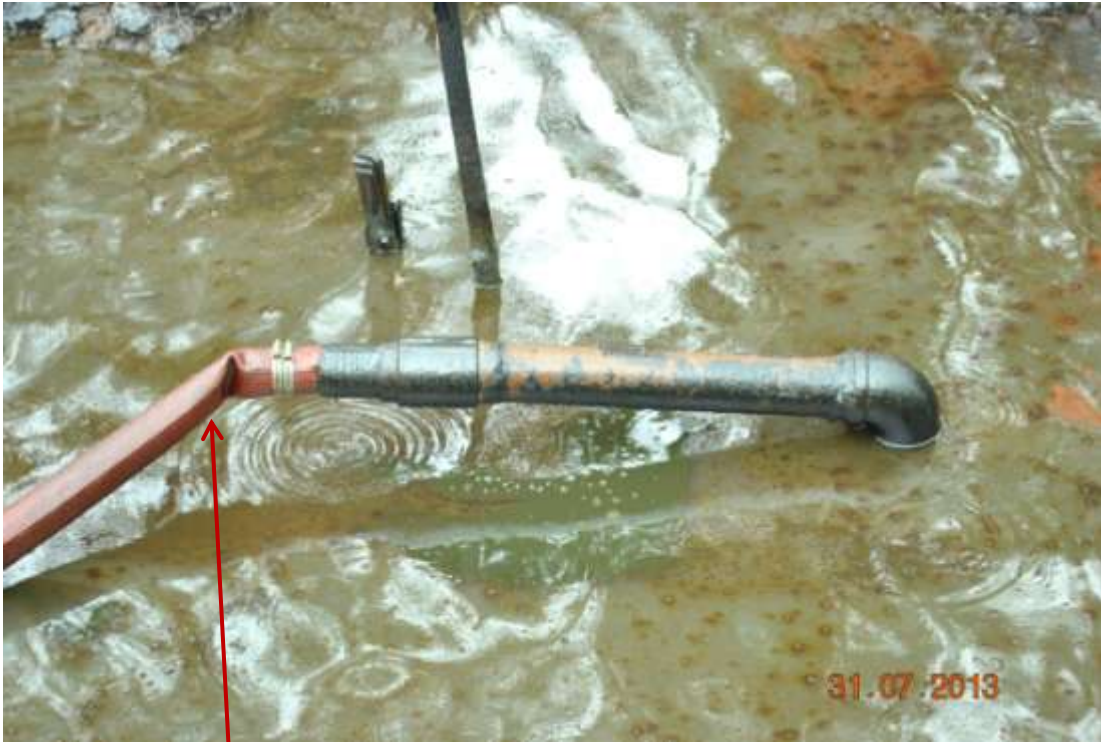
Close up: Illegal fitting on 20" Otumara-Escravos pipeline at Ugboegungun. Picture was taken during Joint Investigation of 31st July 2013.

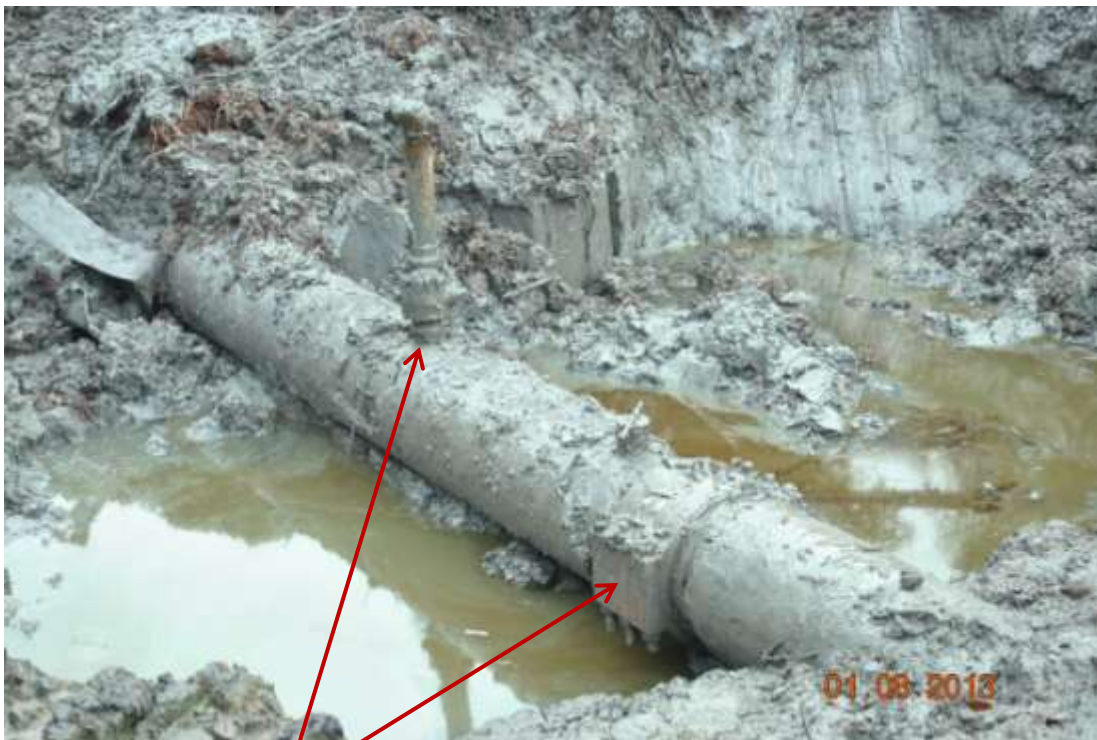
Close up: Illegal fittings on 20" Otumara-Escravos pipeline at Ugboegungun. Picture was taken during Joint Investigation of 1st August 2013.

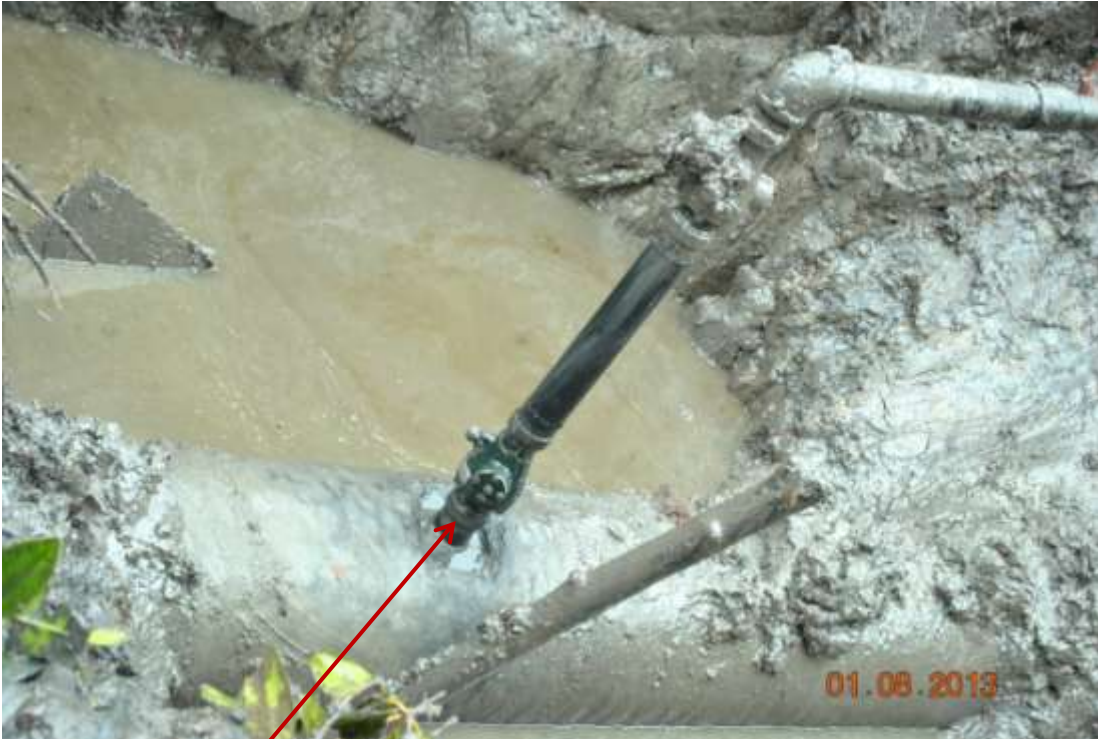
Close up: Illegal fitting on 20" Otumara-Escravos pipeline at Ugboegungun. Picture was taken during Joint Investigation of 1st August 2013.

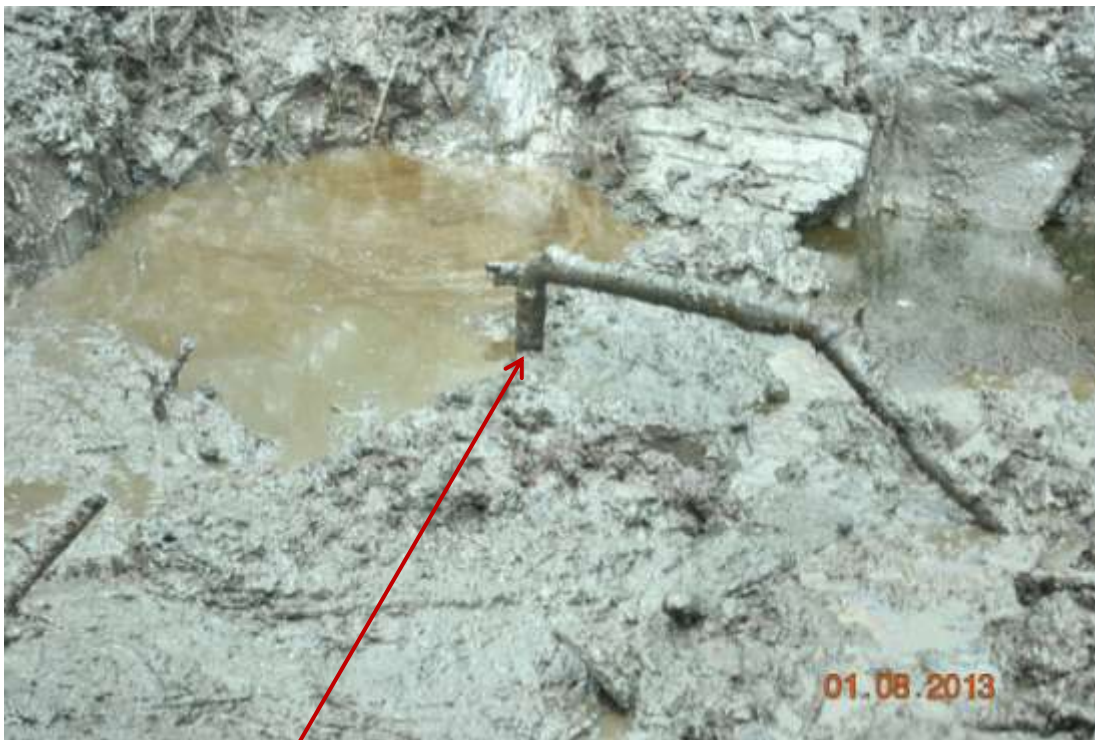
Close up: Illegal fitting on 20" Otumara-Escravos pipeline at Ugboegungun. Picture was taken during Joint Investigation of 1st August 2013.
