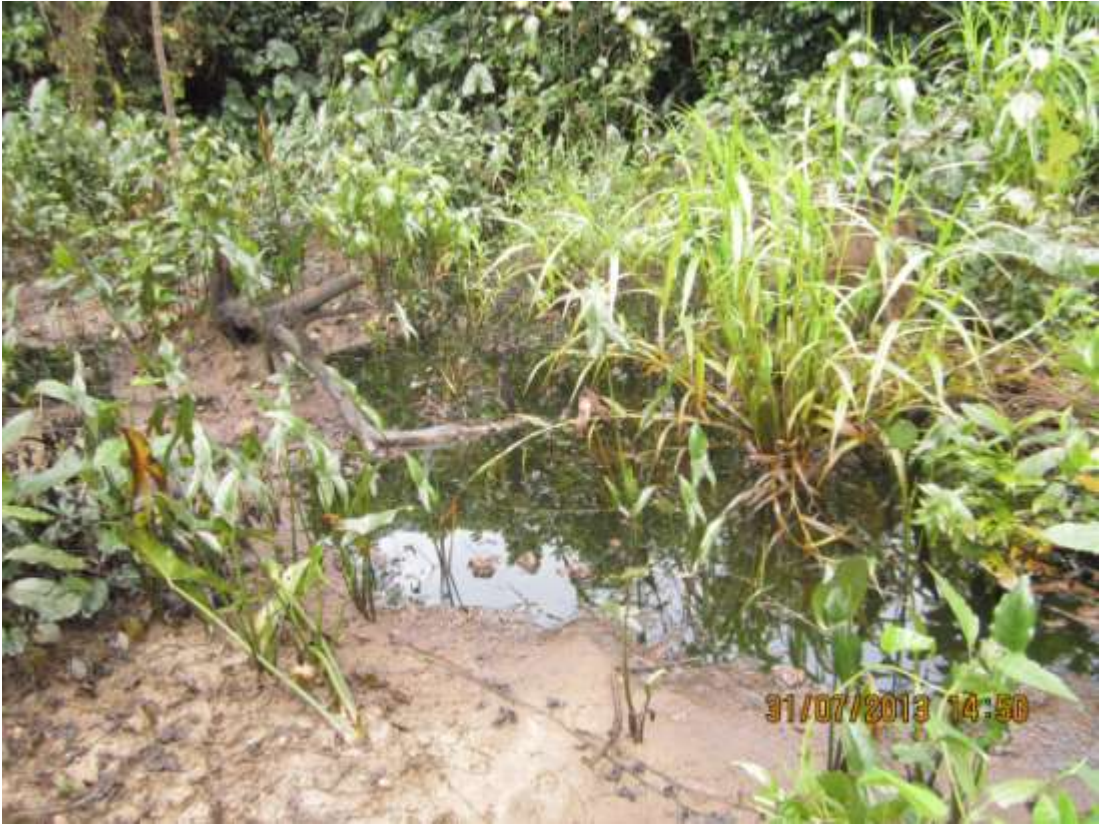
Overview: Part of spill impact on 4" Imo River Well55S flowline right of way at Igiriukwu. Picture was taken during Joint Investigation of 31st July 2013.

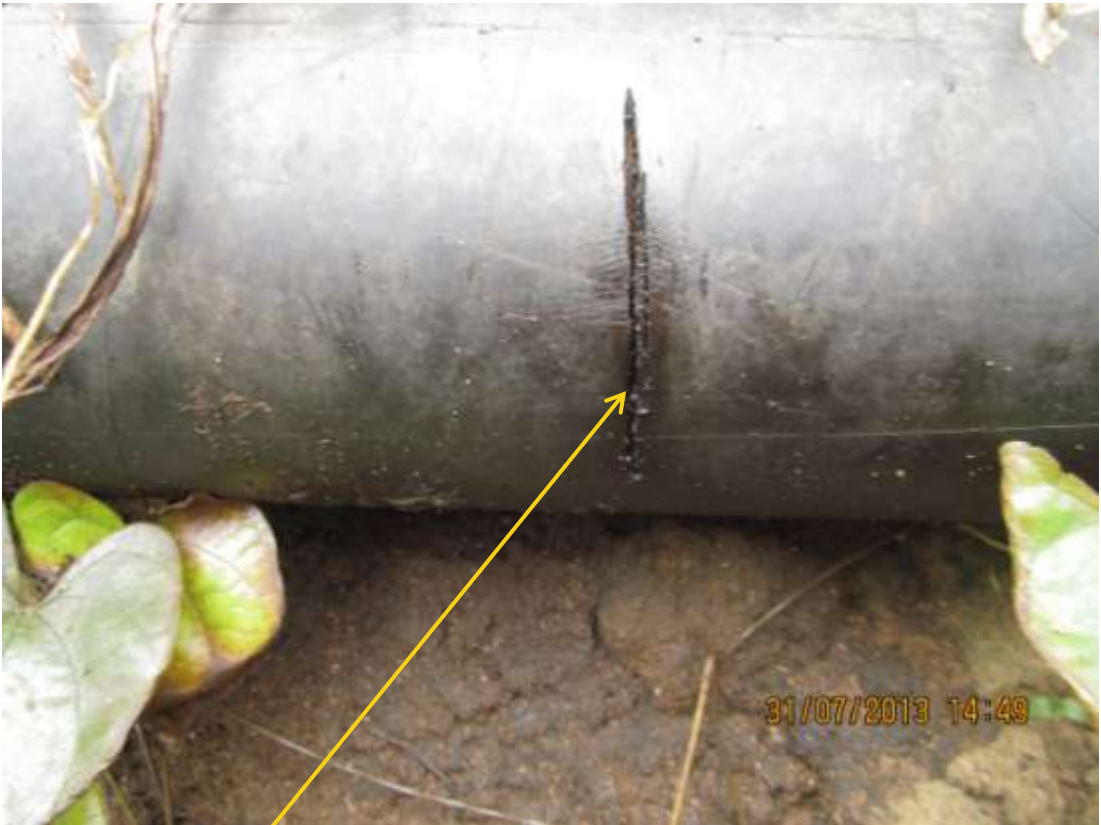
Close up: Hacksaw cut on 4" Imo River Well55S flowline at Igiriukwu. Picture was taken during Joint Investigation of 31st July 2013.
