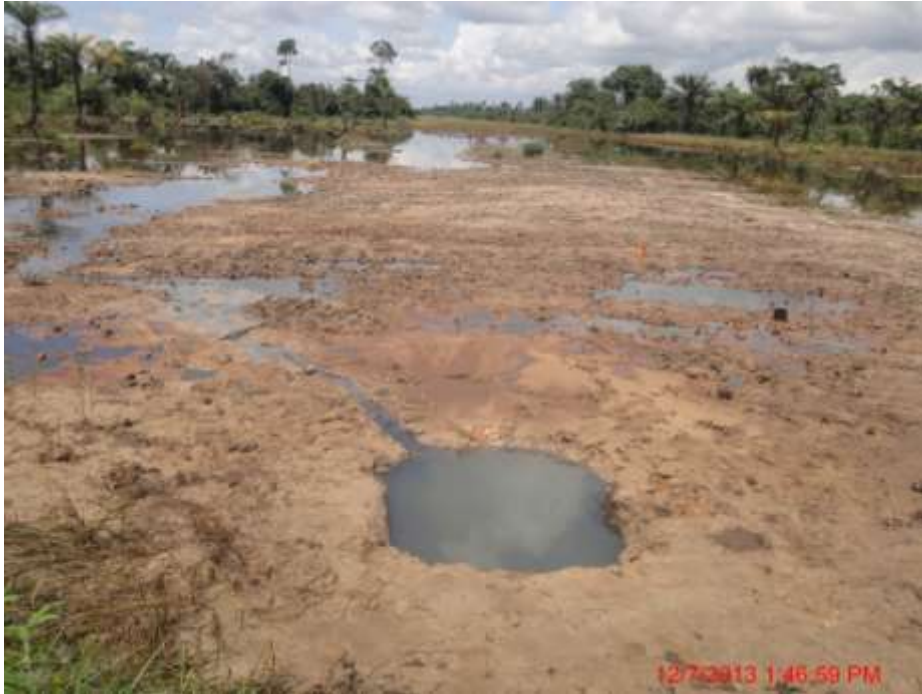
Overview: Part of spill impact on 20" Rumuekpe-Nkpoku pipeline right of way at Ibaa. Picture was taken during Joint Investigation of 12<sup>th</sup> July 2013.

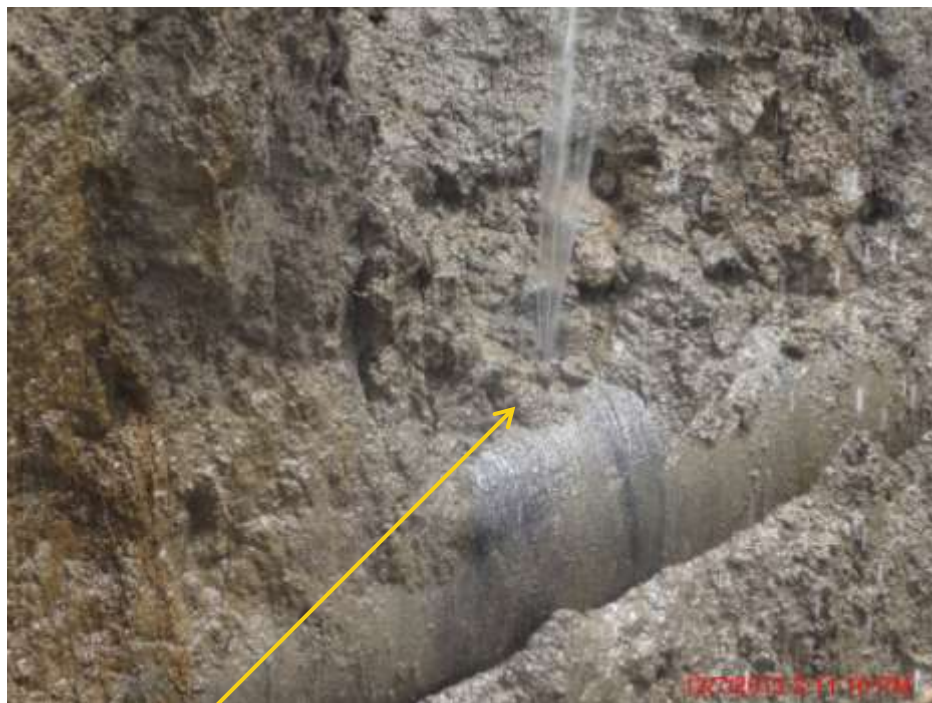
Close up: Drilled hole before plugging on 20" Rumuekpe-Nkpoku pipeline at Ibaa. Picture was taken during Joint Investigation of 12<sup>th</sup> July 2013.

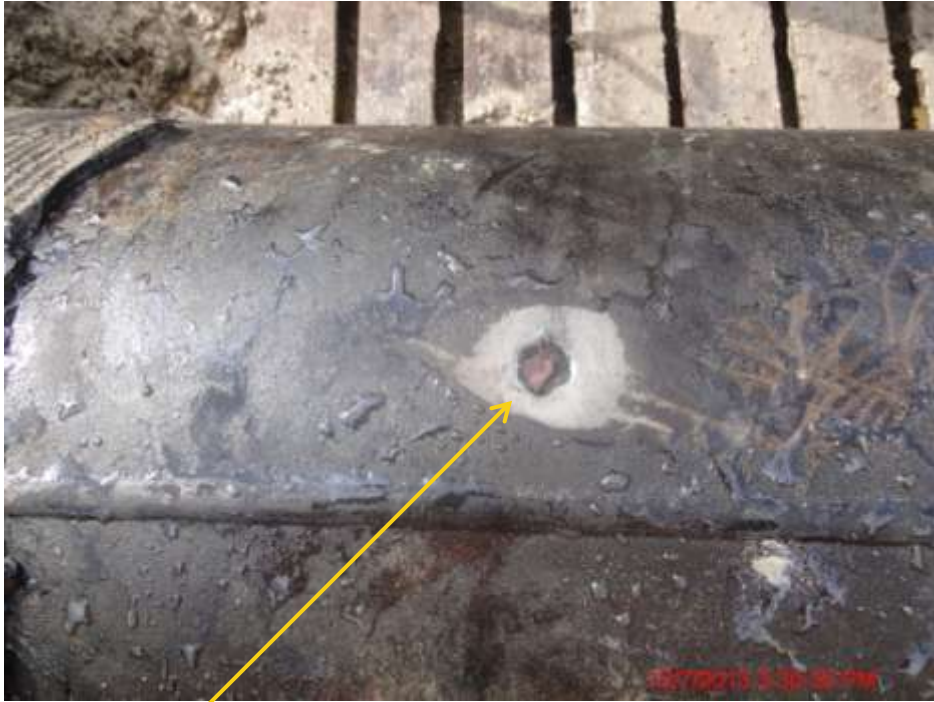
Close up: Drilled hole plugged with a wooden peg on 20" Rumuekpe-Nkpoku pipeline at Ibaa. Picture was taken during Joint Investigation of 12<sup>th</sup> July 2013.
