JOINT INVESTIGATION REPORT

INCIDENT NO: 1684151 JIV report S/N: Nº 0000373

1. Spill incident Number: 1684151 2. Type of incident* OIL SPILL
3. Name of Location 24" TRANS-RAMOS PIPELINE
4. Name of nearest community ODIMODI 5. State: DELTA 6. LGA BURUTU
7. Type of Production facility/Installation OIL PIPELINE
8. Asset owner/District THE SHELL PETROLEUM DEVELOPMENT COMPANY OF NIGERIA LIMITED / PIPELINE

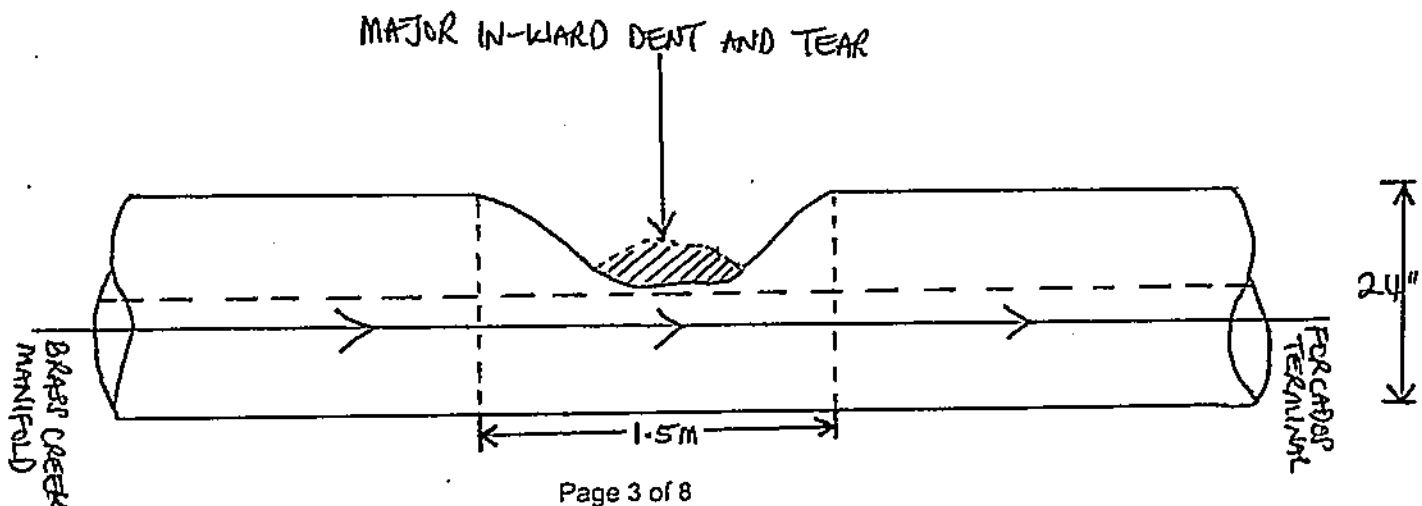
Additional observations around the spill point: INCIDENT CAUSE WAS CONFIRMED AS THIRD PARTY INTERPERENCE, ESTABLISHED ON EXCAVATION OF THE LEAK POINT. A MAJOR IN-WARD DENT AND TEAR (AT 12 O'CLOCK POSITION) DUE TO EXTERNAL IMPACT WAS OBSERVED ON THE PIPELINE.

SECTION OF 24" TRANS-RAMOS PIPELINE AT ODIMADI AXIS, SHOWING A MAJOR IN-WARD BENT AND TEAR AT 12 O'CLOCK POSITION
