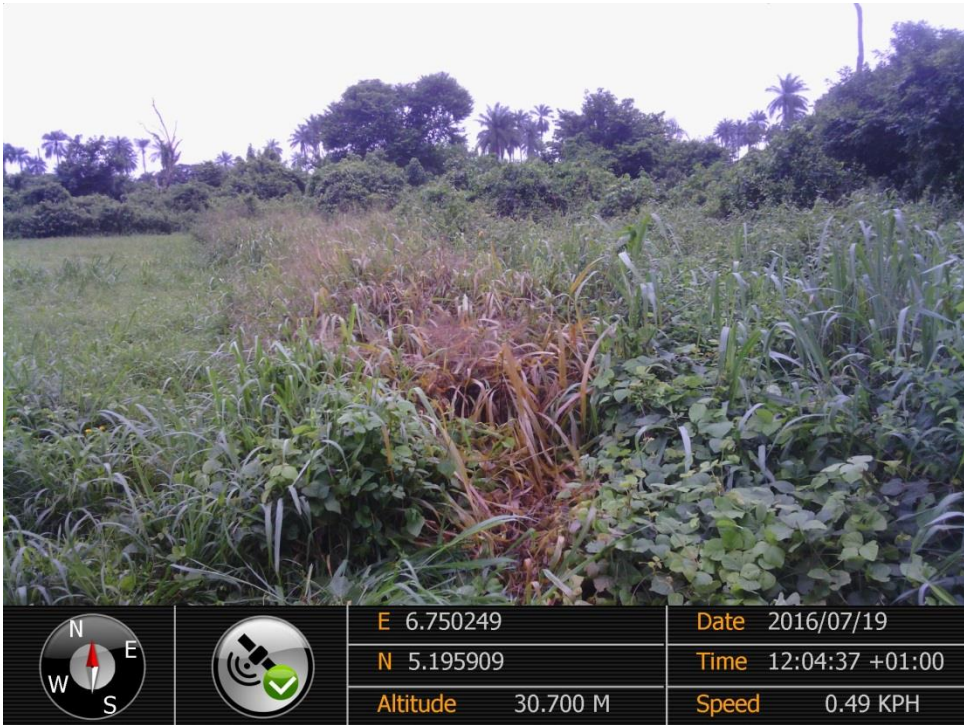
Overview: Part of spill impact on Ahia Well 3S Flowline at Egbeda. Picture was taken during Joint Investigation of 19<sup>th</sup> July 2016.

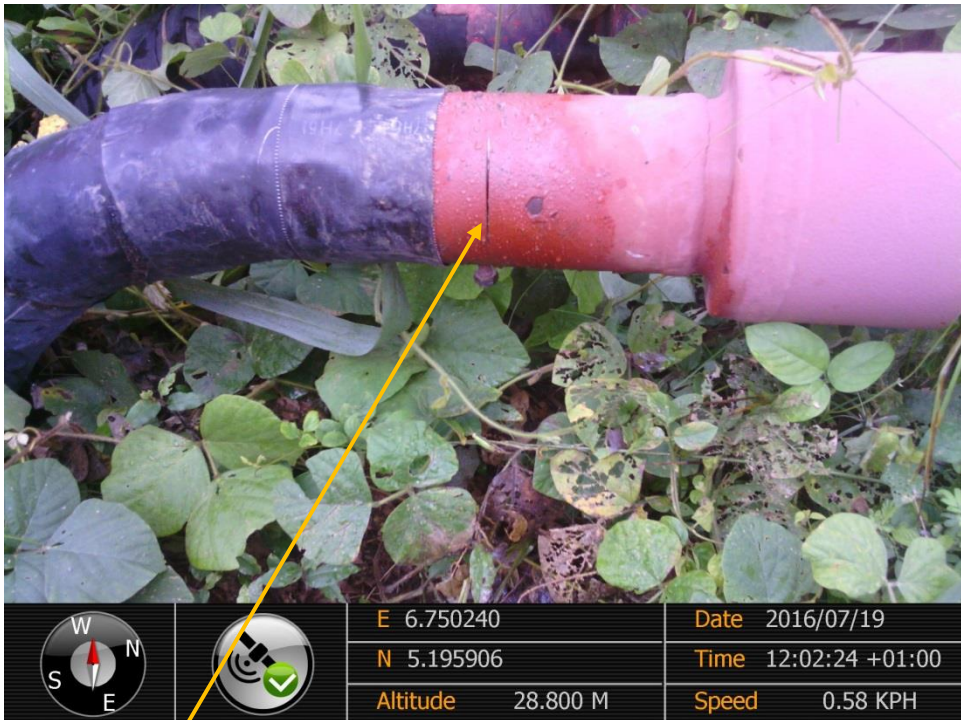
Close-up: Hack Saw Cut on Ahia Well 3S Flowline at Egbeda. Picture was taken during Joint Investigation of 19<sup>th</sup> July 2016.

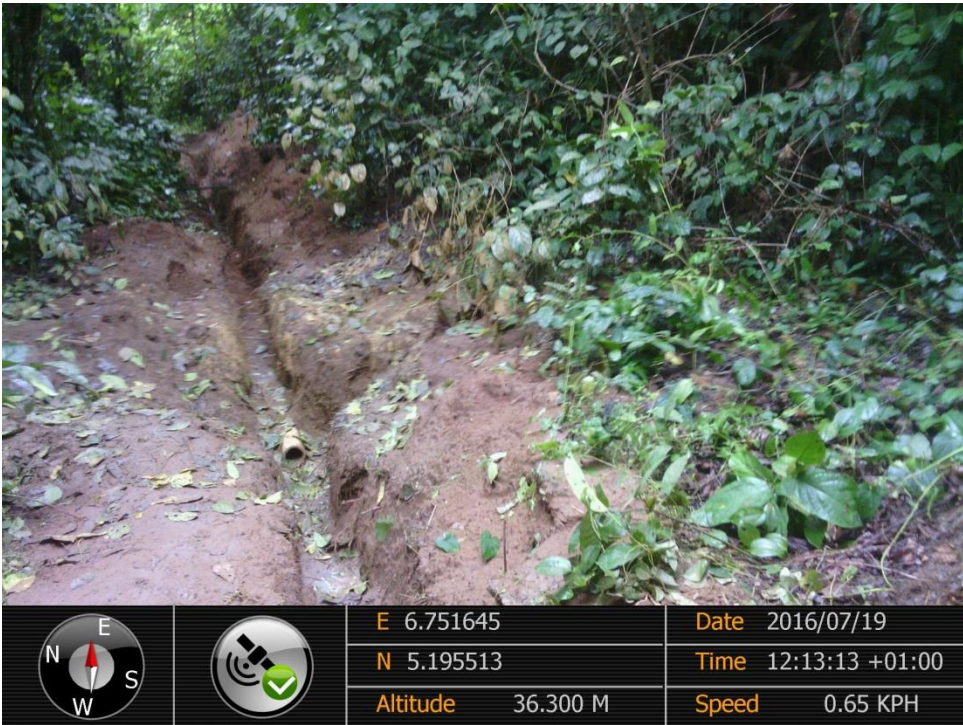
Overview: Part of spill impact on Ahia Well 3S Flowline at Egbeda. Picture was taken during Joint Investigation of 19<sup>th</sup> July 2016.

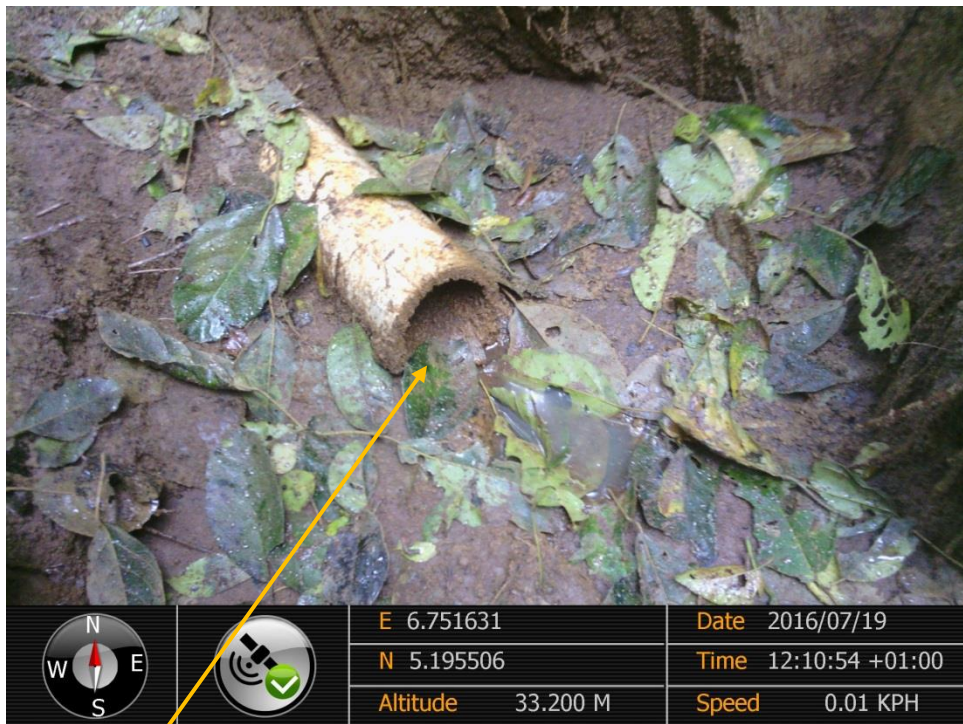
Close-up: Part of Missing Flowline on Ahia Well 3S Flowline at Egbeda. Picture was taken during Joint Investigation of 19<sup>th</sup> July 2016.
