JOINT INVESTIGATION REPORT

INCIDENT NO: 1677744 JIV report S/N: Nº 0000182

1. Spill incident Number: 1677744 2. Type of incident* OIL SPILL/FIRE
3. Name of Location 16" EGBEMA - ASSA PIPELINE
4. Name of nearest community ORILE 5. State: IMO 6. LGA OHATI/EGBEMA
7. Type of Production facility/Installation OIL PIPELINE
8. Asset owner/District THE SHELL PETROLEUM DEVELOPMENT COMPANY OF NIGERIA LIMITED/ PIPELINE

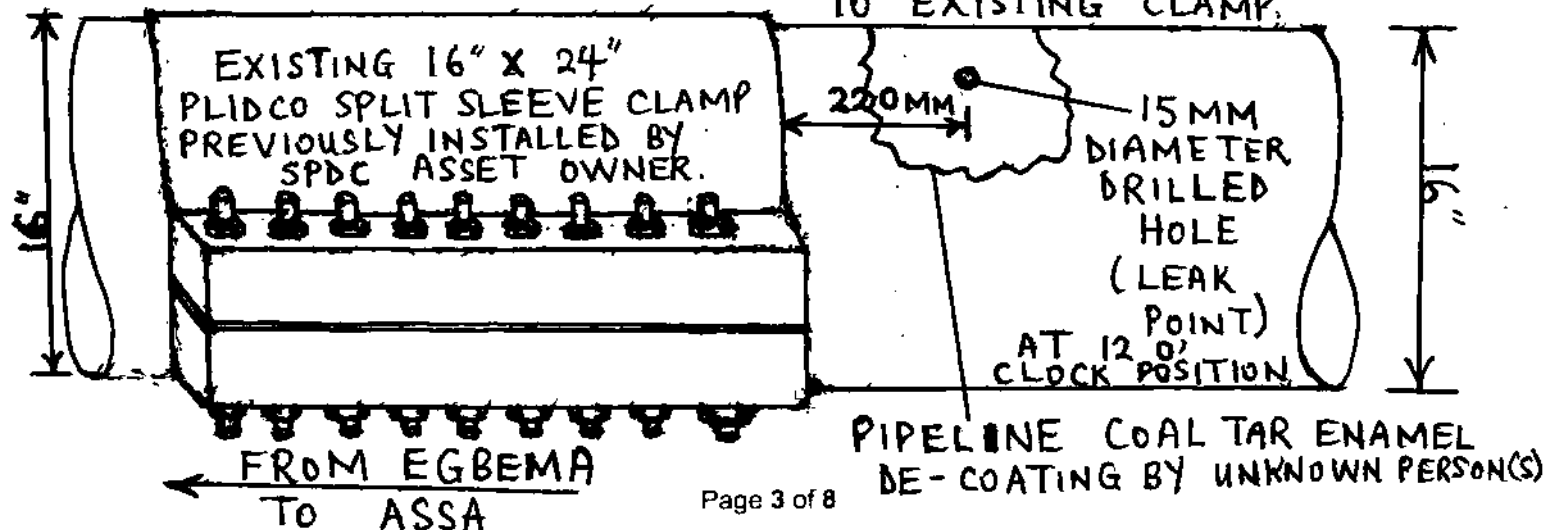
Additional observations around the spill point: ON ARRIVAL AT SITE, THE JOINT INVESTIGATION TEAM OBSERVED A FIRE-BURNT DITCH EXCAVATED AROUND THE SPILL POINT BY UNKNOWN PERSON(S), SOME SOLID BLOCKS AND A HEAP OF SAND WERE OBSERVED CLOSE TO THE EXCAVATED DITCH. ON EXPOSURE, A SECTION OF THE PIPELINE COAL TAR ENAMEL COATING SURROUNDING THE SPILL POINT WAS NOTICED REMOVED BY UNKNOWN PERSON(S). THE SEAL OF AN EXISTING SPDC CLAMP WAS OBSERVED 220MM FROM THE SPILL POINT.

| <input checked="" type="checkbox"/> Drilled hole | <input type="checkbox"/> Hack saw cut | <input type="checkbox"/> Tear (_____). |

SECTION OF 16" EGBEMA - ASSA PIPELINE AT OBILE SHOWING ONE NO. DRILLED HOLE (LEAK POINT) ADJACENT TO EXISTING CLAMP.

REPAIR WAS CARRIED OUT ON THE AFFECTED PIPELINE SECTION BY CLAMPING.
