Overview: Part of spill impact on Imo River 3 Well 22S Flowline Right of Way at Igiriukwu-Owaza. Picture was taken during Joint Investigation of 20th July 2017.

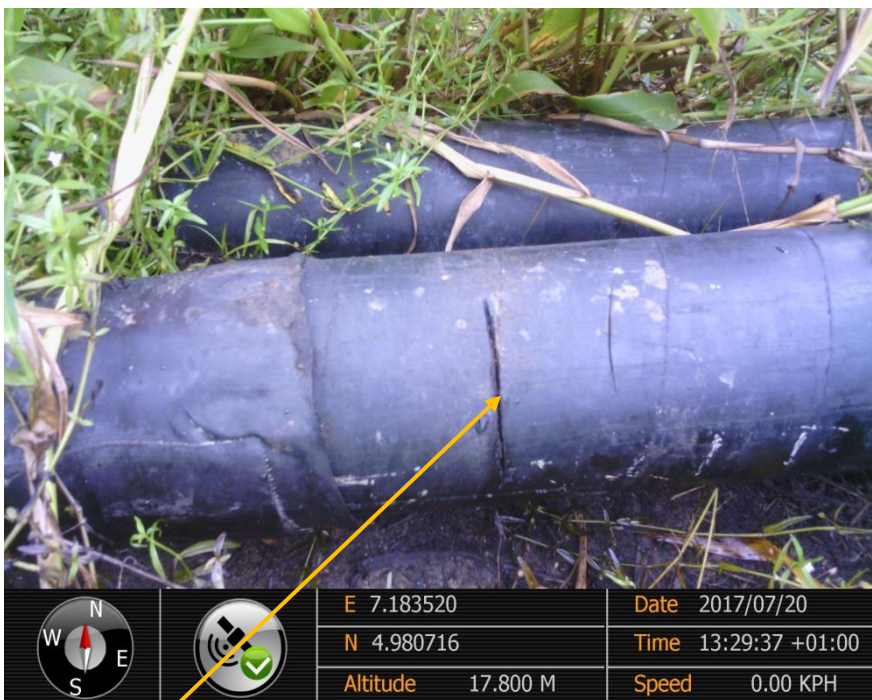
Close-up: Hacksaw Cut on Imo River 3 Well 22S Flowline at Igiriukwu-Owaza. Picture was taken during Joint Investigation of 20th July 2017.
