# JOINT INVESTIGATION REPORT

INCIDENT NO: 1887762 JIV report S/N: 000013

1. Spill incident Number: 1887762 2. Type of incident\* OIL SPILL  
3. Name of Location 12" IMO RIVER - OGACE (TRUNKLINE) PIPELINE  
4. Name of nearest community KDMKOM 5. State: RIVERS 6. LGA OYIGBO  
7. Type of Production facility/Installation OIL PIPELINE  
8. Asset owner/District THE SHELL PETROLEUM DEVELOPMENT COMPANY OF NIGERIA LIMITED

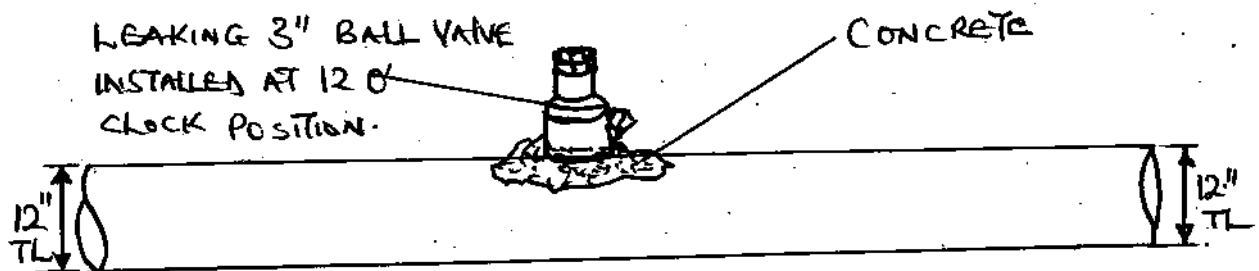
Additional observations around the spill point: THE JOINT INVESTIGATION TEAM OBSERVED THE CRUDE OIL THEFT FITTING WAS PARTLY CONCEALED IN CONCRETE. THE SECTIONS OF THE PIPELINE POLYKENE TAPE COATING SURROUNDING THE THEFT POINTS WAS OBSERVED TO HAVE BEEN REMOVED BY UNKNOWN PERSONS.

SECTION OF 12" IMO RIVER - OUALLE (TRUNKLINE) PIPELINE AT KOMKOM SHOW 3" CRUNE OIL THEFT POINT INSTALLED AT 12 O' CLOCK POSITION

RECOVERY OF FREE-PHASE OIL WAS BEING DONE AND REPAIRS WERE CARRIED OUT ON THE AFFECTED PIPELINE SECTION BY CLAMPING.
