JOINT INVESTIGATION REPORT

INCIDENT NO: 1884939 JIV report S/N: 09??

1. Spill incident Number: 1884939 2. Type of incident* MYSTERY SPILL
3. Name of Location 4" ADIBAWA WELL 4 AND 7 RIGHT OF WAY
4. Name of nearest community EDAGBERI 5. State: RIVERS 6. LGA AHOADA WEST
7. Type of Production facility/Installation FLOWLINE
8. Asset owner/District THE SHELL PETROLEUM DEVELOPMENT COMPANY OF NIGERIA LTD (SPDC)
PIPELINE CENTRAL HUB

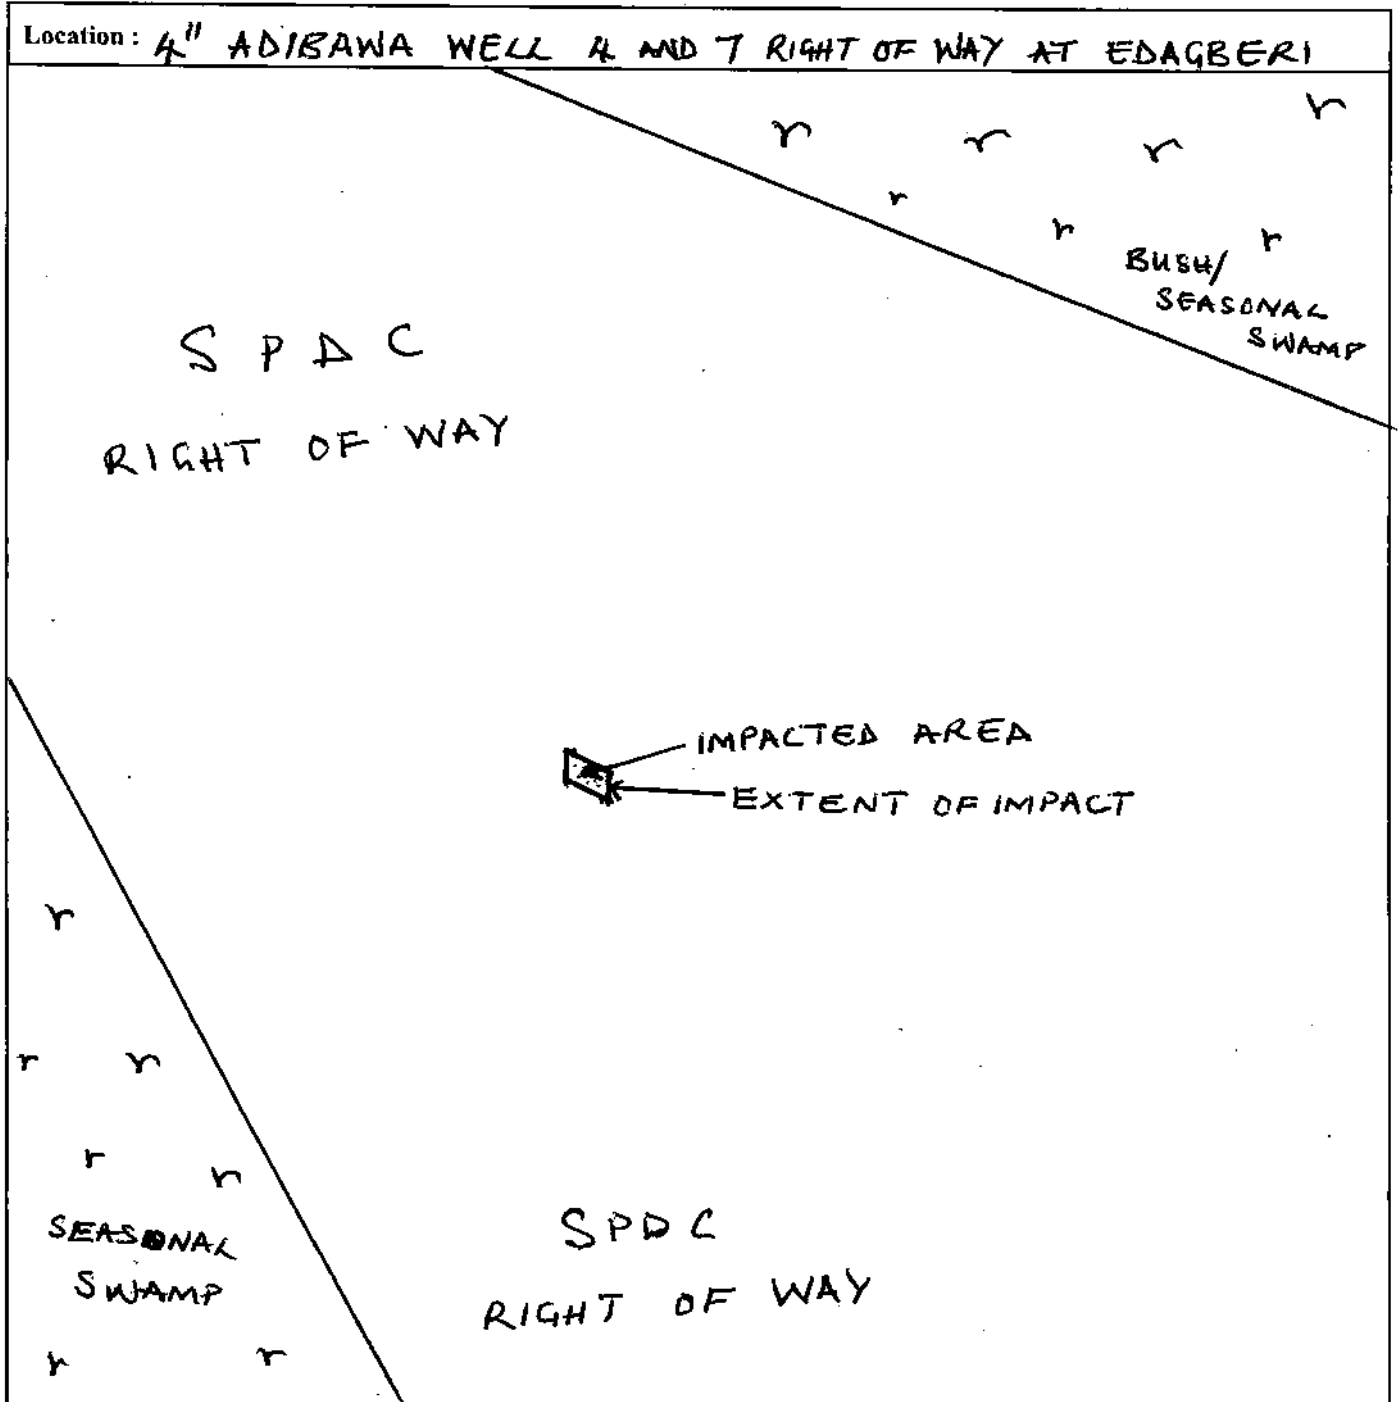
f. Appendix 1: Overview sketch of the site

Additional observations around the spill point: ON 5TH JULY 2017, THE SPILL WAS ON A FLOODED AREA, AND JOINT INVESTIGATION COULD NOT CONTINUE. AFTER THE FLOODWATERS HAD RECEDED, THE JOINT INVESTIGATION TEAM RECONVENED AND FOUND NO LEAK POINT AROUND THE IMPACTED AREA.
