JOINT INVESTIGATION REPORT

INCIDENT NO: 2403232 JIV report S/N: 1030049

1. Fountain Incident Number: 2403232 2. Type of incident* OIL SPILL
3. Name of Location 20" KOLO CREEK - RUMUEKPE PIPELINE
4. Name of nearest community ODAU (Km 19) 5. State: RIVERS 6. LGA ABUA/ODUAL
7. Type of Production facility/Installation OIL PIPELINE
8. Asset owner/District THE SHELL PETROLEUM DEVELOPMENT COMPANY OF NIGERIA LIMITED (SPDC) PIPELINE

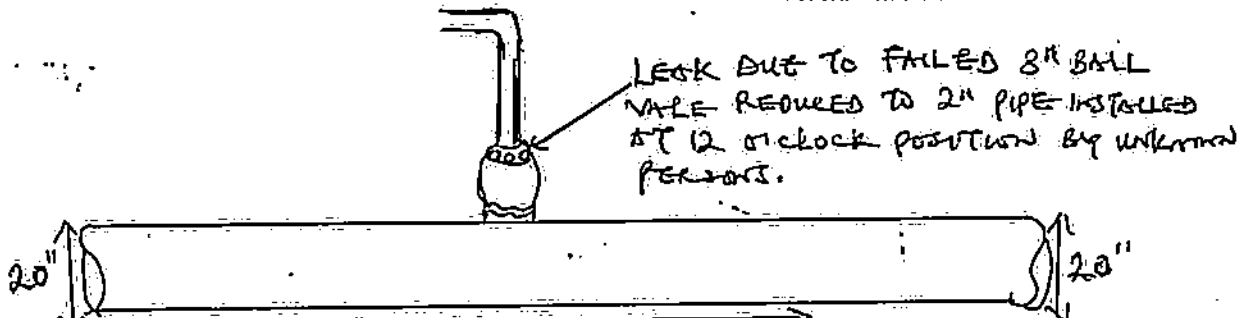
| <input checked="" type="checkbox"/> Failed Weld-on illegal hot tap valve | <input type="checkbox"/> Failed Clamp, | <input type="checkbox"/> Missing Pipeline/Flowline |
| <input checked="" type="checkbox"/> Crude oil theft (illegal bunkering) point, | <input type="checkbox"/> Saver-pit over flow | <input type="checkbox"/> Third party tampering with Clamp |

E. GRAPHIC DESCRIPTION OF LEAK POINT (while detail report of the leak point should be contained in the leak report, overview sketch of the site should be added as an appendix 1) A SECTION OF 26" KOLOCREEK - RUMUEKPE PIPELINE AT 604U (Km 19) SHOWING A 3" BALL VALVE REDUCED TO 2" PIPE INSTALLED AT 12 O'CLOCK POSITION BY UNKNOWN PERSONS

REPAIR BY CLAMPING ONGOING
