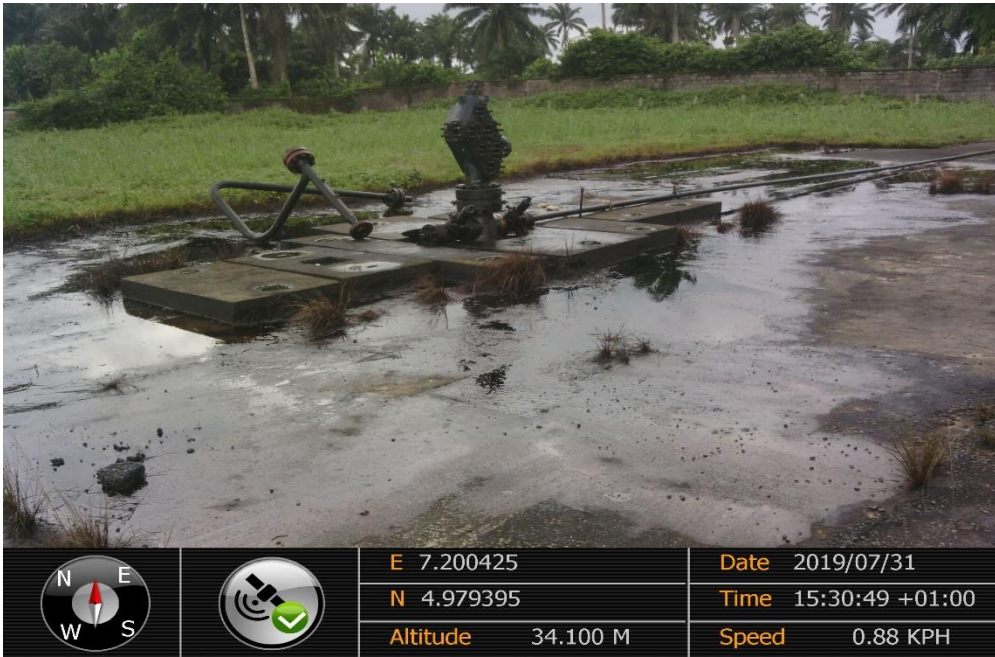
Overview: Part of spill impact on Imo River Well 33 at IpuWest-Owaza. Picture was taken during Joint Investigation of 31<sup>st</sup> July 2019.

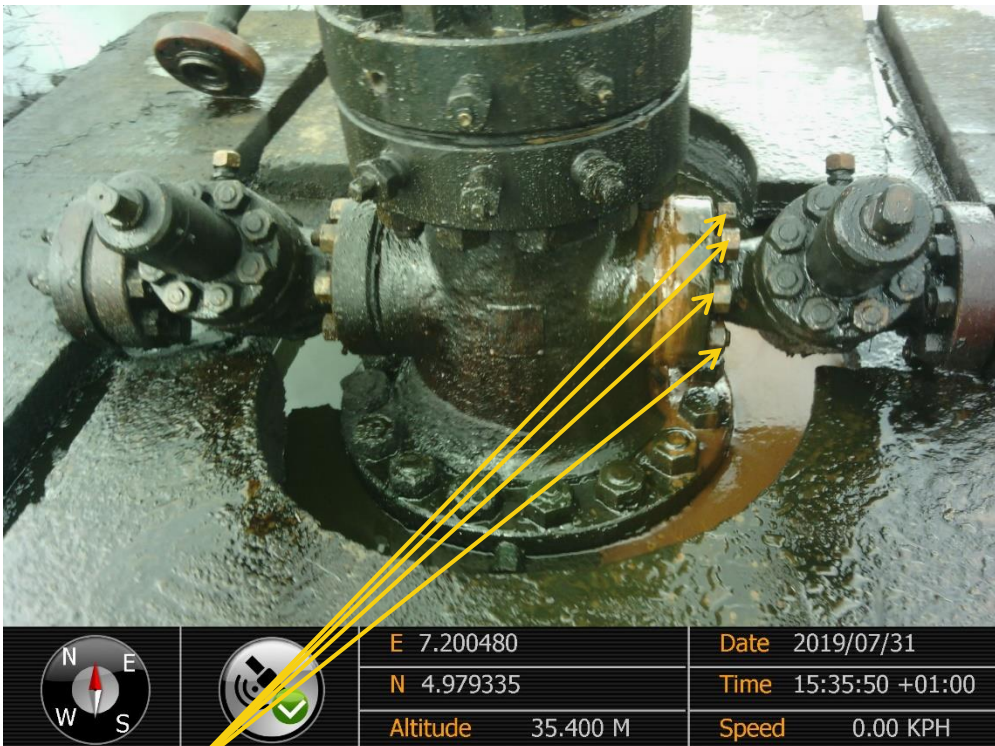
Close-up: Tampered Valves on Imo River Well 33 at IpuWest-Owaza. Picture was taken during Joint Investigation of 31<sup>st</sup> July 2019
