Overview: Part of the spill impact on Cawthorne channel Well 45T flowline at Mbiama.  
Picture taken during Joint Investigation of 23<sup>rd</sup> June, 2011

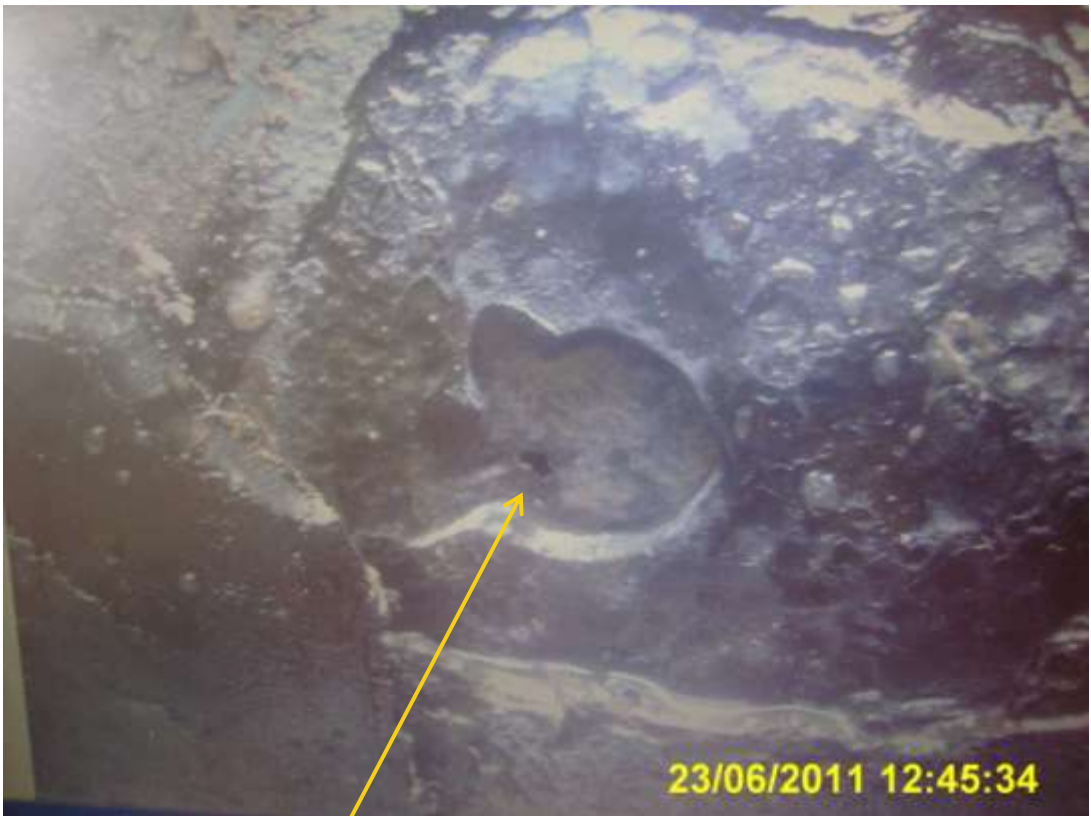
Close-up: Spill point due to corrosion on Cawthorne channel Well 45T flowline at Mbiama.  
Picture taken during Joint Investigation of 23<sup>rd</sup> June, 2011
