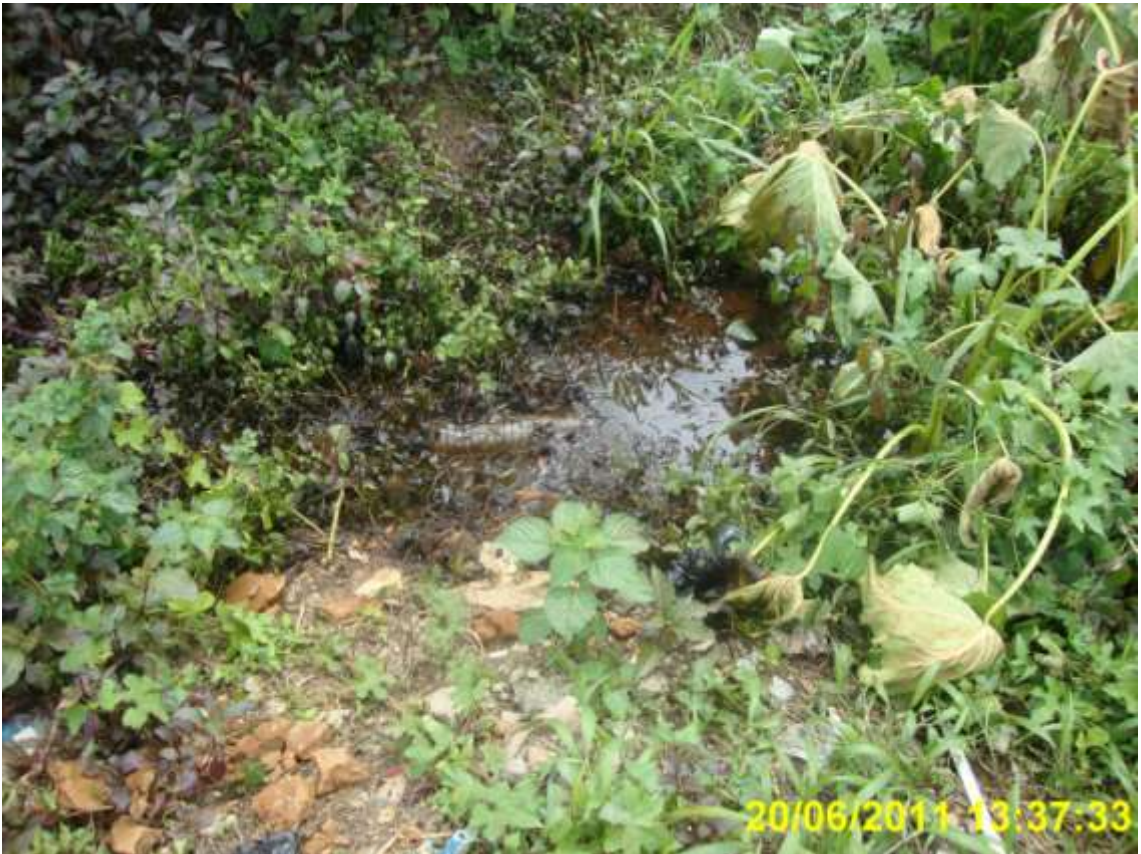
Overview: Part of spill impact on 6" bulkline to Agbada2 flowstation at Agbada. Picture taken during Joint Investigation of 20th June, 2011

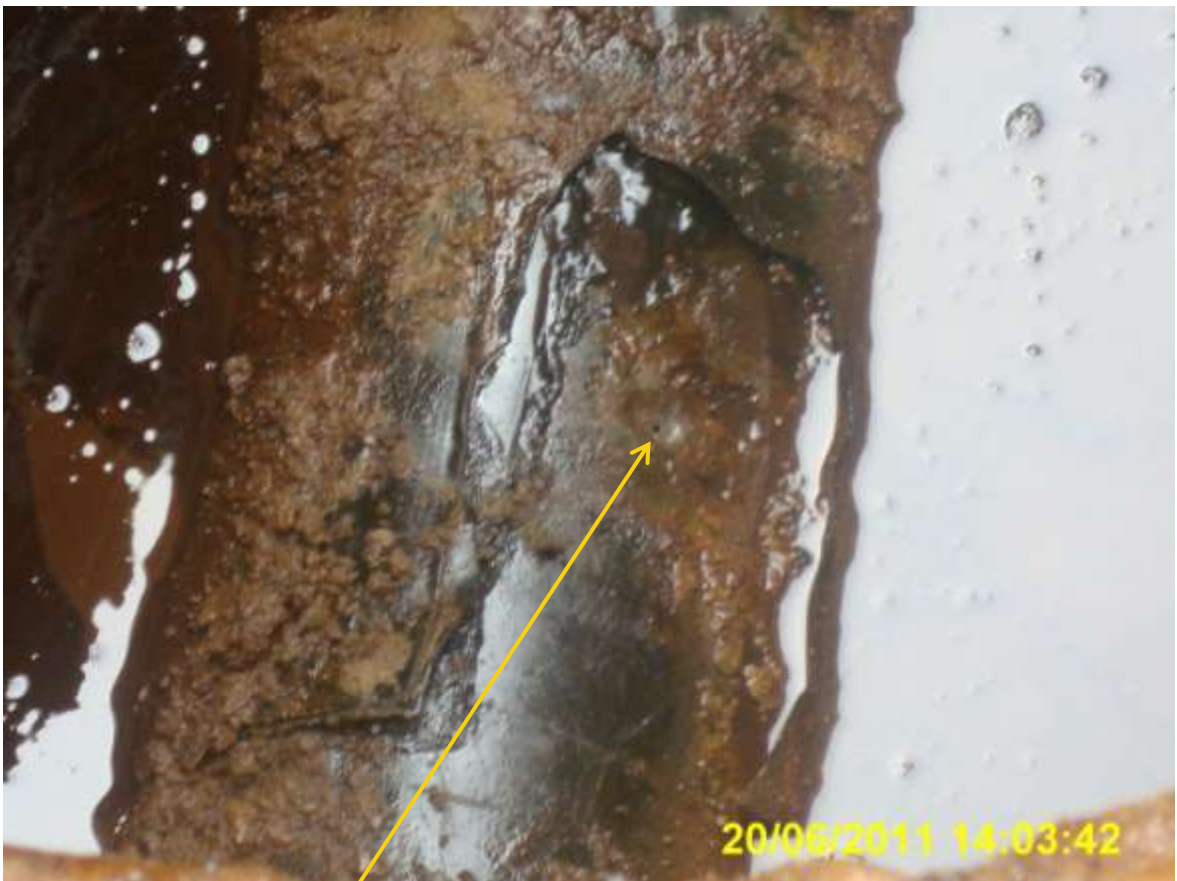
Close-up: Spill from pinhole due to corrosion on 6" bulkline to Agbada2 flowstation at Agbada. Picture taken during Joint Investigation of 20th June, 2011
