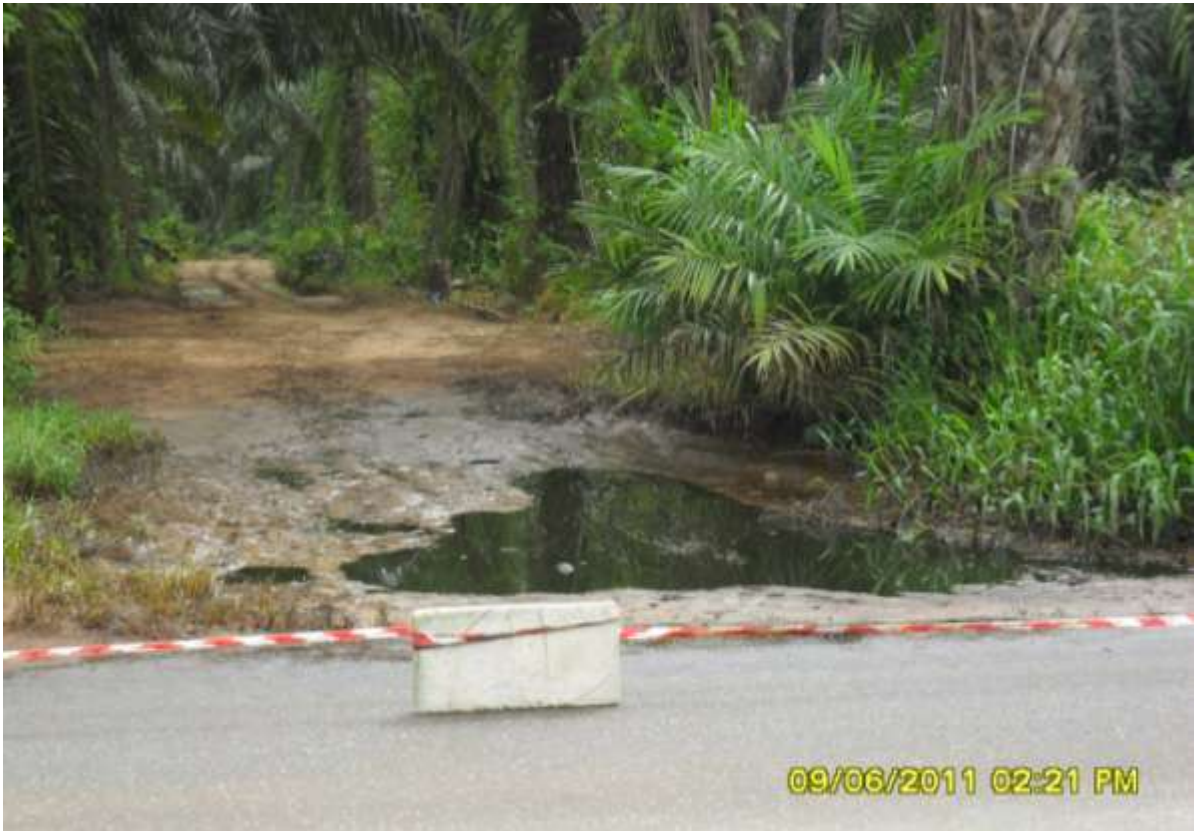
Overview: Part of extent of the spill incident impact on 12" Imo River 1 pipeline route in Owaza. Picture taken during Joint Investigation of 9<sup>th</sup> June, 2011

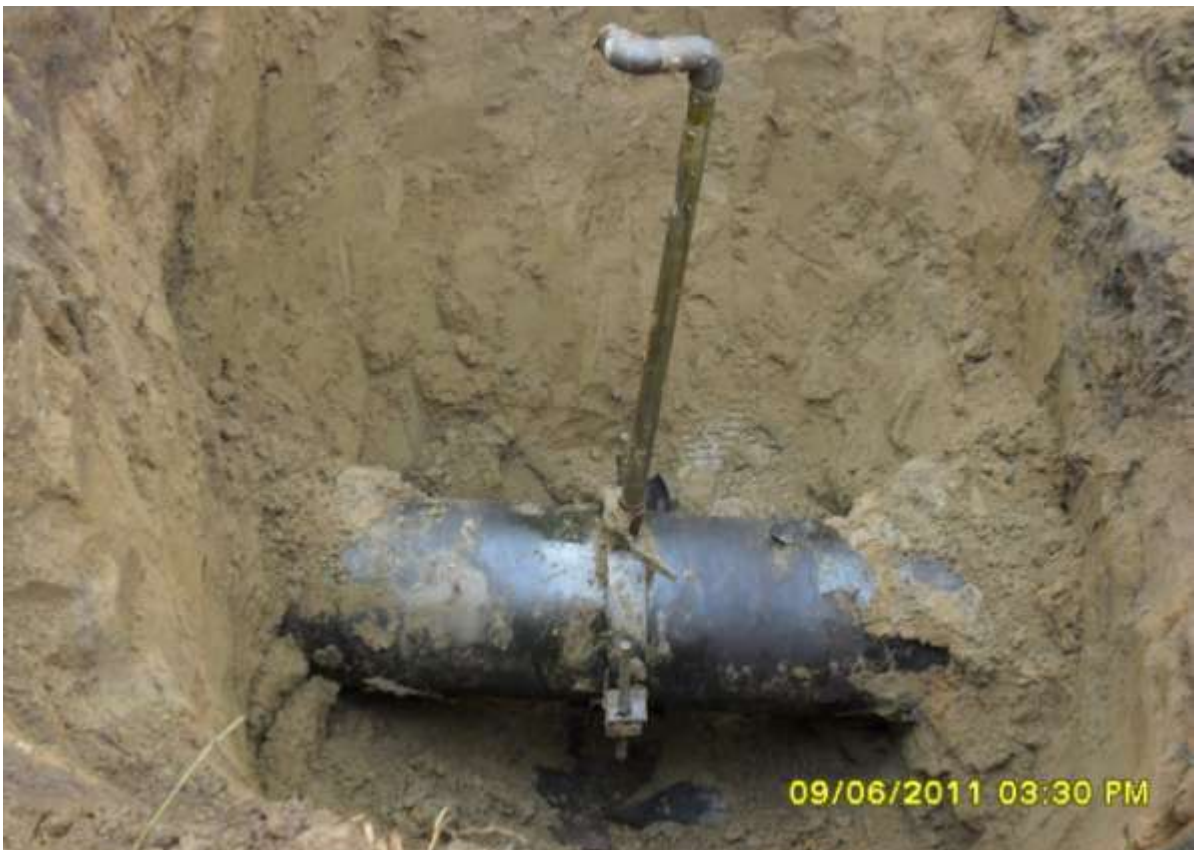
Close-up: Illegally welded fitting on 12" Imo River 1 pipeline in Owaza. Picture taken during Joint Investigation of 9<sup>th</sup> June, 2011.
