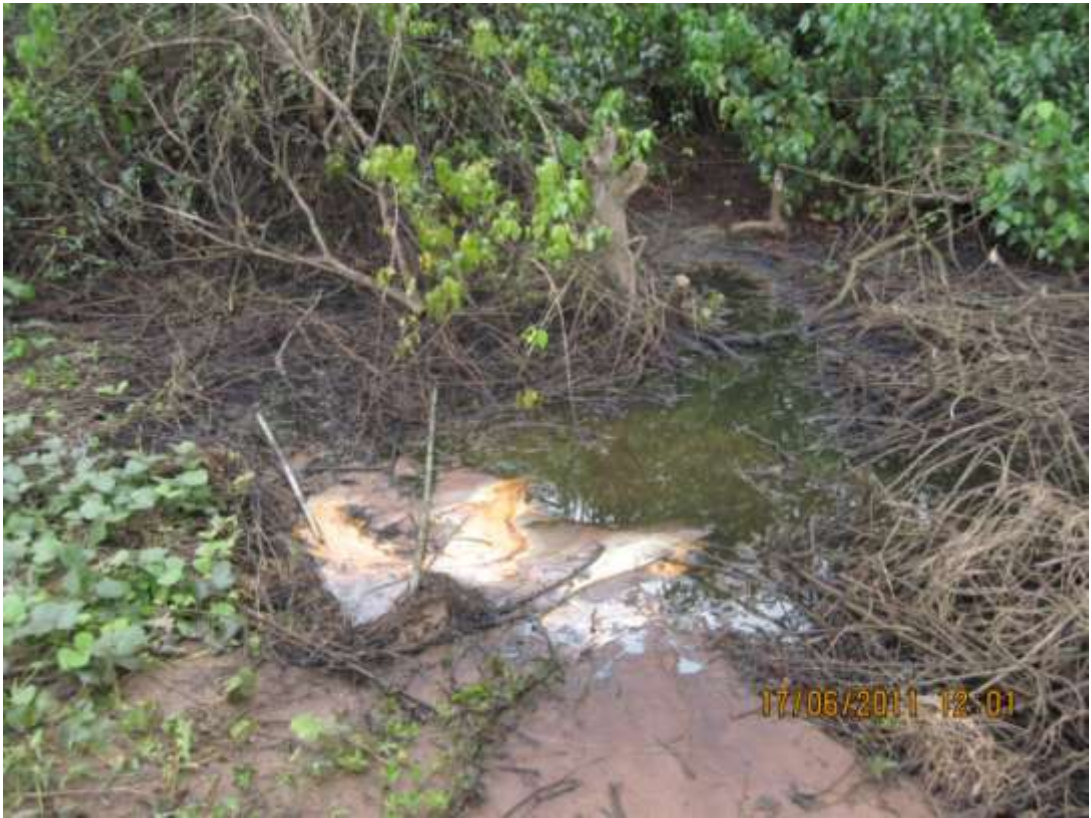
Overview: Part of spill impact on 12" ImoRiver2 pipeline at Odagwa. Picture taken during Joint Investigation of 17th June, 2011

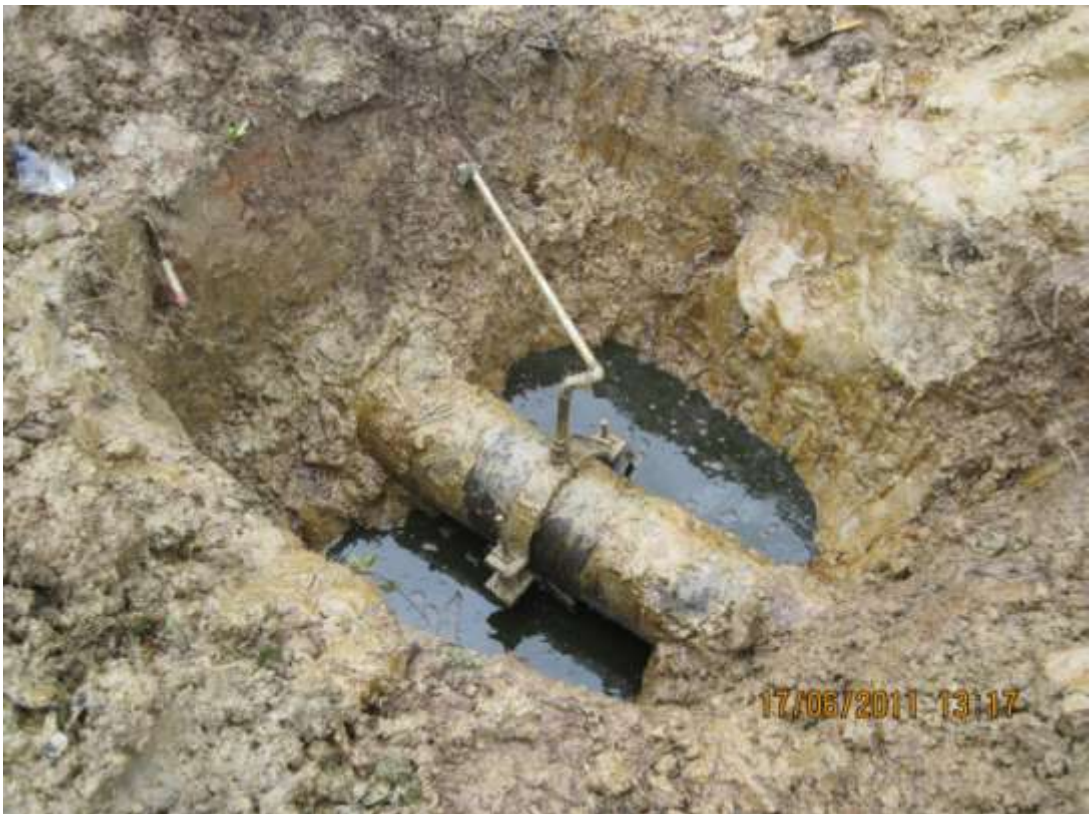
Close-up: Illegally welded fitting on 12" ImoRiver2 pipeline at Odagwa. Picture taken during Joint Investigation of 17th June, 2011

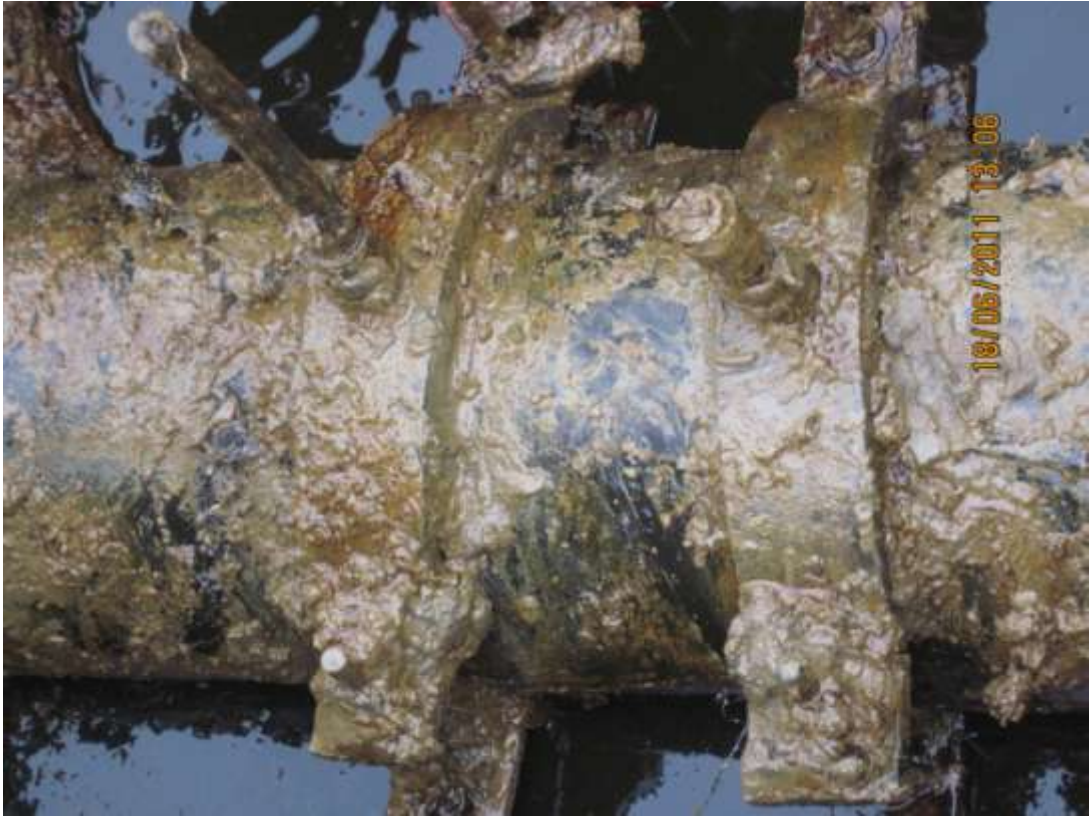
Close-up: Illegally welded fittings on 12" ImoRiver2 pipeline at Odagwa. Picture taken during Joint Investigation of 18th June, 2011

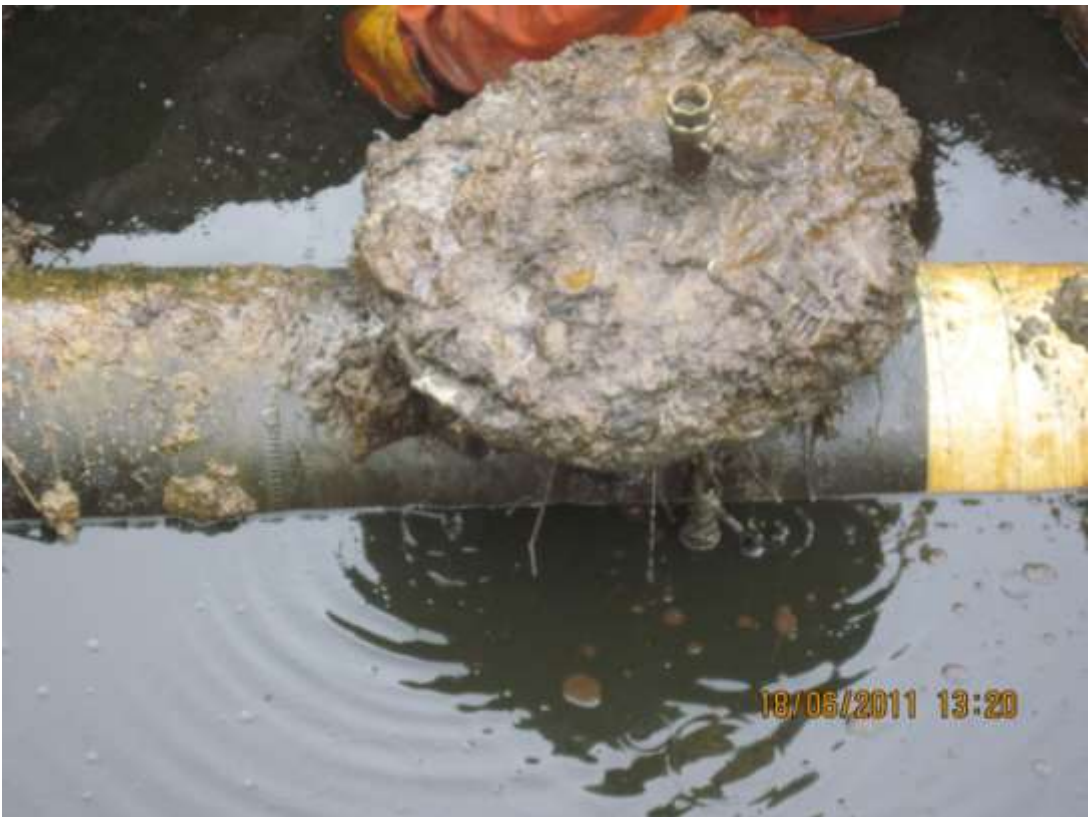
Close-up: Illegally welded fitting on 12" ImoRiver2 pipeline at Odagwa. Picture taken during Joint Investigation of 18th June, 2011

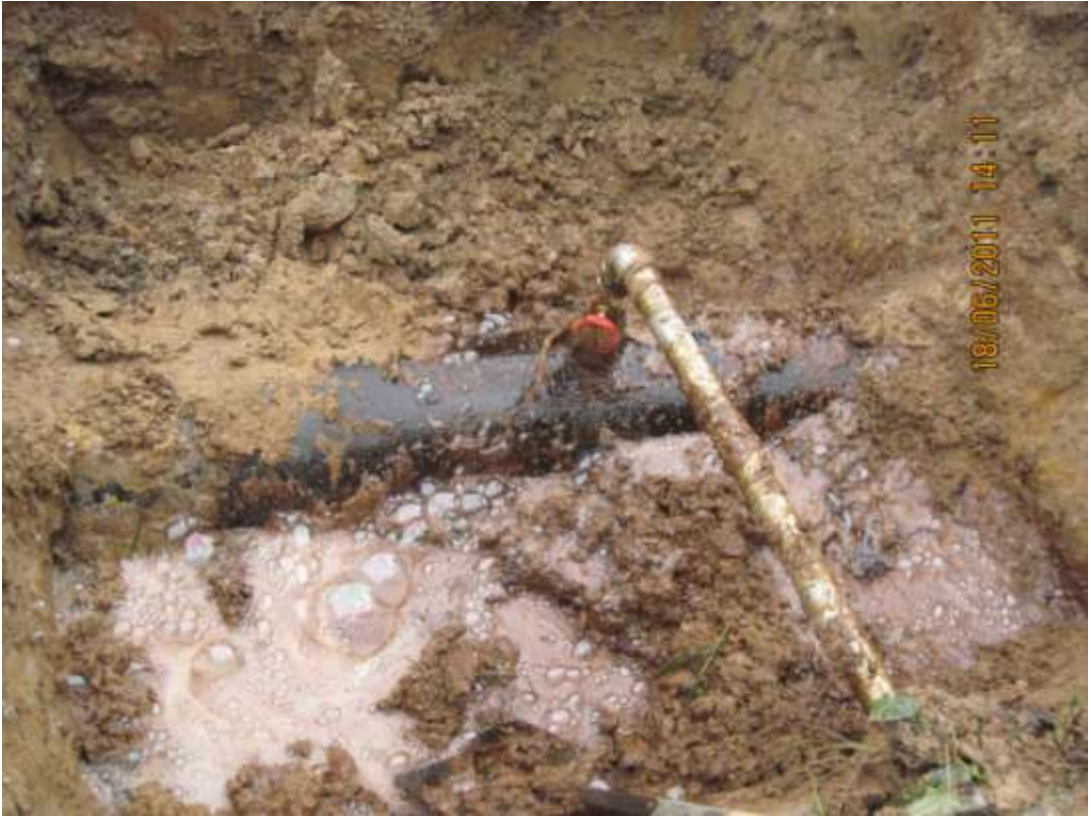
Close-up: Illegally welded fitting on 12" ImoRiver2 pipeline at Odagwa. Picture taken during Joint Investigation of 18th June, 2011
