Overview: Part of the spill impact on Obigbo Well 28LS flowline at Imea. Picture taken during Joint Investigation of 10<sup>th</sup> June, 2011

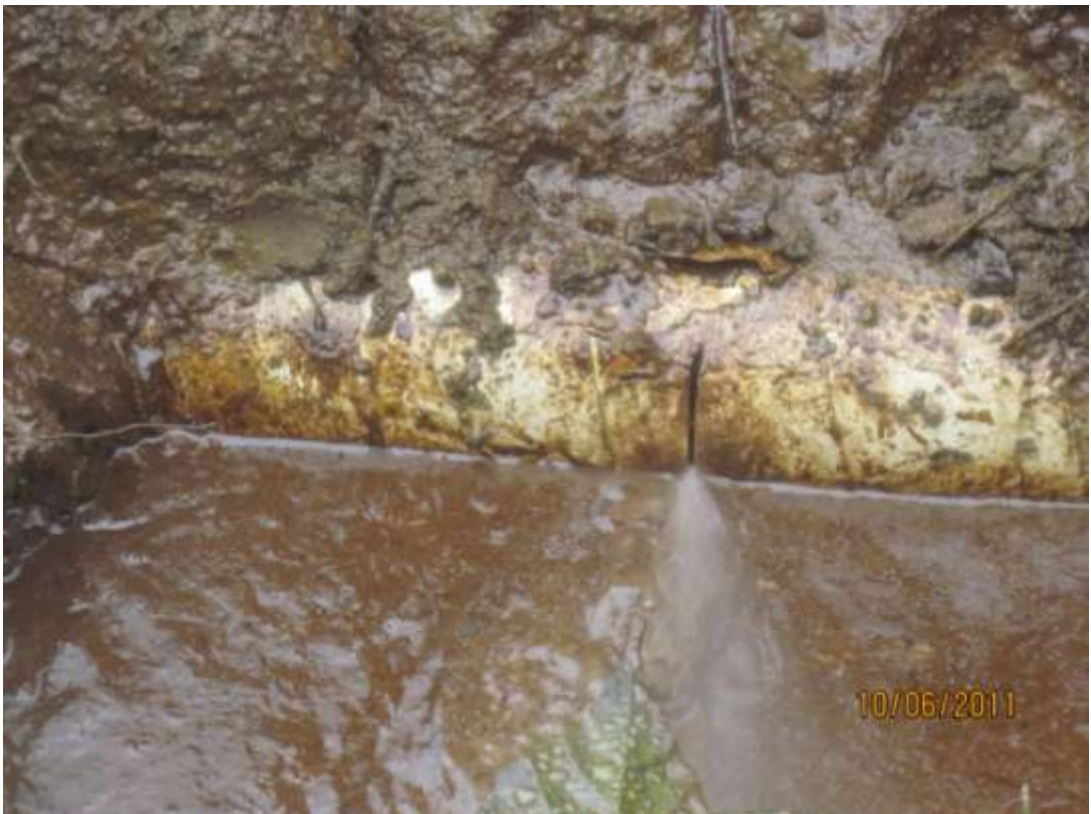
Close-up: Hacksaw cut on Obigbo Well 28LS flowline at Imea. Picture taken during Joint Investigation of 10<sup>th</sup> June, 2011
