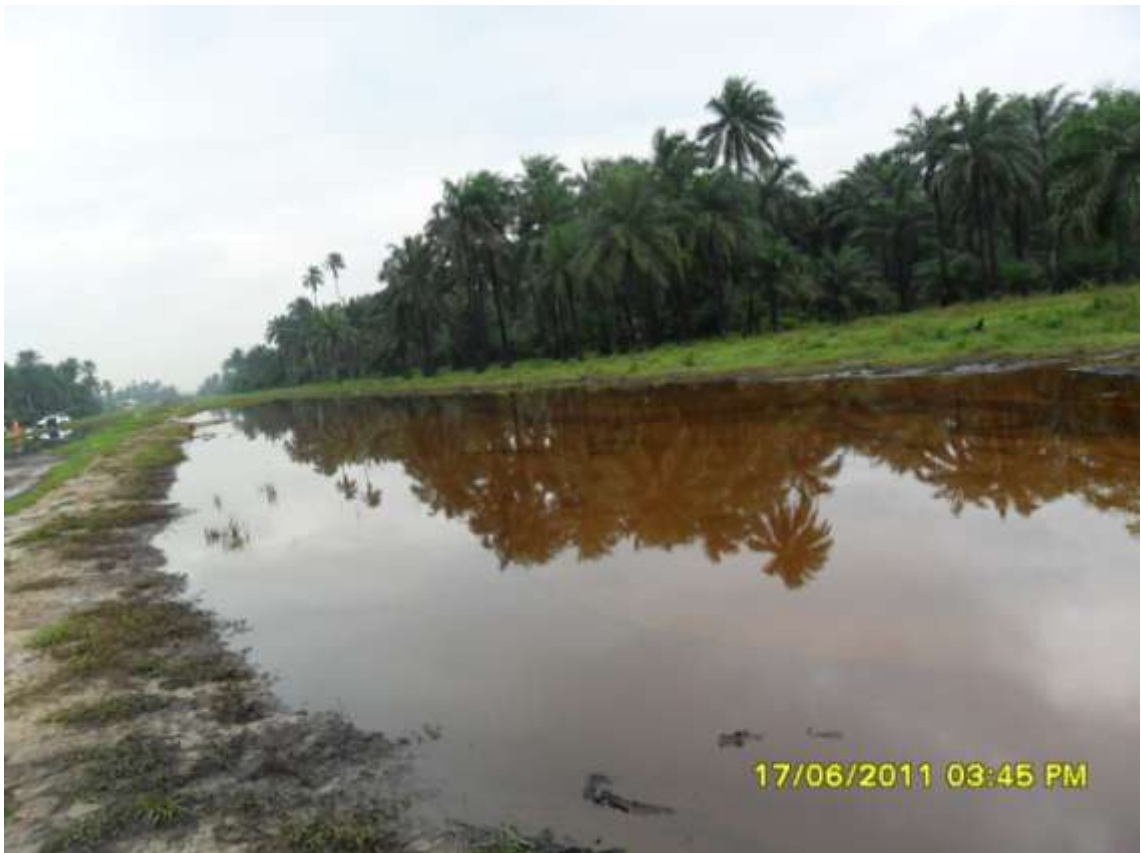
Overview: Part of spill impact on 24" Nkpoku-Boma pipeline at Akpajo. Picture taken during Joint Investigation of 17<sup>th</sup> June, 2011

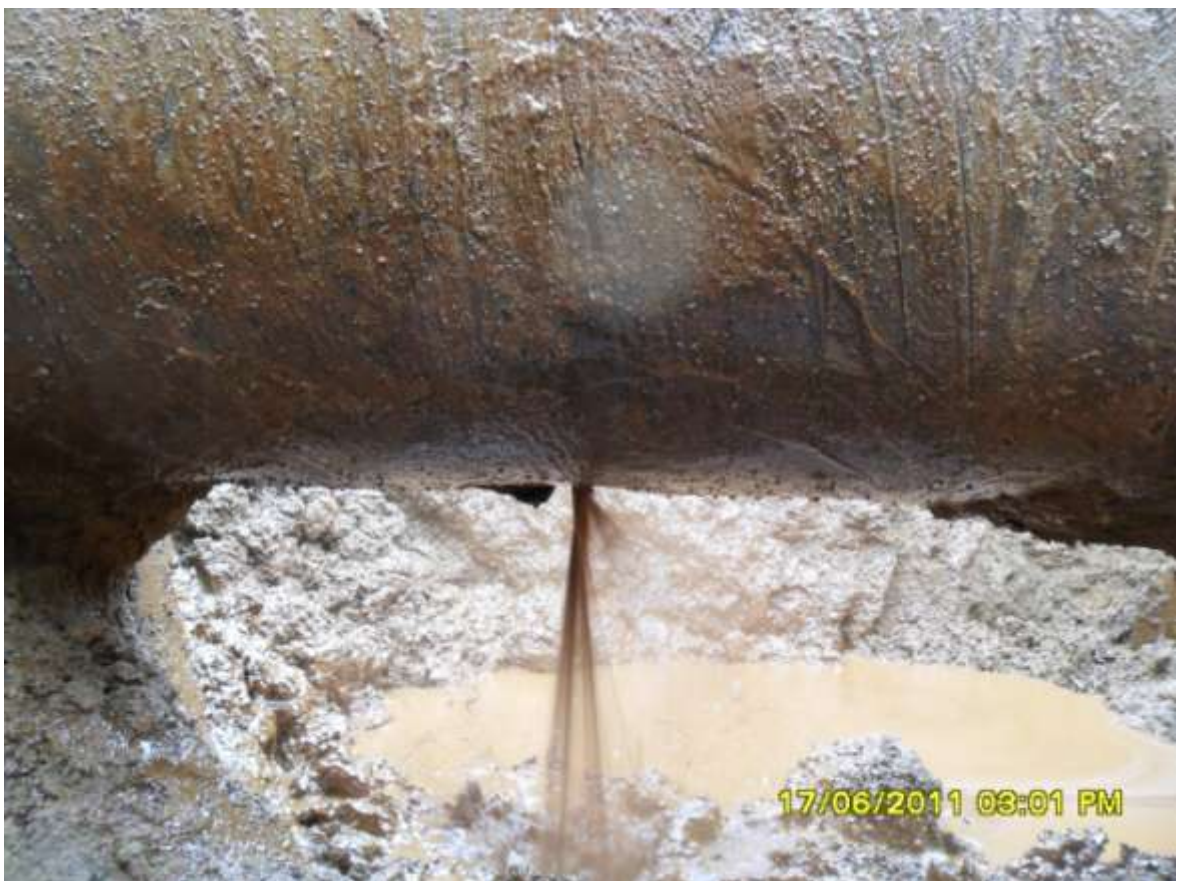
Close-up: Spill due to corrosion between 6 and 7 o'clock position on 24" Nkpoku-Boma pipeline at Akpajo. Picture taken during Joint Investigation of 17<sup>th</sup> June, 2011
