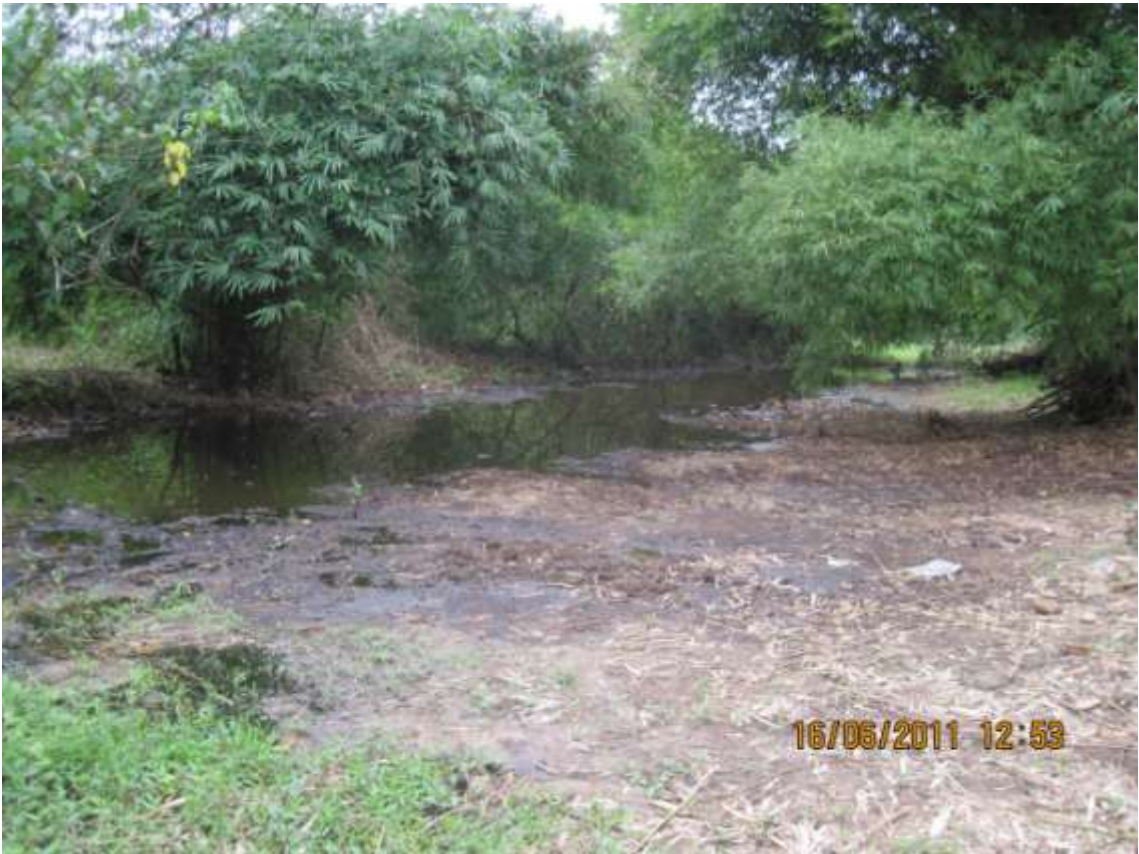
Overview: Part of spill impact on 12" ImoRiver2 pipeline at Owaza. Picture taken during Joint Investigation of 16th June, 2011

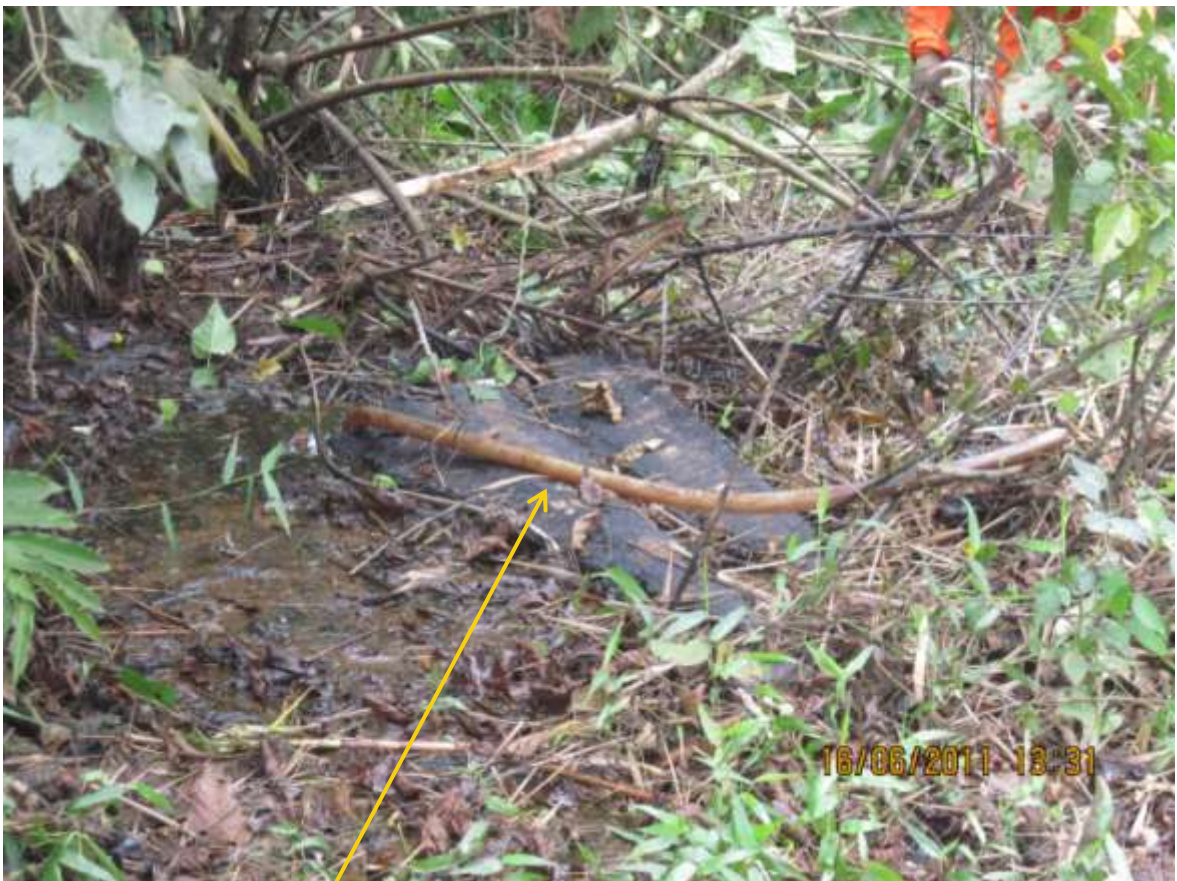
Close-up: Spill from hose used for illegal transport of crude on 12" ImoRiver2 pipeline at Owaza. Picture taken during Joint Investigation of 16th June, 2011

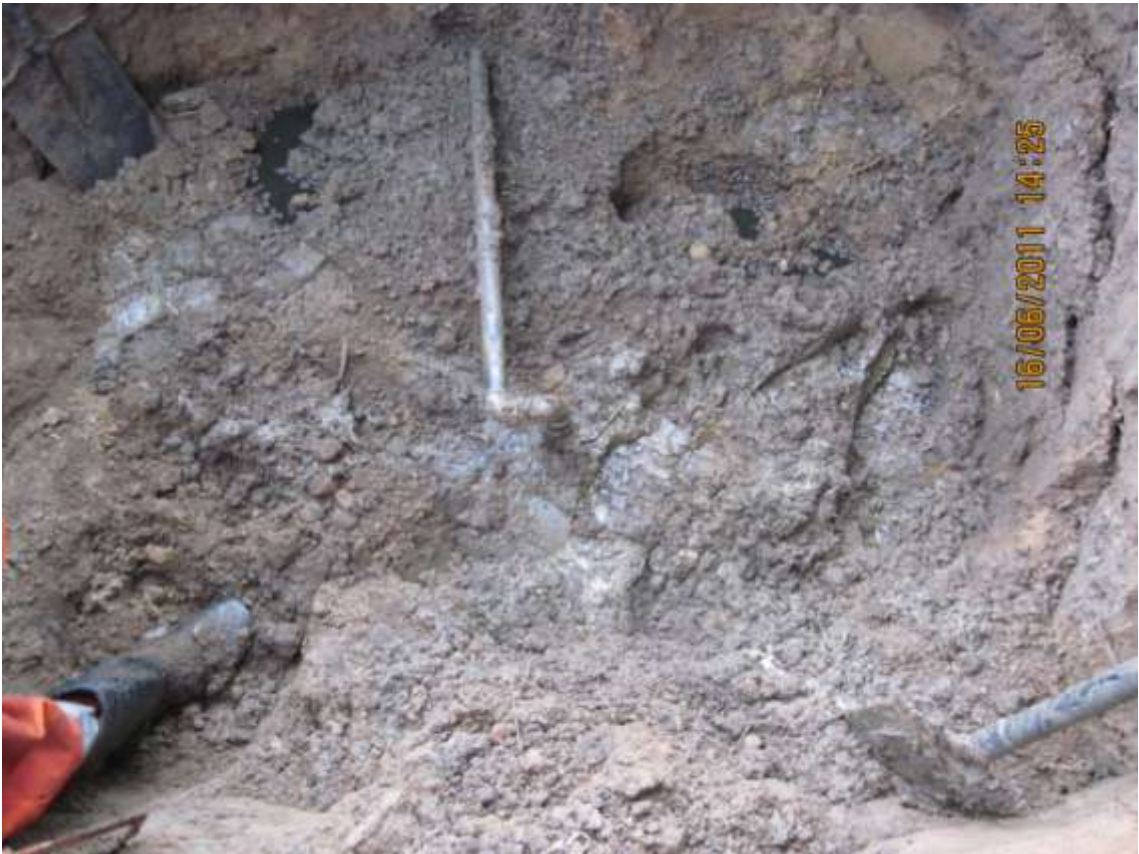
Close-up: Illegally welded fitting at 12 o'clock position on 12" ImoRiver2 pipeline at Owaza.
Picture taken during Joint Investigation of 16th June, 2011
