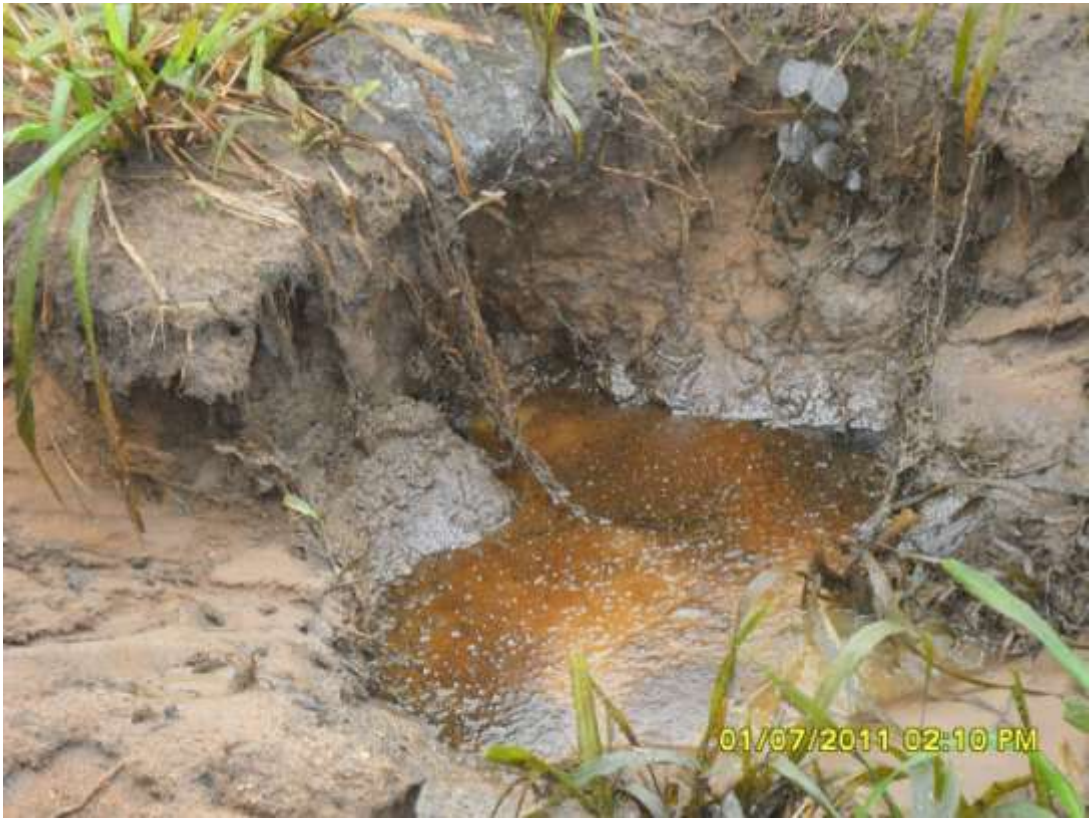
Overview: Part of the spill impact on Imoriver2 Well28L flowline at Umuedeokware. Picture taken during Joint Investigation of 1st July, 2011

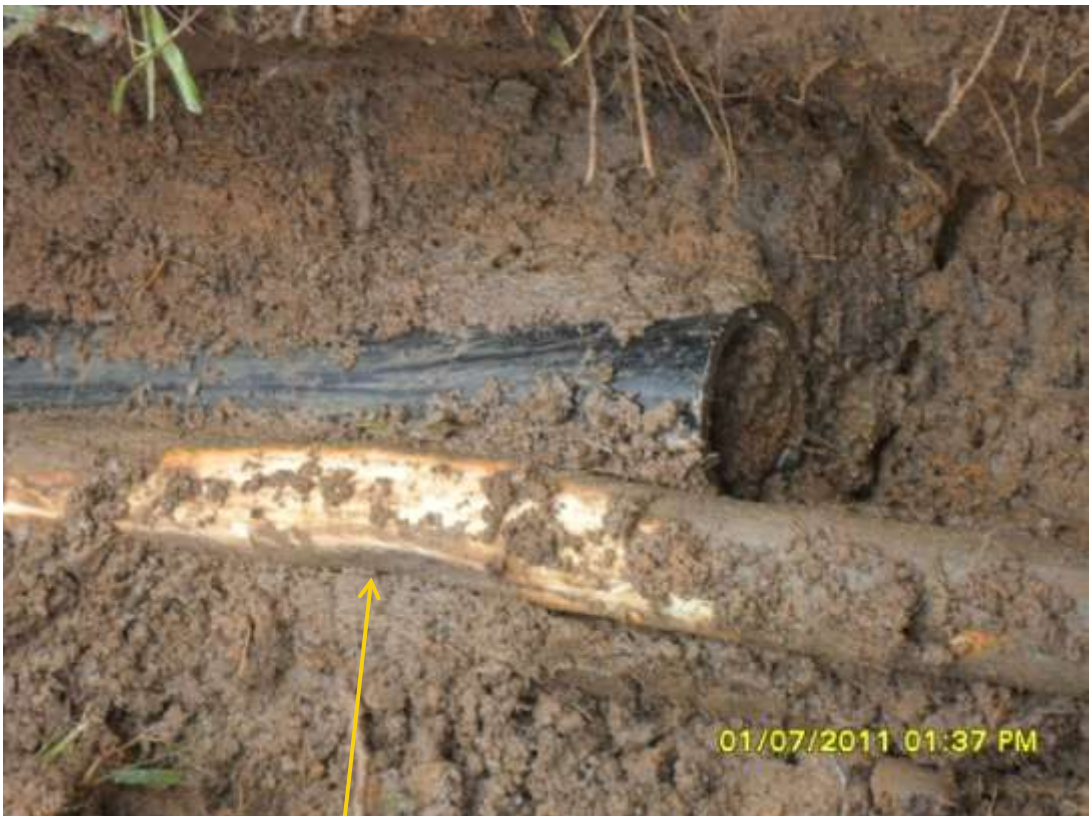
Close-up: Spill due to cut pipe on Imoriver2 Well28L flowline at Umuedeokware. Picture taken during Joint Investigation of 1st July, 2011
