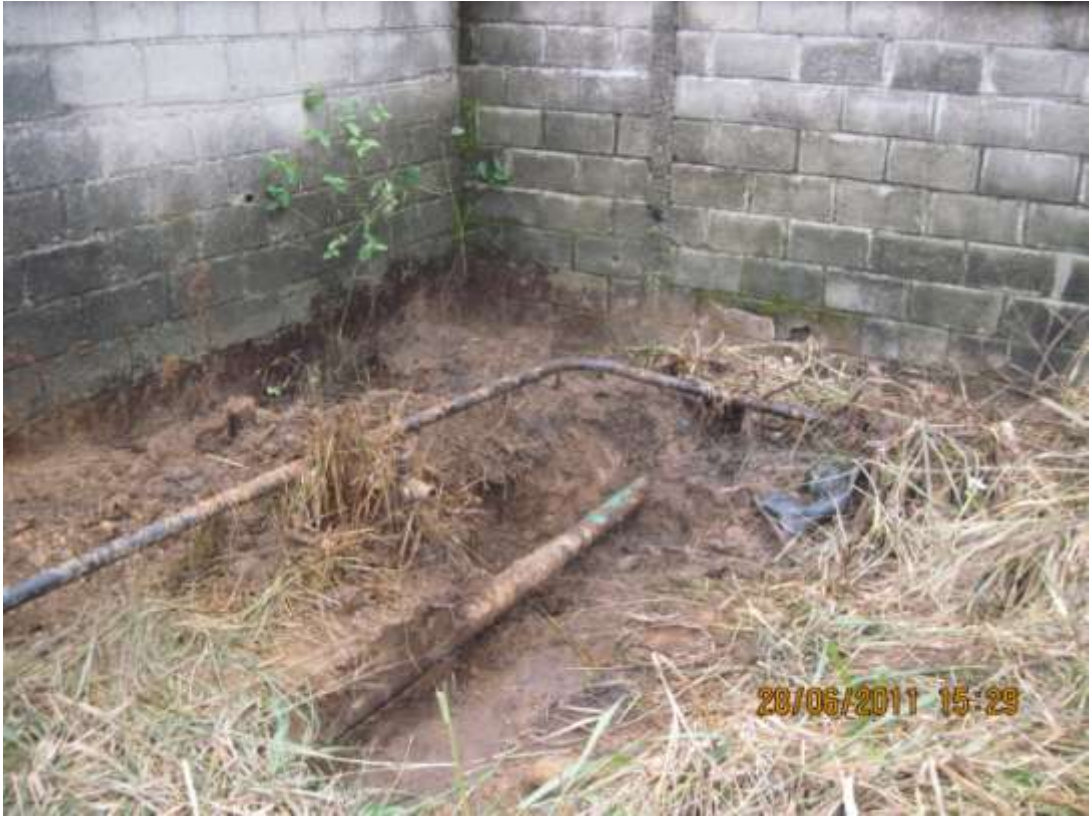
Overview: Impacted area within Obigbo Well20T wellhead facility at Umuebule. Picture taken during Joint Investigation of 28th June, 2011

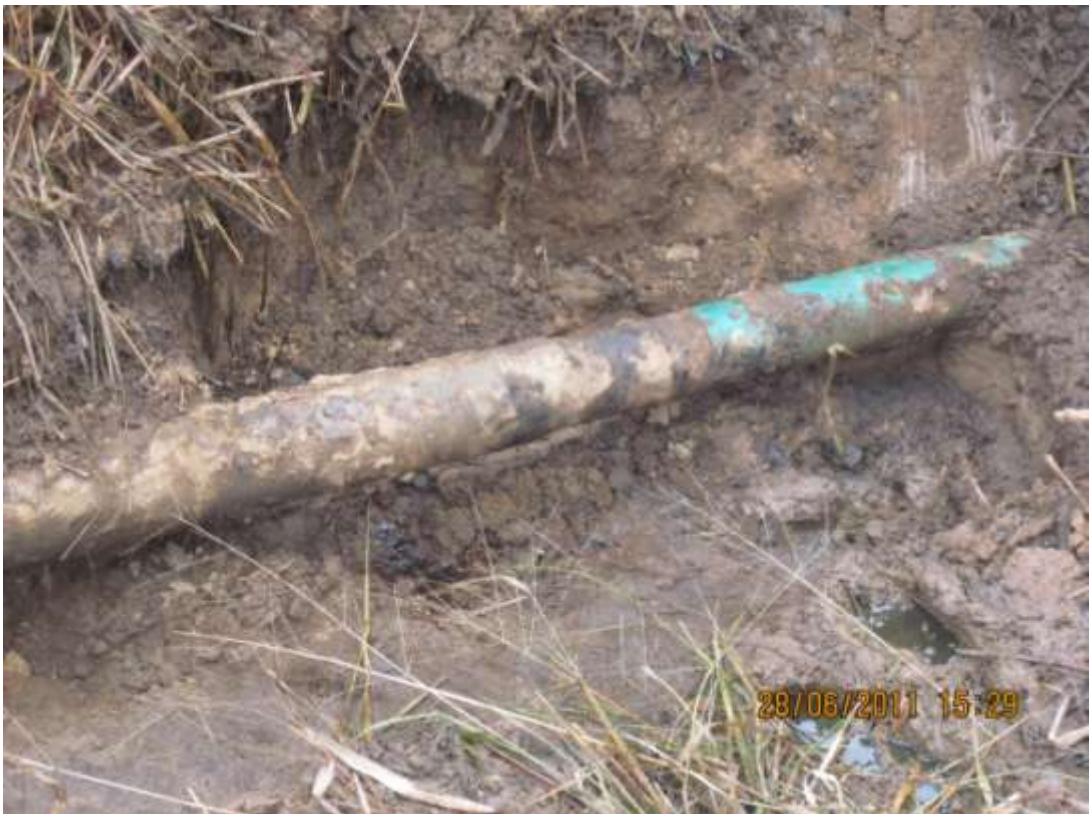
Close-up: Spill due to corrosion on Obigbo Well20T flowline at Umuebule. Picture taken during Joint Investigation of 28th June, 2011
