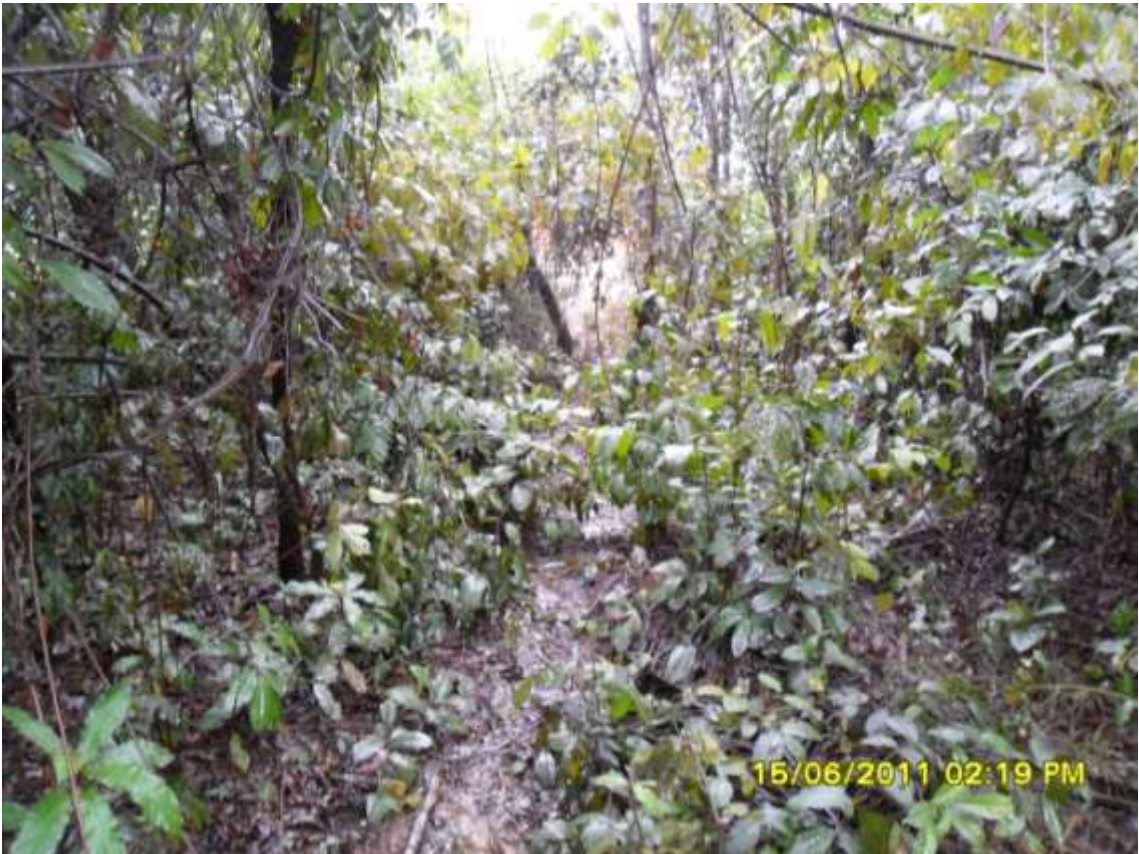
Overview: Spill impact on surrounding vegetation on 12" Imo River1 to Oghale pipeline Right of Way at Owaza. Picture taken during Joint Investigation of 15<sup>th</sup> June, 2011

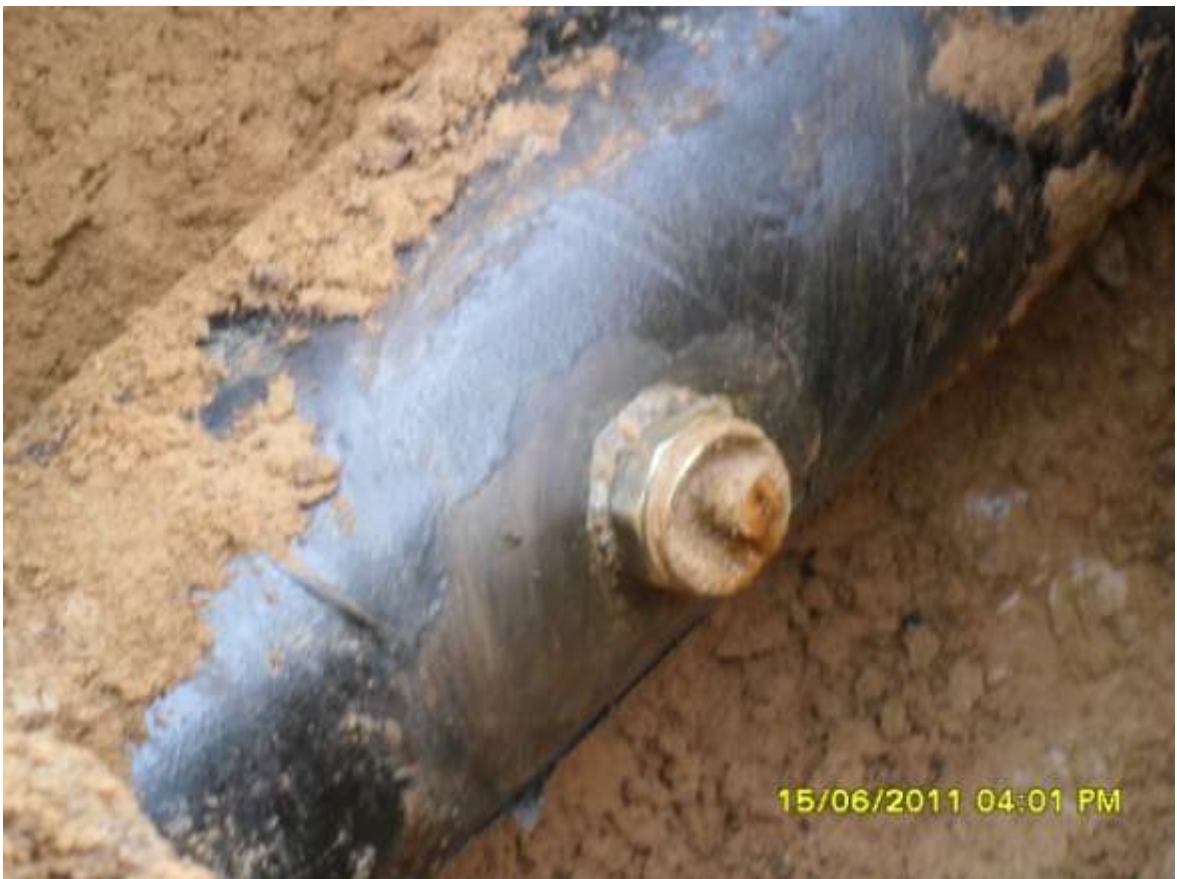
Close-up: Spill due to illegally welded nipple at 2 o'clock position on 12" Imo River1 to Oghale pipeline at Owaza. Picture taken during Joint Investigation of 15<sup>th</sup> June, 2011
