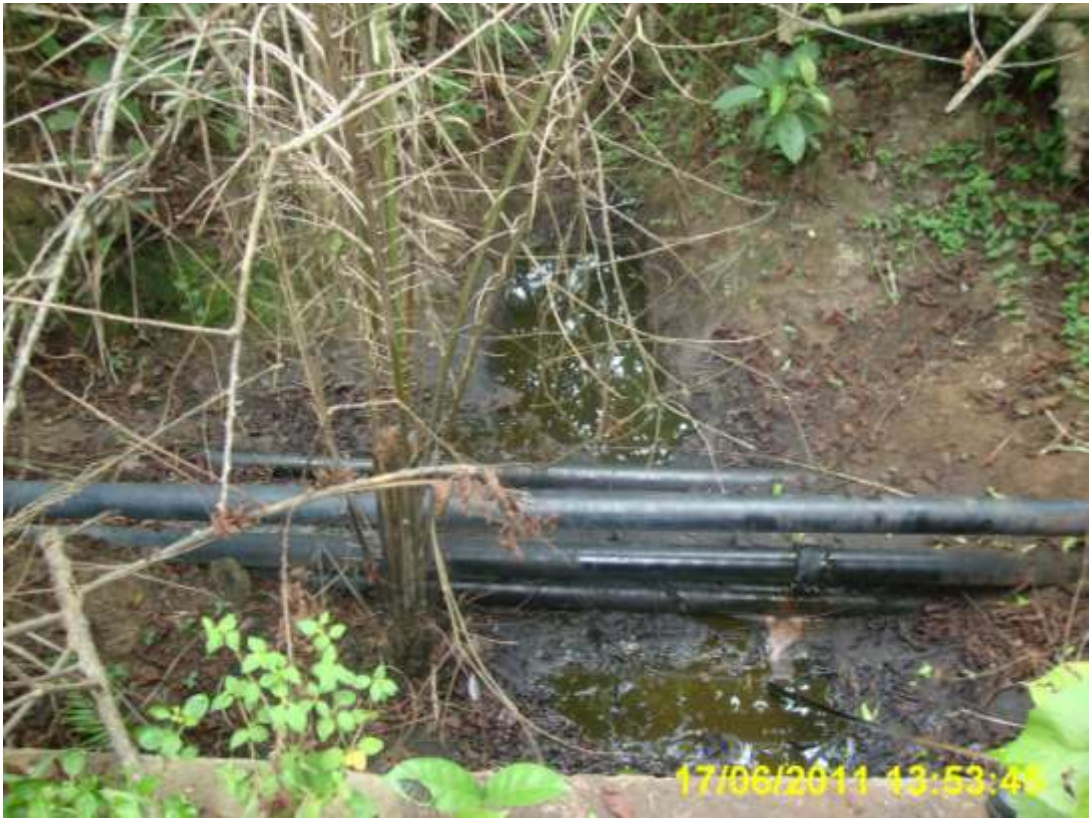
Overview: Part of the spill impact on Imo River Well 55S flowline at Igiriukwu. Picture taken during Joint Investigation of 17<sup>th</sup> June, 2011

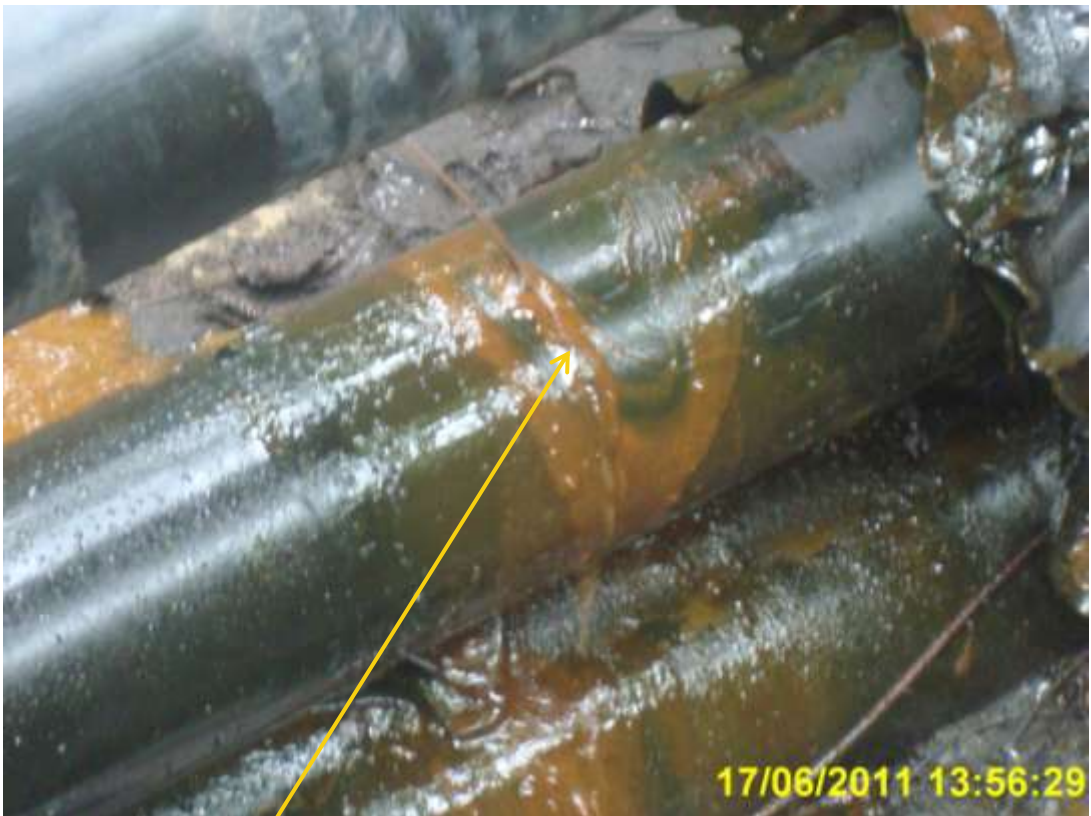
Close-up: Hacksaw cut on Imo River Well 55S flowline at Igiriukwu. Picture taken during Joint Investigation of 17<sup>th</sup> June, 2011
