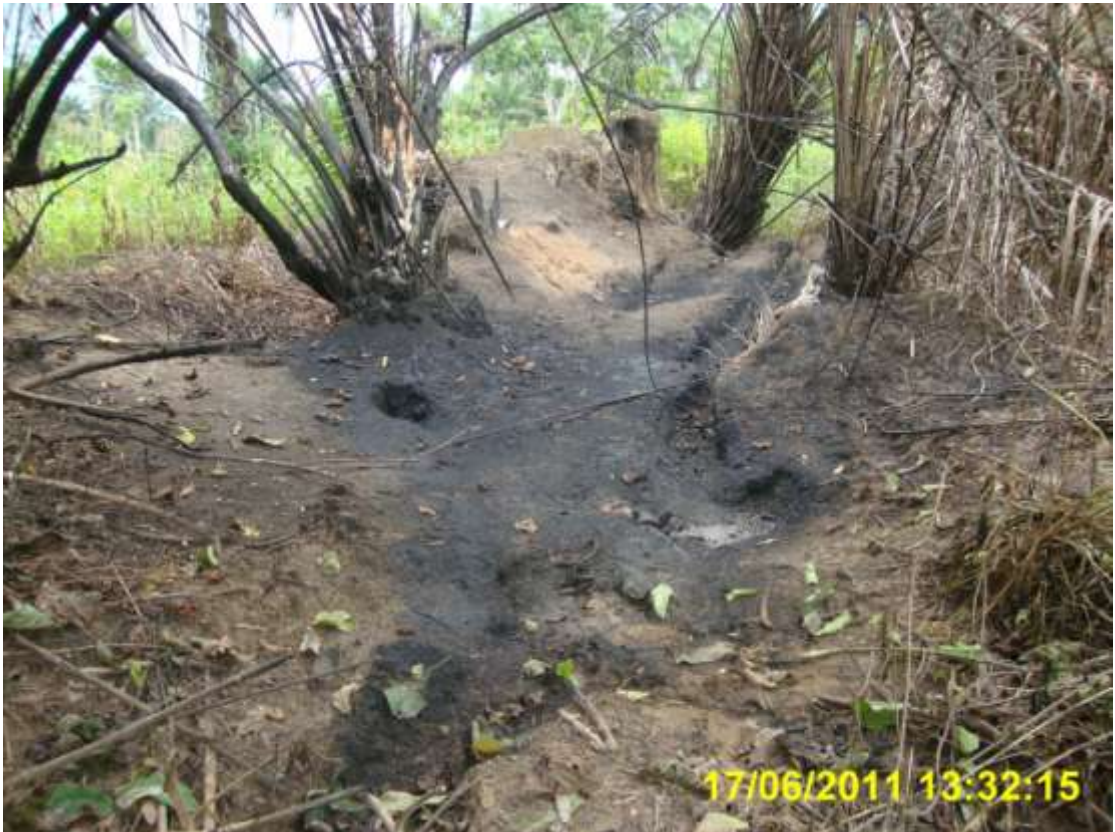
Overview: Part of area burnt by fire on Well56L flowline at Isietitioha. Picture taken during Joint Investigation of 17th June, 2011

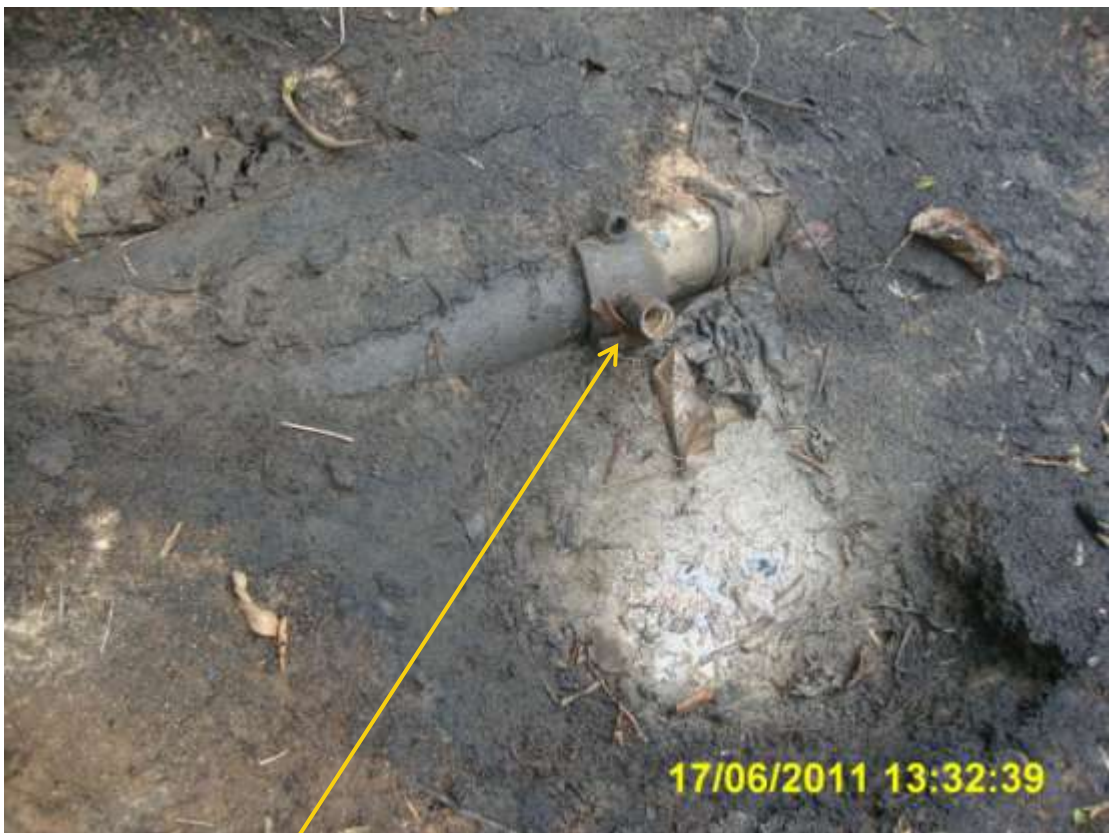
Close-up: Illegally welded fitting on Well56L flowline at Isietitioha. Picture taken during Joint Investigation of 17th June, 2011
