JOINT INVESTIGATION REPORT

INCIDENT NO: 2097834 JIV report S/N 1086

1. Spill incident Number: 2097834 2. Type of incident* OIL SPILL
 3. Name of Location OKORDIA MANIFOLD
 4. Name of nearest community IKARMA 5. State: BAYELSA 6. LGA YENAGOA
 7. Type of Production facility/Installation MANIFOLD
 8. Asset owner/District THE SHELL PETROLEUM DEVELOPMENT COMPANY OF NIGERIA LIMITED PIPELINE.

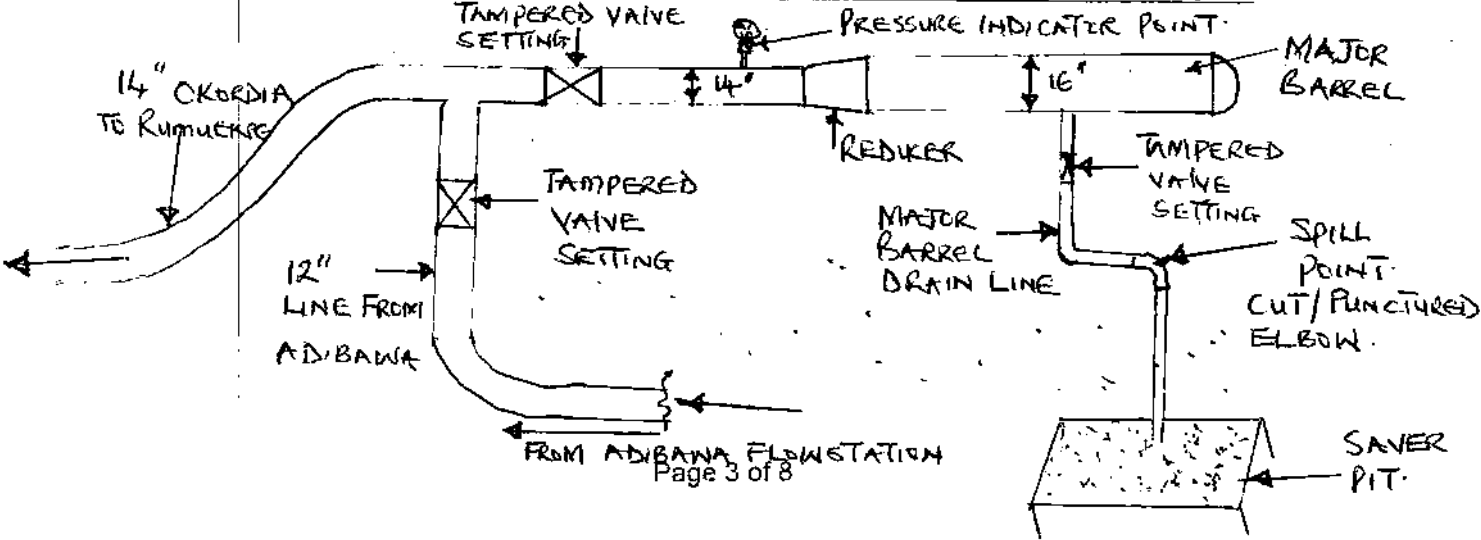
Additional observations around the spill point: THE OKORDIA MAJOR BARREL DRAIN VALVES WERE OBSERVED TAMPERED BY UNKNOWN PERSON (S) WHILE THE ELBOW ON THE DRAIN LINE WAS OBSERVED CUT AND PUNCTURED TO WIDEN THE POINT OF FLOW OR SPILL.

| <input type="checkbox"/> Corrosion | <input checked="" type="checkbox"/> Others(specify) <u>PUNCTURED DRAIN LINE BY UNKNOWN PERSON (S)</u> | |

SECTIONAL VIEW OF OKORDIA MANIFOLD AT IKRAMIA SHOWING THIRD PARTY TAMPERING WITH MAJOR BARREL DRAIN VALVES AND PUNCTURED DRAIN LINE BY UNKNOWN PERSON (S)

RECOVERY AND REPAIR WORK ARE ON-GOING.
