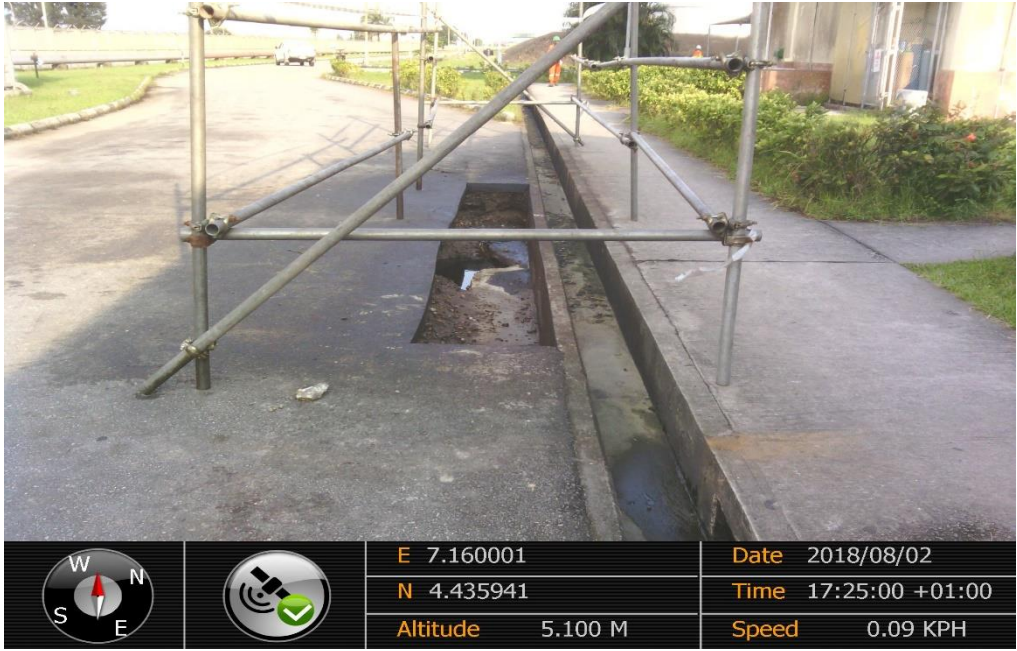
Overview: Part of spill impact on 16" Bonny Disused Export Pipelines at Bonny. Picture was taken during Joint Investigation of 2nd August 2018.

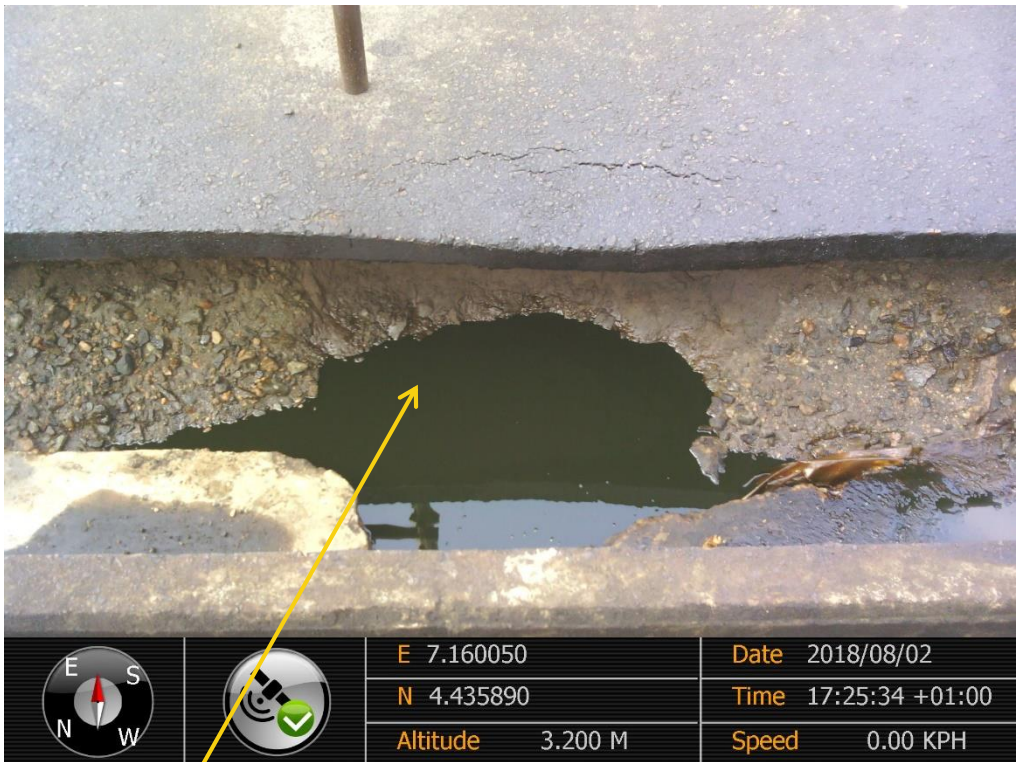
Close-up: Crude oil seeping from ground on 16" Bonny Disused Export Pipelines at Bonny. Picture was taken during Joint Investigation of 2nd August 2018.

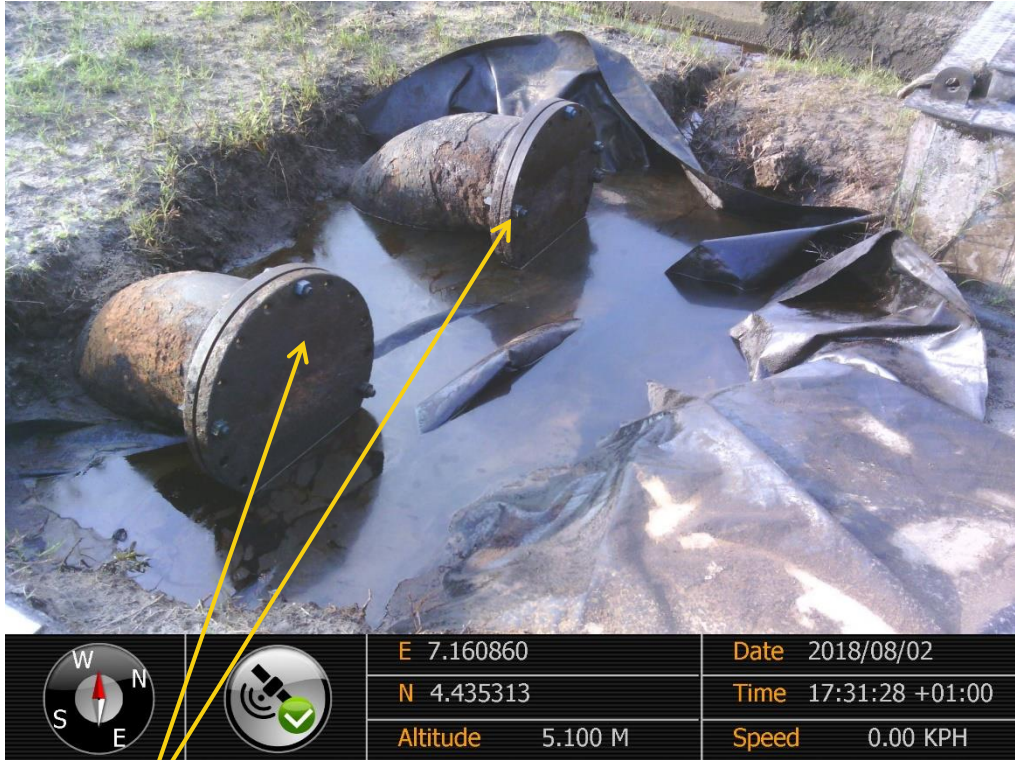
Close-up: Corroded Disused 16" Flanges on 16" Bonny Disused Export Pipelines at Bonny.
Picture was taken during Joint Investigation of 2nd August 2018.
