JOINT INVESTIGATION REPORT

INCIDENT NO: 2377510 JIV report S/N: 1030026

1. Fountain Incident Number: 2377510 2. Type of incident* OIL SPILL
3. Name of Location 24" OGALE - BOMU PIPELINE
4. Name of nearest community AGBETA 5. State: RIVERS 6. LGA ELEME
7. Type of Production facility/Installation OIL PIPELINE
8. Asset owner/District THE SHELL PETROLEUM DEVELOPMENT COMPANY OF NIGERIA LIMITED / PIPELINE

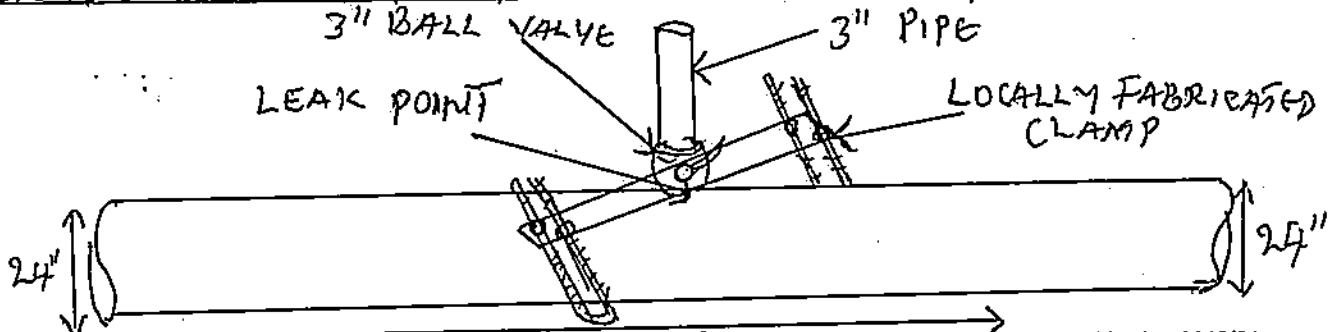
E. GRAPHIC DESCRIPTION OF LEAK POINT (while detail report of the leak point should be contained in the leak report, overview sketch of the site should be added as an appendix 1)

| <input checked="" type="checkbox"/> Failed Weld-on illegal hot tap valve | <input type="checkbox"/> Failed Clamp, | <input type="checkbox"/> Missing Pipeline/Flowline |
| <input checked="" type="checkbox"/> Crude oil theft (illegal bunkering) point, | <input type="checkbox"/> Saver-pit over flow | <input type="checkbox"/> Third party tampering with Clamp |

SECTION OF 24" OGALE - BOMU PIPELINE AT AGBETA SHOWING CRUDE OIL TEEFT POINT AT 12 O'CLOCK POSITION.

REPAIR WORK ACTIVITIES ONGOING.
