# JOINT INVESTIGATION REPORT

INCIDENT NO: 2372023 JIV report S/N: 1030028

1. Fountain Incident Number: 2372023 2. Type of incident\* OIL SPILL.  
3. Name of Location 14" OKORDIA - RUMUEKPE PIPELINE  
4. Name of nearest community OSHIE 5. State: RIVERS 6. LGA ATTOADA WEST.  
7. Type of Production facility/Installation OIL PIPELINE.  
8. Asset owner/District THE SHELL PETROLEUM DEVELOPMENT COMPANY OF NIGERIA LIMITED / PIPELINE.

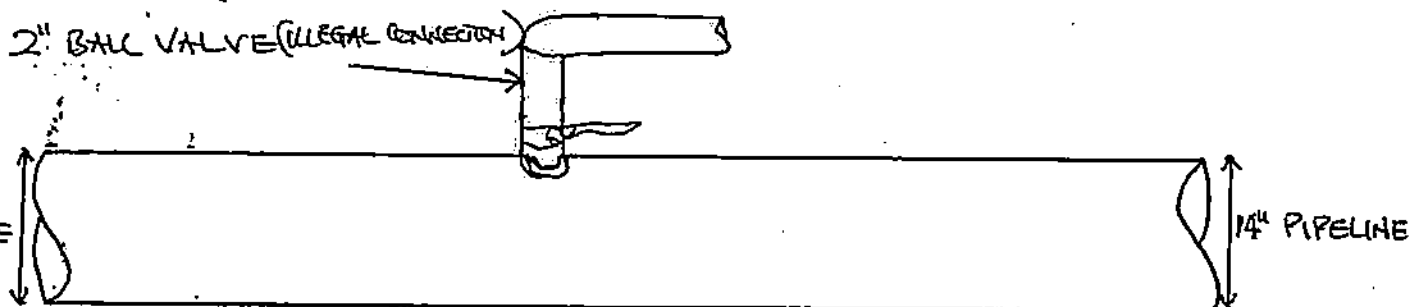
**E. GRAPHIC DESCRIPTION OF LEAK POINT** (while detail report of the leak point should be contained in the leak report, overview sketch of the site should be added as an appendix 1) A SECTION OF 14" OKORDIA-RUMUEKPE PIPELINE AT OSHI SHOWING A 2" BALL VALVE (ILLEGAL CONNECTION) INSTALLED AT 12 O'CLOCK POSITION BY UNKNOWN PERSON(S).

FROM OKORDIA TO RUMUEKPE

REPAIR BY CLAMPING.
