# JOINT INVESTIGATION REPORT

INCIDENT NO: 2368339 JIV report S/N: 1030020

1. Fountain Incident Number: 2368339 2. Type of incident\* OIL SPILL  
3. Name of Location 4" OBELE - IBAA PIPELINE  
4. Name of nearest community IBAA 5. State: RIVERS 6. LGA EMOHUA  
7. Type of Production facility/Installation OIL SPILL  
8. Asset owner/District THE SHELL PETROLEUM DEVELOPMENT COMPANY OF NIGERIA LIMITED / PIPELINE

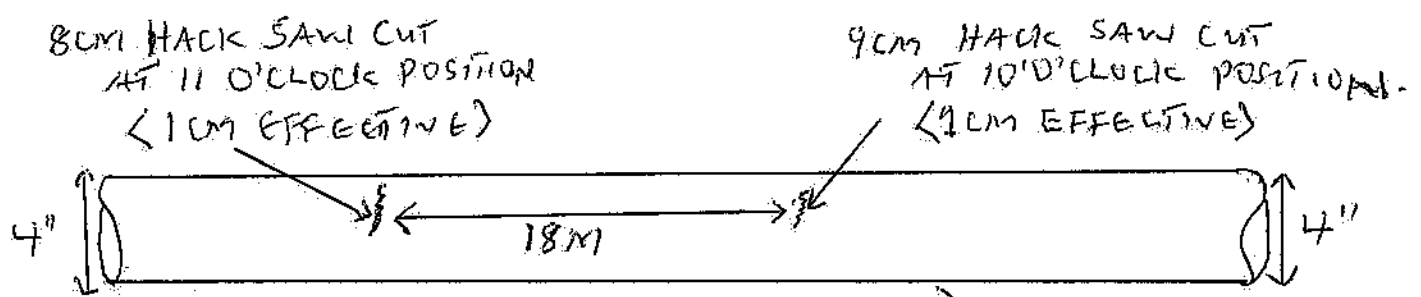
**E. GRAPHIC DESCRIPTION OF LEAK POINT** (while detail report of the leak point should be contained in the leak report, overview sketch of the site should be added as an appendix 1)

| <input type="checkbox"/> Drilled hole | <input checked="" type="checkbox"/> Hack saw cut | <input type="checkbox"/> Tear (_____) |

- Third party interference (Sabotage ; crude theft ; Line theft ; Accidental 3<sup>rd</sup> party damage   
 Operational  Others (including Mystery spills) \_\_\_\_\_

SECTION OF 4" OBELE - IBAA PIPELINE AT IBAA SHOWING HACK SAW CUTS AT 10 O'CLOCK AND 11 O'CLOCK POSITIONS.

REPAIR DONE BY CLAMPING
