# JOINT INVESTIGATION REPORT

INCIDENT NO: 2372017 JIV report S/N: 1030017

1. Fountain Incident Number: 2372017 2. Type of incident: OIL SPILL  
3. Name of Location: 14" OKORDIA - RUMUEKPE PIPELINE  
4. Name of nearest community: AKARA - OLU 5. State: RIVERS 6. LGA: AHOADA WEST  
7. Type of Production facility/Installation: OIL PIPELINE  
8. Asset owner/District: THE SPELL PETROLEUM DEVELOPMENT COMPANY OF NIGERIA LIMITED/PIPELINE

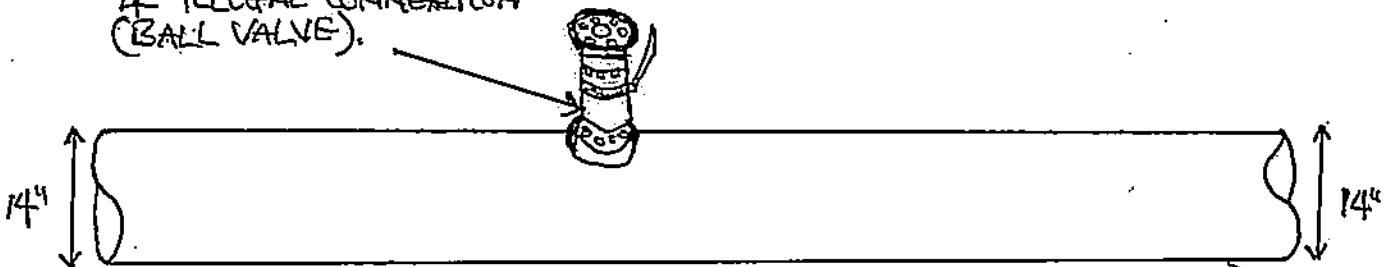
4" ILLEGAL CONNECTION (BALL VALVE).

**E. GRAPHIC DESCRIPTION OF LEAK POINT** (while detail report of the leak point should be contained in the leak report, overview sketch of the site should be added as an appendix 1) **A SECTION OF THE 14" OKORDIA - RUMUEKPE PIPELINE SHOWING A 4" ILLEGAL CONNECTION (BALL VALVE) INSTALLED AT 12 O'CLOCK POSITION BY UNKNOWN PERSON(S).**

FROM OKORDIA - RUMUEKPE PIPELINE

REPAIR BY CLAMPING ONGOING.
