# JOINT INVESTIGATION REPORT

INCIDENT NO: 2382108

1. Fountain Incident Number: 2382108 2. Type of incident\* OIL SPILL
3. Name of Location 28" NKPOKU - BOMU PIPELINE
4. Name of nearest community EJAMA H - EBUBU 5. State: RIVERS 6. LGA ELEME
7. Type of Production facility/Installation OIL PIPELINE
8. Asset owner/District THE SHELL PETROLEUM DEVELOPMENT COMPANY OF NIGERIA LIMITED PIPELINE

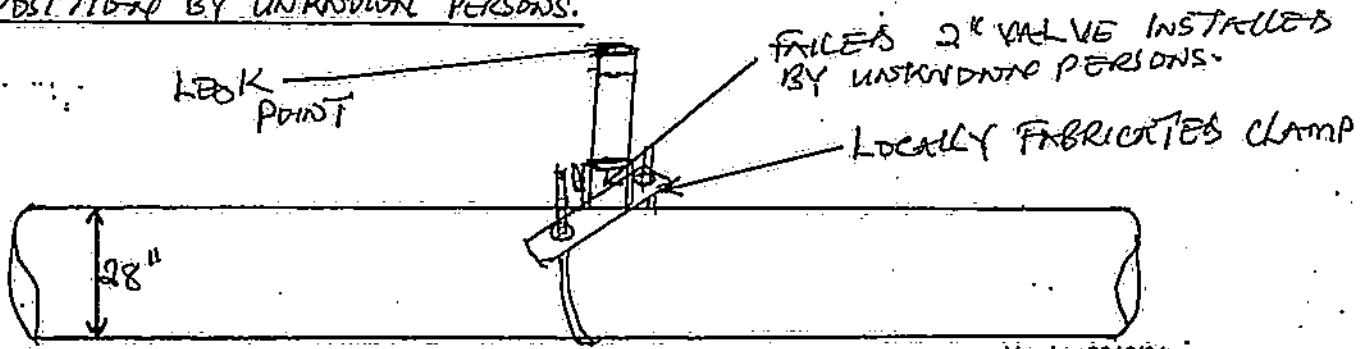
| <input checked="" type="checkbox"/> Failed Weld on illegal hot tap valve | <input type="checkbox"/> Failed Clamp, | <input type="checkbox"/> Missing Pipeline/Flowline |
| <input checked="" type="checkbox"/> Crude oil theft (illegal bunkering) point, | <input type="checkbox"/> Saver-pit over flow | <input type="checkbox"/> Third party tampering with Clamp |

**E. GRAPHIC DESCRIPTION OF LEAK POINT** (while detail report of the leak point should be contained in the leak report, overview sketch of the site should be added as an appendix 1) A SECTION OF 28" NKPOKU-BDMU PIPELINE SHOWING FAILES 2" VALVE INSTALLED AT 12 O'CLOCK POSITION BY UNKNOWN PERSONS.

FROM NKPOKU — BDMU MANIFOLDS. →

CRUDE OIL RECOVERY AND REPAIR BY

CLAMPING ARE ONGOING.
