JOINT INVESTIGATION REPORT

INCIDENT NO: 2382868 JIV report S/N: 1030039

1. Fountain Incident Number: 2382868 2. Type of incident* OIL SPILL
3. Name of Location 14^R OKORDIA - Rumuekpe (TRUNKLINE) PIPELINE
4. Name of nearest community OSHE 5. State: RIVERS 6. LGA ATOKADA WEST
7. Type of Production facility/Installation OIL PIPELINE
8. Asset owner/District THE SHELL PETROLEUM DEVELOPMENT COMPANY OF NIGERIA LIMITED PIPELINE.

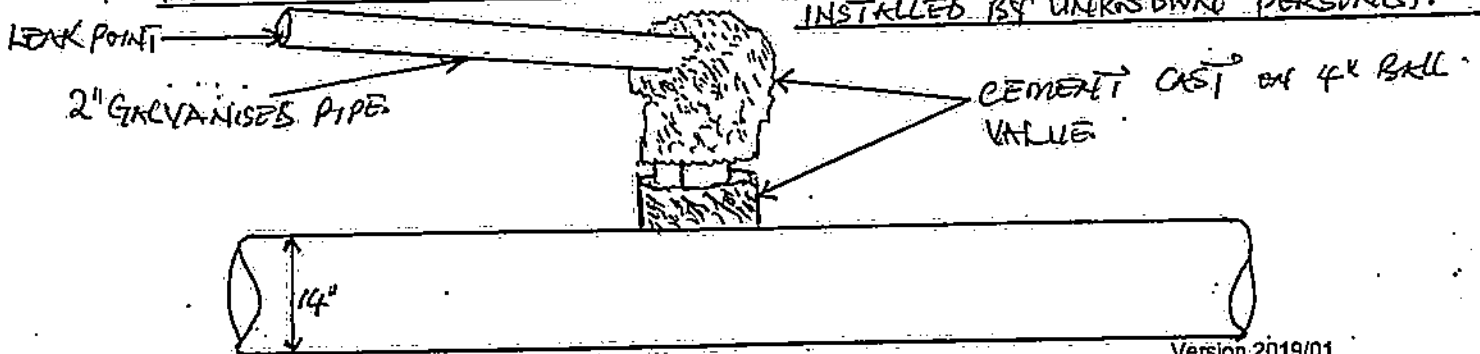
E. GRAPHIC DESCRIPTION OF LEAK POINT (while detail report of the leak point should be contained in the leak report, overview sketch of the site should be added as an appendix 1) SECTION 14' OKORDEA - KUMUEKPE

Additional observations around the spill point: THE JOINT INVESTIGATION TEAM OBSERVED CEMENT CAST ON THE 4" BALL VALVE AND 2" PIPE EL BOW.

PIPELINE AT OSHIE SHOWING ONE NO. 4" BALL VALVE WITH CEMENT CAST AT 12 O'CLOCK INSTALLED BY UNKNOWN PERSON(S).
