# JOINT INVESTIGATION REPORT

INCIDENT NO: 2660550 JIV report S/N: 0546

1. Fountain Incident Number: 2660550 2. Type of incident\* OIL SPILL  
3. Name of Location (NEW) 20" KOLOCREEK - RUMUEKPE PIPELINE  
4. Name of nearest community DDAU KP.1535 State: RIVERS 6. LGA ABUA/ODUAL  
7. Production Facility/Installation OIL PIPELINE  
8. Asset Owner/Hub THE SHELL PETROLEUM DEVELOPMENT COMPANY OF NIGERIA LIMITED (SPDC)/PIPELINE

NEW 20"KOLOCREEK-RUMUEKPE TL @ODAU KP 15.3

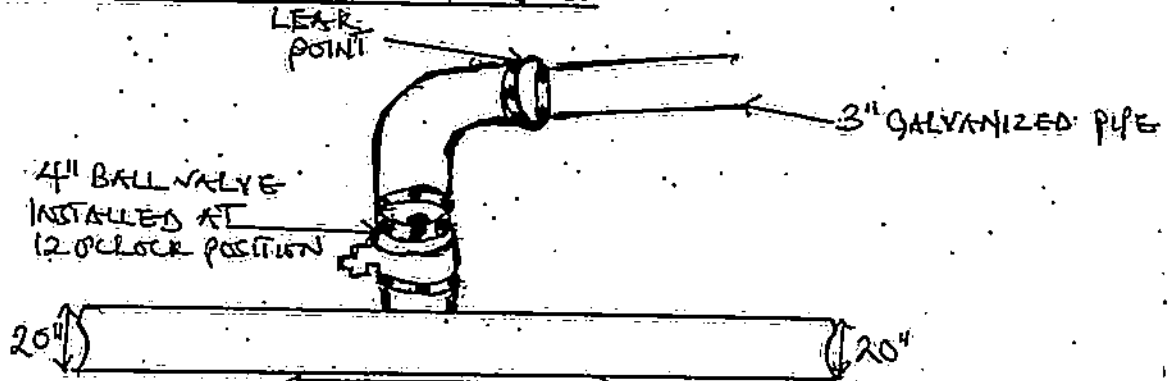
**E. GRAPHIC DESCRIPTION OF LEAK POINT** (while detailed description of the leak point should be contained in the leak report, overview sketch of the site should be added as appendix 1) A SECTION OF NEW 20" KOLO-CREEK - RUMUERGIE PIPELINE AT ODAU (KP 15.3) STRIKING A 4" BALL VALVE INSTALLED AT 12 O'CLOCK POSITION CONNECTED TO A 3" GALVANIZED PIPE WITH A 4" FLANGE BY UNKNOWN PERSONS.
