Overview: Part of spill impact on 12" Imo River - Ogale Pipeline at Umuololo . Picture was taken during Joint Investigation 9th June 2020.

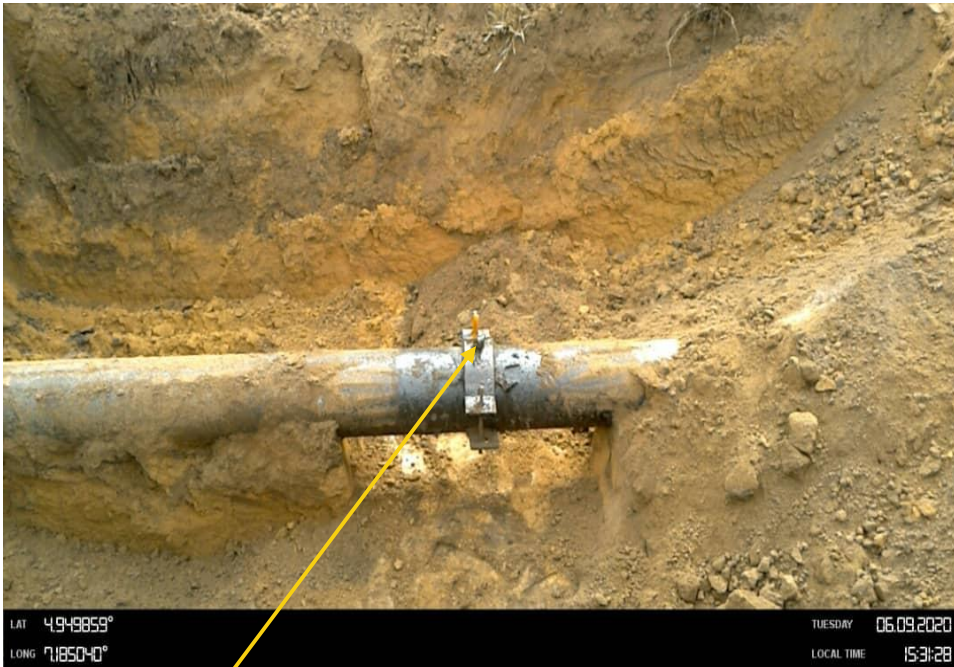
Close-up: 2" Crude oil theft valve on a locally fabricated clamp on 12" Imo River - Ogale Pipeline at Umuololo . Picture was taken during Joint Investigation 9th June 2020.
